# Hazardous Building Materials Assessment Portuguese Welfare Centre and Aldeas de Portugal

24A Australia Street,  
Camperdown NSW 2050

Inner West Council  
April 2018

Job No.: 57722-107

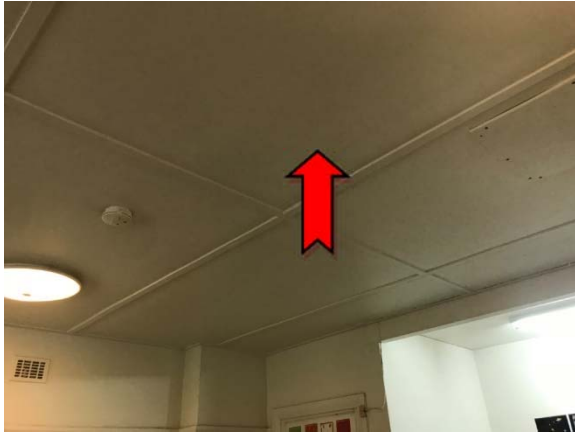
**Photo 1.** Interior, throughout, ceiling – asbestos-containing fibre cement sheeting.

- Non-friable asbestos was identified or assumed in the form of fibre cement sheeting throughout the ceiling of the building.

Area / Level	Room & Location	Feature	Item Description	Hazard Type	Sample No.	Sample Status	Friability	Disturb. Potential	Condition	Risk Status	Approx. Quantity	Recommendations & Comments	Control Priority	Reinspect Date	Photo No.
Interior	Throughout	Ceiling	Fibre cement sheeting	Asbestos	Same as 57722-107-002	Assumed Positive	Non-friable	Low	Good	Low	85 m <sup>2</sup>	Label as containing asbestos and maintain in current condition if to remain in-situ. Remove under controlled non-friable asbestos removal conditions prior to refurbishment or demolition works by a Class B (non-friable) licensed asbestos removal contractor.	P4	Feb-23	1
Interior	Storage room	Ceiling	Fibre cement sheeting	Asbestos	57722-107-003	Positive	Non-friable	Low	Good	Low	40 m <sup>2</sup>	Label as containing asbestos and maintain in current condition if to remain in-situ. Remove under controlled non-friable asbestos removal conditions prior to refurbishment or demolition works by a Class B (non-friable) licensed asbestos removal contractor.	P4	Feb-23	-

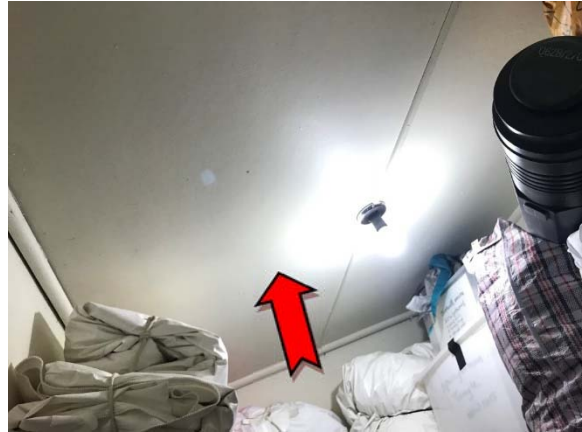
**Photo 2.** Interior, throughout, store cupboard, ceiling – asbestos-containing fibre cement sheeting.

Interior	Store cupboard	Ceiling	Fibre cement sheeting	Asbestos	57722-107-002	Positive	Non-friable	Low	Good	Low	2 m <sup>2</sup>	Label as containing asbestos and maintain in current condition if to remain in-situ. Remove under controlled non-friable asbestos removal conditions prior to refurbishment or demolition works by a Class B (non-friable) licensed asbestos removal contractor.	P4	Feb-23	2
Interior	Kitchen	Floor coverings - brown	Sheet vinyl	Asbestos	57722-107-001A	Negative	-	-	-	-	-	-	-	-	3
Interior	Kitchen	Floor coverings - brown	Adhesive	Asbestos	57722-107-001B	Negative	-	-	-	-	-	-	-	-	-
Interior	Kitchen	Hot water heater	Insulation material - internal	SMF	-	Suspected Positive	Bonded	Low	Good	Low	1 unit	Maintain in current condition if to remain in-situ. Remove under controlled SMF conditions as per the Code of Practice for the Safe Use of Synthetic Mineral Fibres [NOHSC: 2006 (1990)].	-	-	4

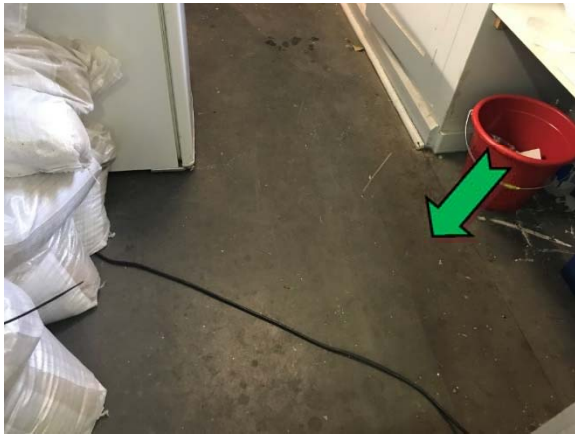
**Photo 3.** Interior, kitchen, floor coverings – non asbestos-containing sheet vinyl.

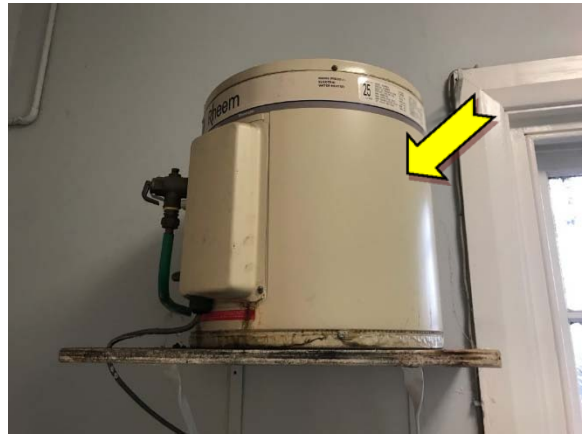
**Photo 4.** Interior, kitchen, hot water heater – suspected SMF internal insulation material.

- SMF internal insulation material was suspected within the hot water heater located in the kitchen.

- SMF materials that are likely to be disturbed during any proposed demolition/refurbishment works should be handled in accordance with the *Code of Practice for the Safe Use of Synthetic Mineral Fibres* [NOHSC:2006(1990)]. If these materials are impacted upon by accident or by pre-planned works, the Inner West Council must be informed via the contact detailed within Section 7: *Accidental Disturbance of Known or Suspected Hazardous Building Materials*. Following disturbance, inspection by a competent person should be undertaken.

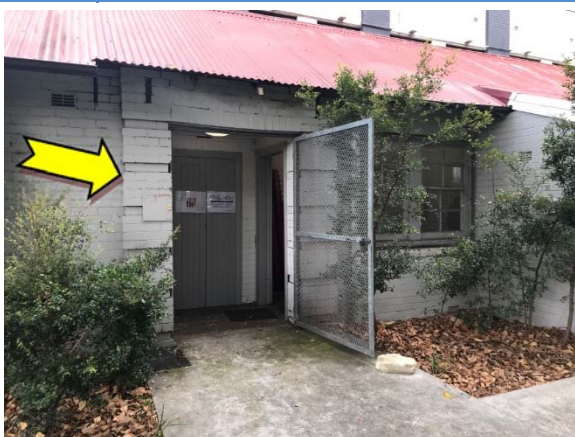
**Photo 5.** Exterior, throughout, walls – suspected lead-containing grey upper paint systems.

- LCP was suspected in the form of grey upper paint systems to the exterior of the building.

- The *LeadCheck* paint swab method can detect lead in paint at concentrations of 0.5% and above, and may indicate lead in some paint films as low as 0.2%. As paint with a lead content greater than 0.1% by dry weight is now considered to be lead-containing, Prensa recommends confirming status of suspected LCP identified during the Assessment by quantitative test method.

- The safest method of dealing with LCP is to replace or remove the items in their entirety that have LCP on them and replace them with new items that do not contain lead. This allows the items to be disposed of as regular building or demolition unsegregated waste in accordance with the NSW Environment Protection Authority (EPA) *Waste Classification Guidelines 2014 Part 1 – Classifying Waste*. The advantage of this method is the reduction in labour requirements to remove the lead paint and also this reduces the risk to workers from exposure to lead dust or fumes. If the removal of the LCP or coatings is the preferred or required option this may generate significant amounts of potential hazardous waste. This waste must be removed, collected and disposed of by an appropriately licensed contractor under controlled conditions that minimises the release to air, water and soil. Disposal of lead waste must be disposed of as hazardous waste at an approved waste facility.
