Hazardous Building Materials Assessment Camperdown Park Rotunda Australia Street, Camperdown NSW 2050

Inner West Council
April 2018

Job No.: 57722-079

Count ID: CID: 92

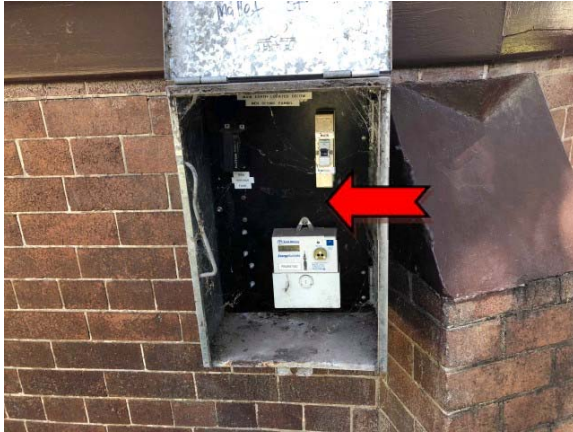
Photo 1. Exterior, electrical backing board – suspected asbestos-containing bituminous backing board.

- Non-friable asbestos was suspected in the form of bituminous backing boards to the exterior and subfloor electrical backing boards.

Area / Level	Room & Location	Feature	Item Description	Hazard Type	Sample No.	Sample Status	Friability	Disturb. Potential	Condition	Risk Status	Approx. Quantity	Recommendations & Comments	Control Priority	Reinspect Date	Photo No.
Exterior	East Elevation	Electrical backing board	Bituminous backing board	Asbestos	Not sampled: electrical hazard	Suspected Positive	Non-friable	Low	Good	Low	1 unit	Confirm status, label as containing asbestos and maintain in current condition if to remain in-situ. Remove under controlled non-friable asbestos removal conditions prior to refurbishment or demolition works by a Class B (non-friable) licensed asbestos removal contractor.	P4	Feb-23	1
Exterior	Throughout	Roof	Tiles	Asbestos	Not sampled: height restrictions	Suspected Negative	-	-	-	-	-	Suspected negative due to age and appearance.	-	-	2
Interior	Subfloor	Electrical backing board	Bituminous backing board	Asbestos	Not sampled: electrical hazard	Suspected Positive	Non-friable	Low	Good	Low	1 unit	Confirm status, label as containing asbestos and maintain in current condition if to remain in-situ. Remove under controlled non-friable asbestos removal conditions prior to refurbishment or demolition works by a Class B (non-friable) licensed asbestos removal contractor.	P4	Feb-23	3

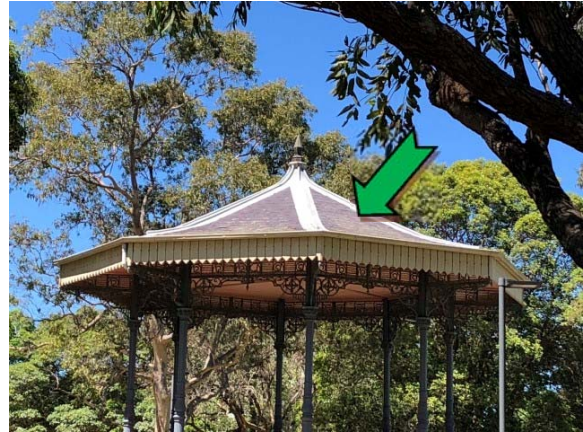
Photo 2. Exterior, throughout, roof – suspected non asbestos-containing roof tiles.

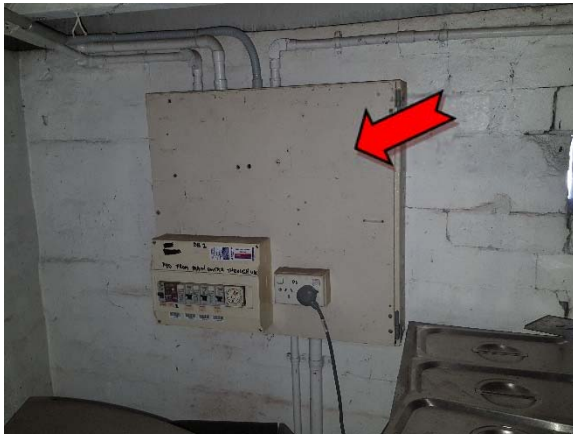
Photo 3. Interior, subfloor, electrical backing board – suspected asbestos-containing bituminous backing board.

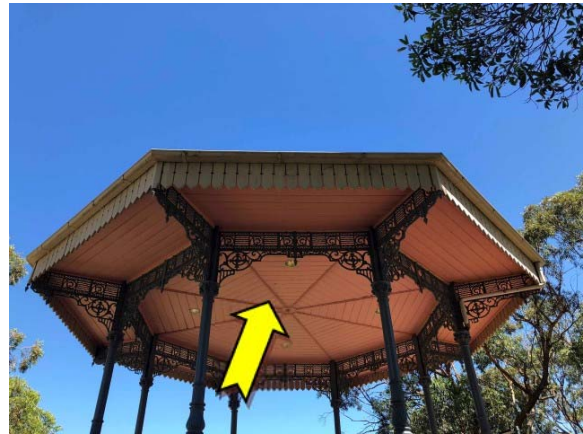
Photo 4. Exterior, throughout, ceiling – suspected lead-containing pink upper paint systems.

- LCP was suspected in the form of pink, grey, beige and white upper coloured paint systems throughout the rotunda.

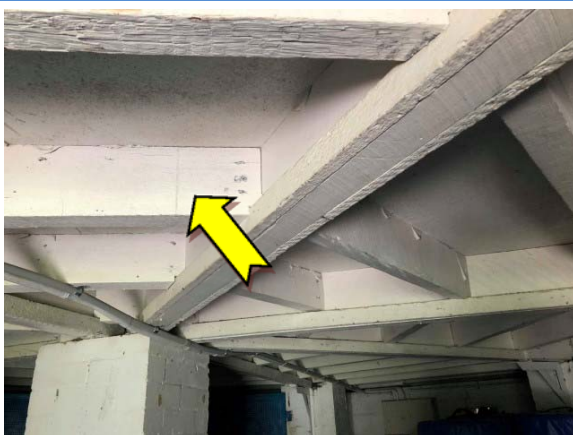
Photo 5. Interior, subfloor, walls, ceiling and timber slats – suspected lead-containing white upper paint systems.
