Hazardous Building Materials Assessment Camperdown Commons – Tennis Centre Mallett Street, Camperdown NSW 2050

Inner West Council
April 2018

Job No.: 57722-103

Executive Summary

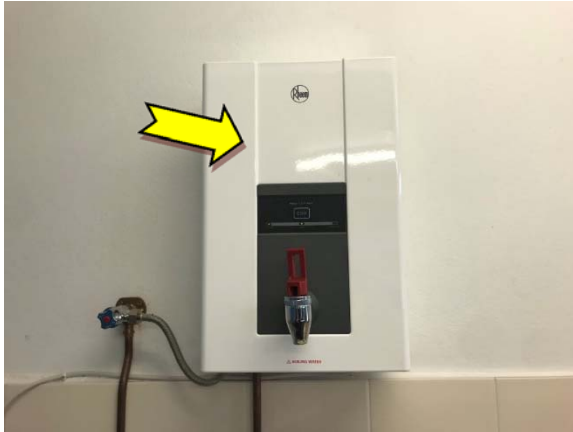
Photo 1. Interior, office, hot water boiler – suspected SMF internal insulation material.

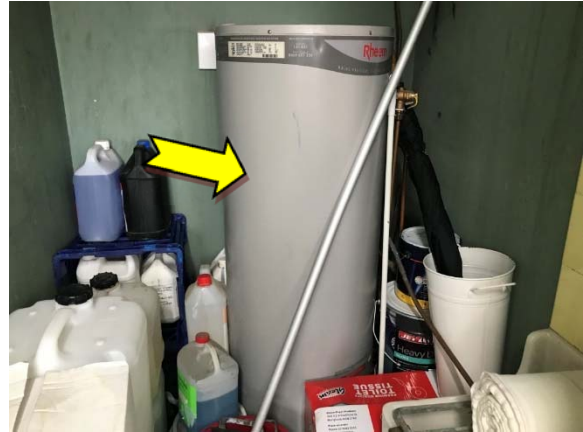
Interior	Female toilets, store cupboard	Hot water heater	Insulation material - internal	SMF	-	Suspected Positive	Bonded	Low	Good	Low	1 unit	Maintain in current condition if to remain in-situ. Remove under controlled SMF conditions as per the Code of Practice for the Safe Use of Synthetic Mineral Fibres [NOHSC: 2006 (1990)].	-	-	2
Interior	Male toilets, store cupboard	Hot water heater	Insulation material - internal	SMF	-	Suspected Positive	Bonded	Low	Good	Low	1 unit	Maintain in current condition if to remain in-situ. Remove under controlled SMF conditions as per the Code of Practice for the Safe Use of Synthetic Mineral Fibres [NOHSC: 2006 (1990)].	-	-	3
Throughout	-	-	-	PCBs	-	-	-	-	-	-	-	No suspect PCB-containing capacitors identified at the time of the assessment.	-	-	-
Interior	Female toilets, store cupboard	Floor	Green (dark) - upper coloured paint system	Lead Paint - Swab	-	Suspected Positive	-	Low	Fair	Low	1m ²	Confirm status by quantitative test method, maintain in current condition, over paint with a lead-free paint as part of ongoing maintenance. Remove under controlled conditions in accordance with AS 4361.2:2017 Guide to hazardous paint management prior to renovation or demolition works.	-	-	4

Photo 2. Interior, female toilets, store cupboard, hot water heater – suspected SMF internal insulation material.

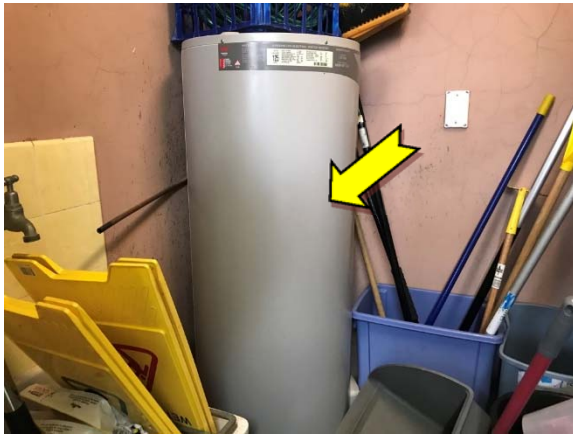
Photo 3. Interior, men's toilets, store cupboard, hot water heater – suspected SMF internal insulation material.

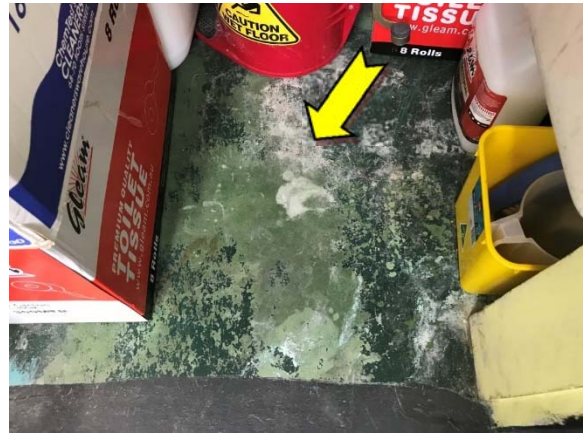
Photo 4. Interior, female toilets, store cupboard, floor – suspected lead-containing dark green upper and light green lower coloured paint systems.

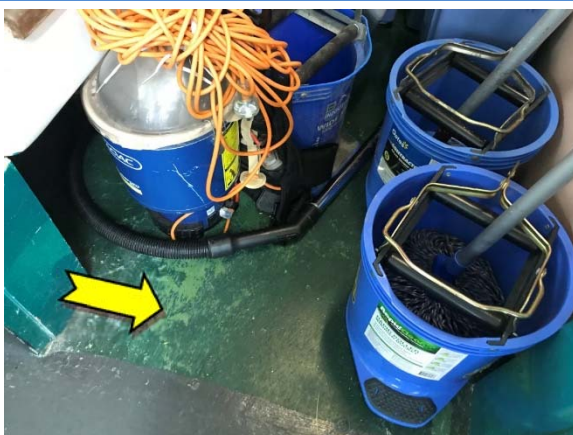
Interior	Female toilets, store cupboard	Floor	Green (light) - lower coloured paint system	Lead Paint - Swab	-	Suspected Positive	-	Low	Fair	Low	1m ²	Confirm status by quantitative test method, maintain in current condition, over paint with a lead-free paint as part of ongoing maintenance. Remove under controlled conditions in accordance with AS 4361.2:2017 Guide to hazardous paint management prior to renovation or demolition works.	-	-	4
Interior	Male toilets, store cupboard	Floor	Green (dark) - upper coloured paint system	Lead Paint - Swab	-	Suspected Positive	-	Low	Fair	Low	1m ²	Confirm status by quantitative test method, maintain in current condition, over paint with a lead-free paint as part of ongoing maintenance. Remove under controlled conditions in accordance with AS 4361.2:2017 Guide to hazardous paint management prior to renovation or demolition works.	-	-	5
Interior	Male toilets, store cupboard	Floor	Green (light) - lower coloured paint system	Lead Paint - Swab	-	Suspected Positive	-	Low	Fair	Low	1m ²	Confirm status by quantitative test method, maintain in current condition, over paint with a lead-free paint as part of ongoing maintenance. Remove under controlled conditions in accordance with AS 4361.2:2017 Guide to hazardous paint management prior to renovation or demolition works.	-	-	5

Photo 5. Interior, male toilets, store cupboard, floor – suspected lead-containing dark green upper and light green lower coloured paint systems.

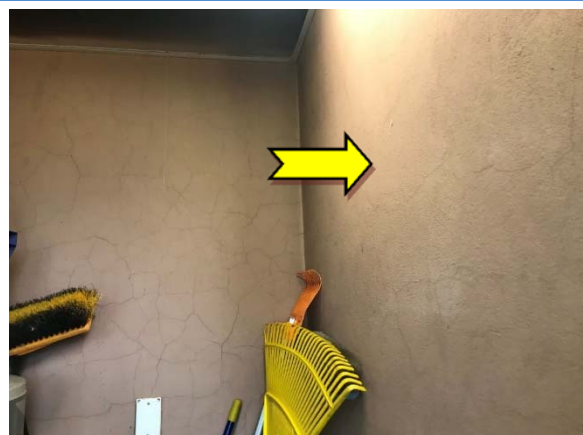
Photo 6. Interior, male toilets, store cupboard, walls – suspected lead-containing pink upper paint systems.
