# Hazardous Building Materials Assessment

## Chrissie Cotter Gallery

Pidcock Street,  
Camperdown NSW 2050

Inner West Council  
April 2018

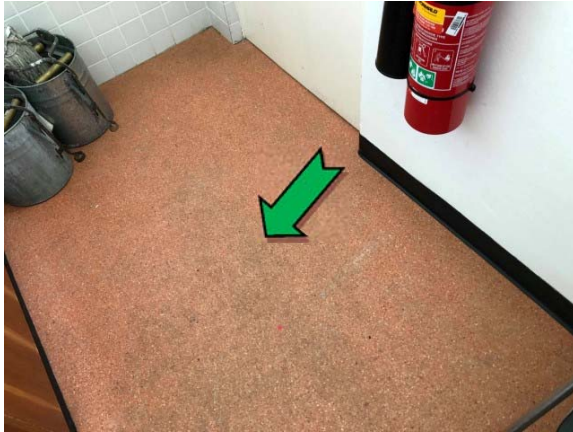
**Photo 1.** Interior, kitchen, beige floor coverings – non asbestos-containing sheet vinyl.

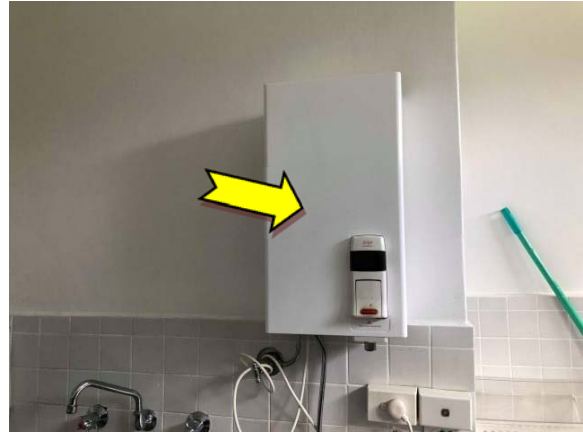
**Photo 2.** Interior, kitchen, hot water heater – suspected SMF internal insulation material.

- SMF internal insulation material was suspected within the hot water heater in the kitchen.

- SMF materials that are likely to be disturbed during any proposed demolition/refurbishment works should be handled in accordance with the *Code of Practice for the Safe Use of Synthetic Mineral Fibres* [NOHSC:2006(1990)]. If these materials are impacted upon by accident or by pre-planned works, the Inner West Council must be informed via the contact detailed within Section 7: *Accidental Disturbance of Known or Suspected Hazardous Building Materials*. Following disturbance, inspection by a competent person should be undertaken.

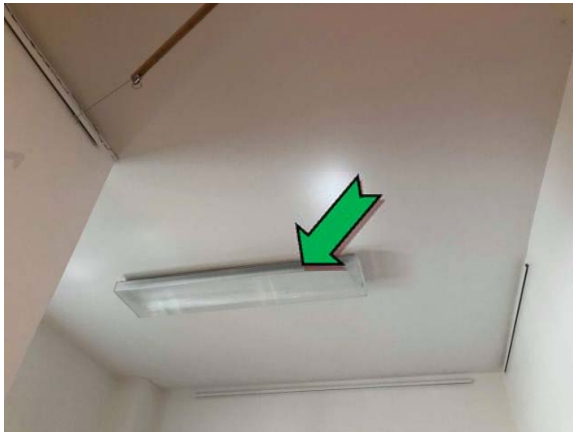
Interior	Kitchen	Fluorescent light fitting - double tube	Capacitor	PCBs	-	Suspected Negative	-	-	-	-	2 units	PCB-containing capacitors are unlikely to be present due to age and appearance of light fittings. Confirm PCB status prior to refurbishment or demolition works.	-	-	-
Exterior	Lower level	Walls	Green - upper coloured paint system	Lead Paint - Swab	-	Suspected Positive	-	Low	Good	Low	30 m <sup>2</sup>	Confirm status by quantitative test method, maintain in current condition, over paint with a lead-free paint as part of ongoing maintenance. Remove under controlled conditions in accordance with AS 4361.2:2017 Guide to hazardous paint management prior to renovation or demolition works.	-	-	-
Exterior	Throughout	Fences	White - upper coloured paint system	Lead Paint - Swab	-	Positive	-	Low	Fair	Medium	1 m <sup>2</sup>	Remove flaking sections and over paint with a lead-free paint. Remove under controlled conditions in accordance with AS 4361.2:2017 Guide to hazardous paint management prior to renovation or demolition works.	-	-	4

**Photo 3.** Interior, adjacent entry, double tubed fluorescent light fitting – suspected non PCB-containing capacitors.

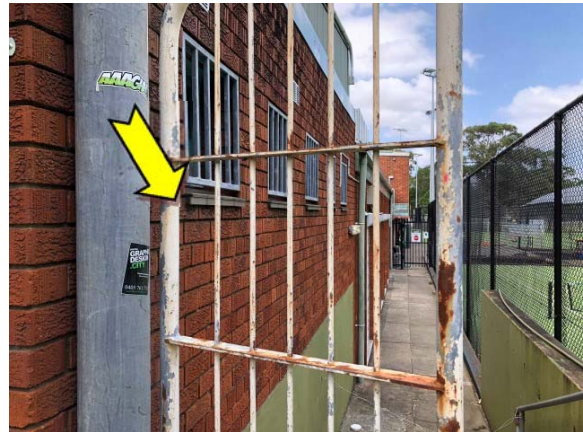
**Photo 4.** Exterior, throughout, fences – lead-containing white upper coloured paint system.

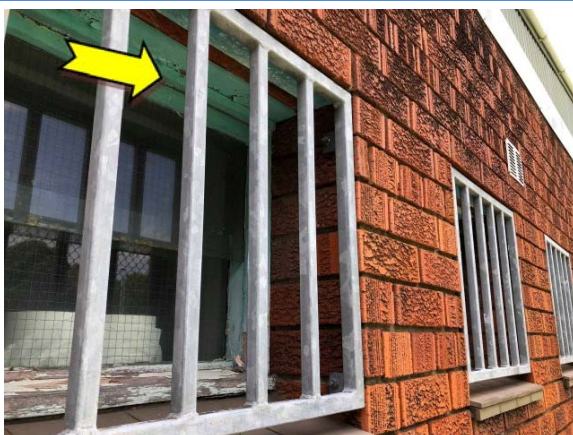
Exterior	Front of house, doors	Doors, window frames and awnings	Blue - upper coloured paint system	Lead Paint - Swab	-	Suspected Positive	-	Low	Good	Low	10 m <sup>2</sup>	Confirm status by quantitative test method, maintain in current condition, over paint with a lead-free paint as part of ongoing maintenance. Remove under controlled conditions in accordance with AS 4361.2:2017 Guide to hazardous paint management prior to renovation or demolition works.	-	-	-
Exterior	Western elevation	Window frames	Blue (light) - upper coloured paint system	Lead Paint - Swab	-	Positive	-	Low	Fair	Medium	3 m <sup>2</sup>	Remove flaking sections and over paint with a lead-free paint. Remove under controlled conditions in accordance with AS 4361.2:2017 Guide to hazardous paint management prior to renovation or demolition works.	-	-	5
Interior	Throughout	Walls	White - upper coloured paint system	Lead Paint - Swab	-	Suspected Positive	-	Low	Good	Low	200 m <sup>2</sup>	Confirm status by quantitative test method, maintain in current condition, over paint with a lead-free paint as part of ongoing maintenance. Remove under controlled conditions in accordance with AS 4361.2:2017 Guide to hazardous paint management prior to renovation or demolition works.	-	-	-

**Photo 5.** Exterior, throughout, window frames – lead-containing blue upper coloured paint systems.

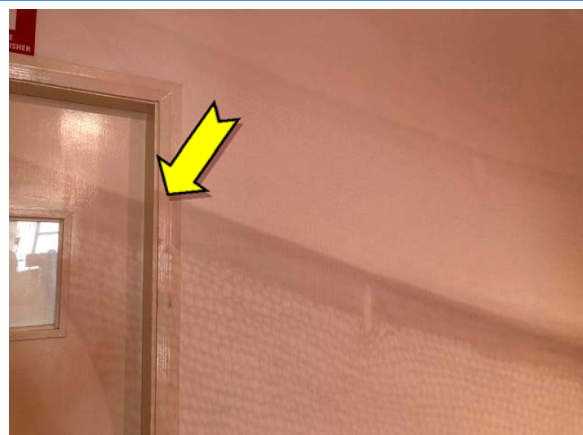
Interior	Throughout	Windows and door frames	Beige - upper coloured paint system	Lead Paint - Swab	-	Positive	-	Low	Fair	Medium	20 m <sup>2</sup>	Remove flaking sections and over paint with a lead-free paint. Remove under controlled conditions in accordance with AS 4361.2:2017 Guide to hazardous paint management prior to renovation or demolition works.	-	-	6
Throughout	-	-	-	Ozone Depleting Substances	-	-	-	-	-	-	-	No suspect ODS's identified at the time of the assessment.	-	-	-

**Photo 6.** Interior, throughout, windows and door frames – lead-containing beige upper coloured paint system.

- Remove flaking lead containing paint to window surrounds throughout the property in accordance with AS4361.2-2017 Guide to Hazardous Paint Management and relevant legislation.
