# Hazardous Building Materials Assessment Deborah Little Early Learning Centre – Main Building 1 MacArthur Parade Dulwich Hill NSW 2203

Inner West Council  
April 2018

Job No.: 57722-009

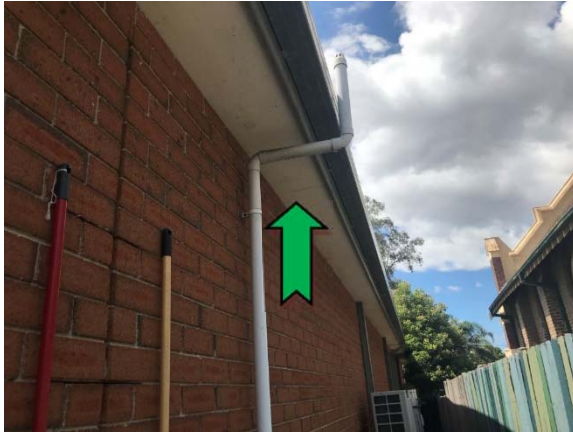
**Photo 1.** Exterior, south elevation, throughout, eaves – non asbestos-containing fibre cement sheeting.

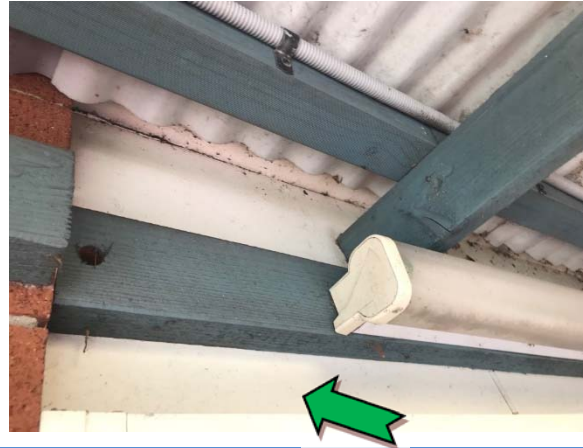
**Photo 2.** Exterior, north-east elevation, high level infill panels above window – non asbestos-containing fibre cement sheeting.

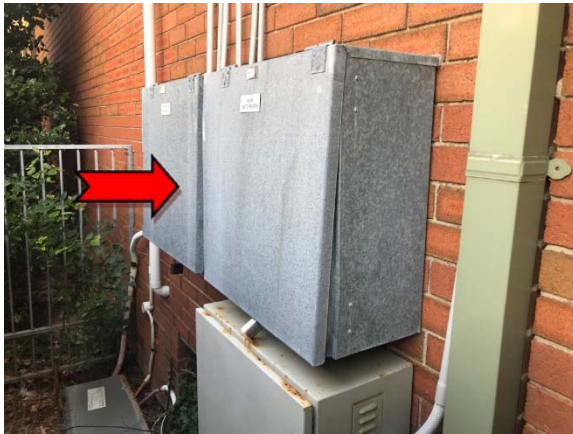
**Photo 3.** Exterior, south elevation, electrical backing board – suspected asbestos-containing bituminous backing board.

Area / Level	Room & Location	Feature	Item Description	Hazard Type	Sample No.	Sample Status	Friability	Disturb. Potential	Condition	Risk Status	Approx. Quantity	Recommendations & Comments	Control Priority	Reinspect Date	Photo No.
Exterior, ground level	South elevation, throughout	Eaves	Fibre cement sheeting	Asbestos	Same as 57722-009-003	Assumed Negative	-	-	-	-	-	-	-	-	1
Exterior, ground level	North-east elevation, above window	Infill panel	Fibre cement sheet	Asbestos	57722-009-003	Negative	-	-	-	-	-	-	-	-	2
Exterior, ground level	South elevation, electrical box	Electrical backing board	Bituminous backing board	Asbestos	Not sampled: electrical hazard	Suspected Positive	Non-friable	Low	Good	Low	2 units	Confirm status, label as containing asbestos and maintain in current condition if to remain in-situ. Remove under controlled non-friable asbestos removal conditions prior to refurbishment or demolition works by a Class B (non-friable) licensed asbestos removal contractor.	P4	Feb-23	3

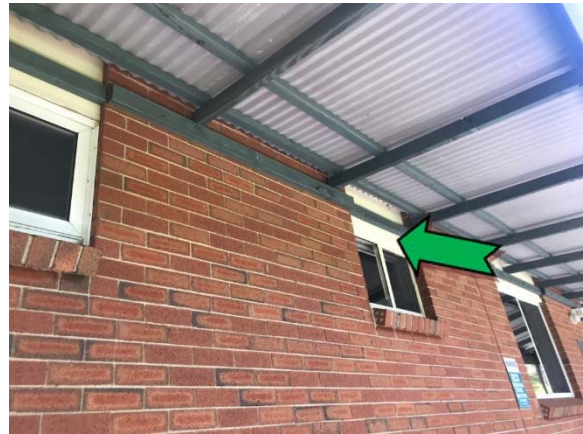
**Photo 4.** Exterior, throughout, high level infill panels above windows – assumed non asbestos-containing fibre cement sheeting.

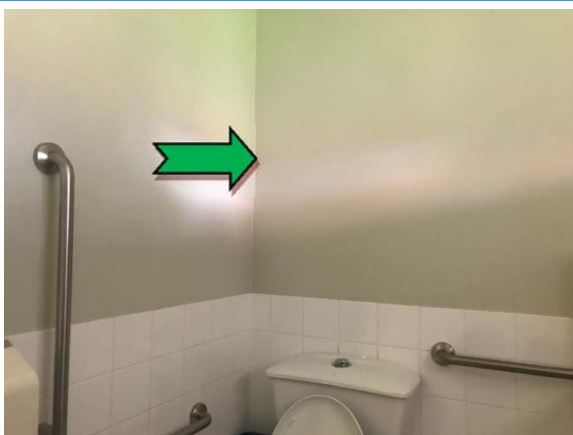
**Photo 5.** Interior, staff WC, throughout walls – non asbestos-containing fibre cement sheeting.

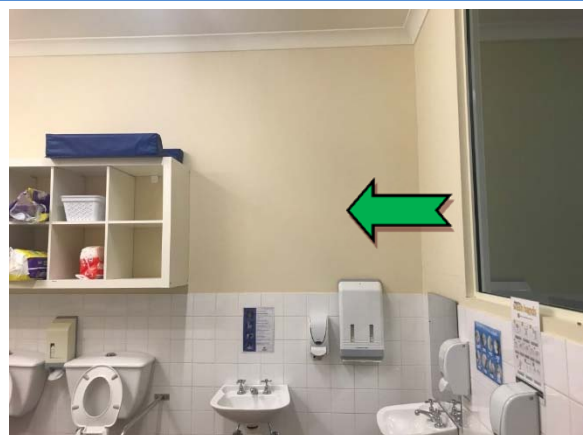
**Photo 6.** Interior, toilets 1, throughout walls – non asbestos-containing fibre cement sheeting.

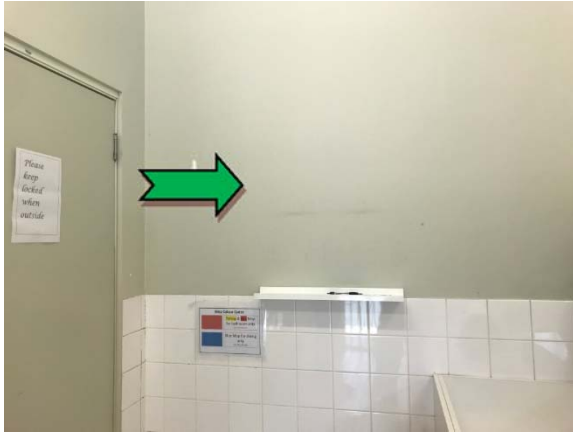
**Photo 7.** Interior, toilets 2, throughout, walls – non asbestos-containing fibre cement sheeting.

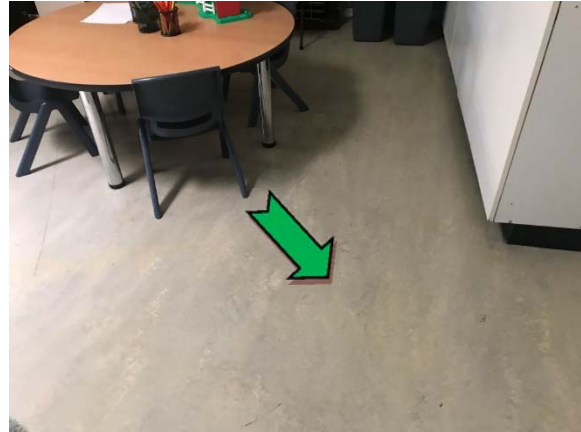
**Photo 8.** Interior, playroom 1, throughout, floor coverings – suspected non asbestos-containing vinyl sheeting.

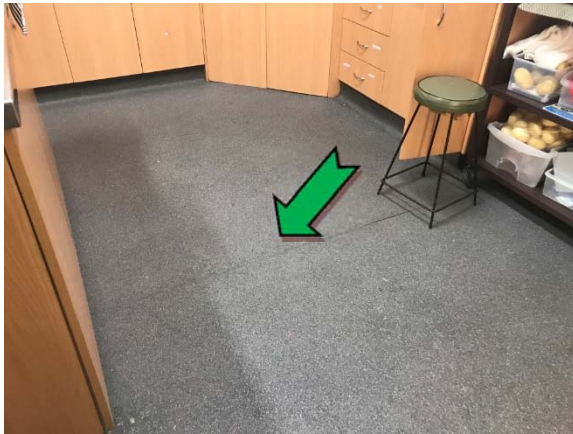
**Photo 9.** Interior, kitchen, throughout, floor coverings – suspected non asbestos-containing vinyl sheeting.

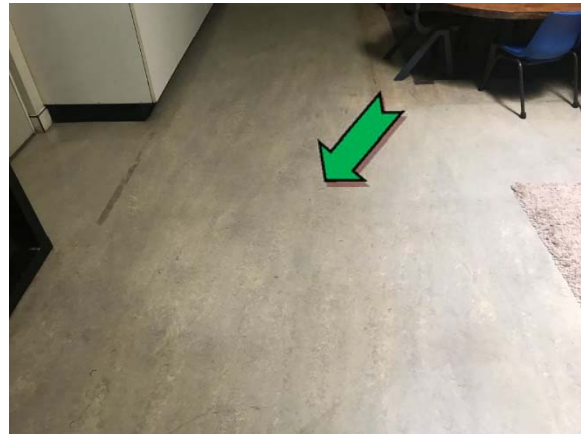
**Photo 10.** Interior, playroom 3, throughout, floor coverings – non asbestos-containing vinyl sheeting.

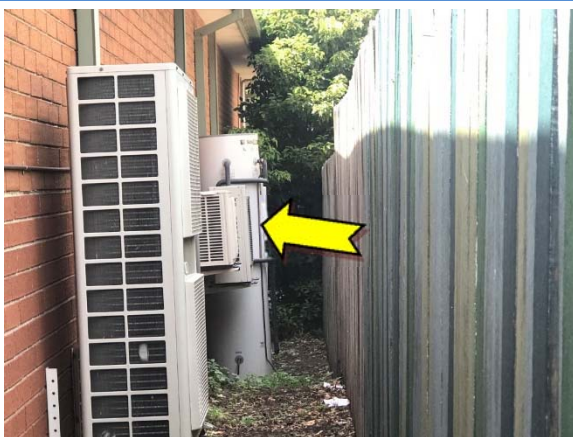
**Photo 11.** Exterior, south elevation, hot water heater – suspected SMF internal insulation.

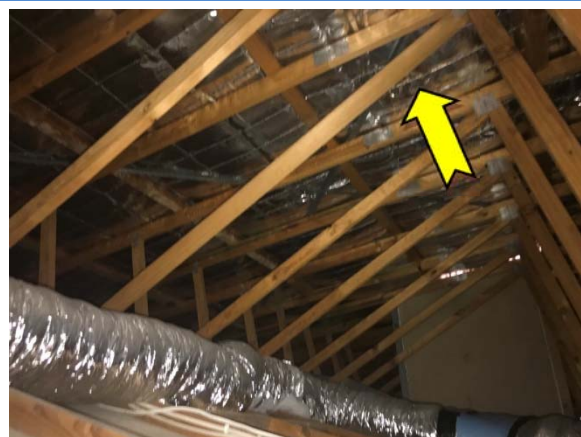
**Photo 12.** Interior, throughout, roof space – suspected SMF sarking insulation.

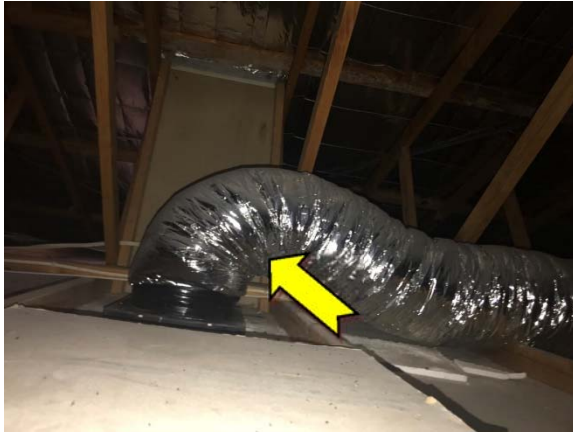
**Photo 13.** Interior, roof space, flexible ductwork – Suspected SMF internal insulation.

Exterior, ground level	South elevation	Hot water heater	Insulation material - internal	SMF	-	Suspected Positive	Bonded	Low	Good	Low	1 unit	Maintain in current condition if to remain in-situ. Remove under controlled SMF conditions as per the Code of Practice for the Safe Use of Synthetic Mineral Fibres [NOHSC: 2006 (1990)].	-	-	11
Interior, ground level	Store room, throughout	Roof space	Sarking insulation	SMF	-	Suspected Positive	Bonded	Low	Good	Low	200 m <sup>2</sup>	Maintain in current condition if to remain in-situ. Remove under controlled SMF conditions as per the Code of Practice for the Safe Use of Synthetic Mineral Fibres [NOHSC: 2006 (1990)].	-	-	12
Interior, ground level	Throughout, ceiling	Flexible ductwork	Insulation material - internal	SMF	-	Suspected Positive	Bonded	Low	Good	Low	20 m	Maintain in current condition if to remain in-situ. Remove under controlled SMF conditions as per the Code of Practice for the Safe Use of Synthetic Mineral Fibres [NOHSC: 2006 (1990)].	-	-	13

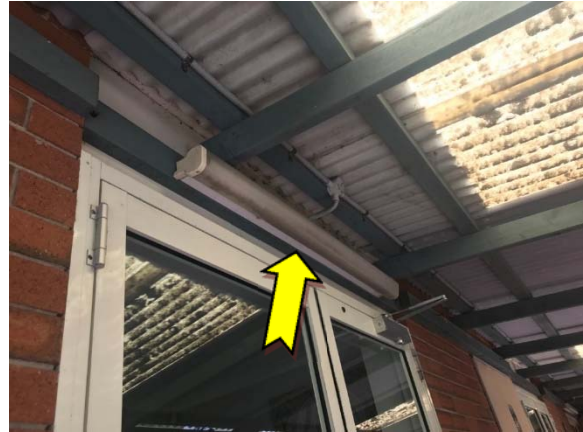
**Photo 14.** Exterior, throughout, single tube fluorescent light fitting – suspected PCB containing capacitor.

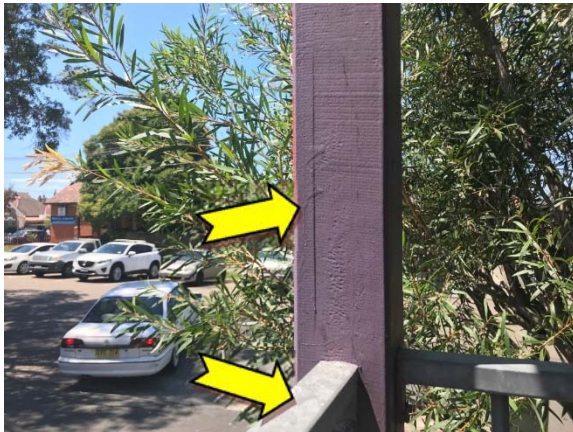
**Photo 15.** Exterior, throughout, verandah, timber beams - suspected lead-containing purple (light & dark) upper paint systems.

Area / Level	Room & Location	Feature	Item Description	Hazard Type	Sample No.	Sample Status	Friability	Disturb. Potential	Condition	Risk Status	Approx. Quantity	Recommendations & Comments	Control Priority	Reinspect Date	Photo No.
Exterior, ground level	Throughout	Fluorescent light fitting - single tube	Capacitor	PCBs	Not sampled: Electrical hazard	Suspected Positive	-	Low	Good	Low	5 units	PCB-containing capacitors are suspected due to age & appearance of electrical fittings. Remove and dispose of in accordance with the Polychlorinated Biphenyls Management Plan, Revised Edition April 2003.	-	-	14
Exterior, ground level	Throughout	Timber work	Purple (light) - upper coloured paint system	Lead Paint - Swab	-	Suspected Positive	-	Low	Good	Low	6 m <sup>2</sup>	Confirm status by quantitative test method, maintain in current condition, over paint with a lead-free paint as part of ongoing maintenance. Remove under controlled conditions in accordance with AS 4361.2:2017 Guide to hazardous paint management prior to renovation or demolition works.	-	-	15

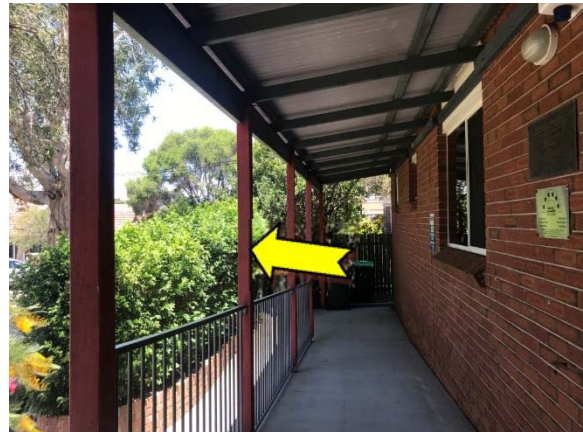
**Photo 16.** Exterior, throughout, verandah, timber beams – suspected lead-containing red upper paint system.

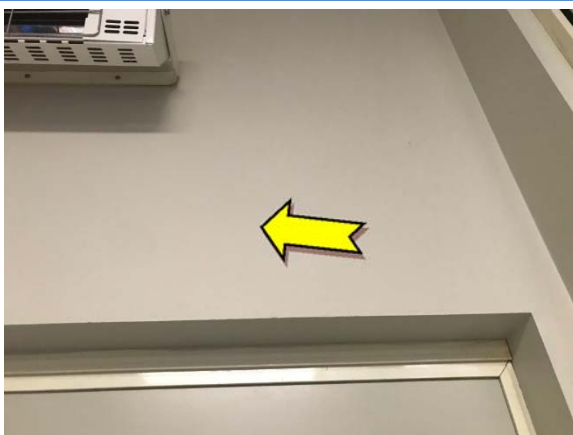
**Photo 17.** Interior, throughout, walls – suspected lead-containing light green upper paint system.

Exterior, ground level	Throughout	Timber work	Purple (dark) - upper coloured paint system	Lead Paint - Swab	-	Suspected Positive	-	Low	Good	Low	6 m <sup>2</sup>	Confirm status by quantitative test method, maintain in current condition, over paint with a lead-free paint as part of ongoing maintenance. Remove under controlled conditions in accordance with AS 4361.2:2017 Guide to hazardous paint management prior to renovation or demolition works.	-	-	15
Exterior, ground level	Throughout	Timber work	Red - upper coloured paint system	Lead Paint - Swab	-	Suspected Positive	-	Low	Good	Low	6 m <sup>2</sup>	Confirm status by quantitative test method, maintain in current condition, over paint with a lead-free paint as part of ongoing maintenance. Remove under controlled conditions in accordance with AS 4361.2:2017 Guide to hazardous paint management prior to renovation or demolition works.	-	-	16
Interior, ground level	Throughout	Walls	Green (light) - upper coloured paint system	Lead Paint - Swab	-	Suspected Positive	-	Low	Good	Low	200 m <sup>2</sup>	Confirm status by quantitative test method, maintain in current condition, over paint with a lead-free paint as part of ongoing maintenance. Remove under controlled conditions in accordance with AS 4361.2:2017 Guide to hazardous paint management prior to renovation or demolition works.	-	-	17

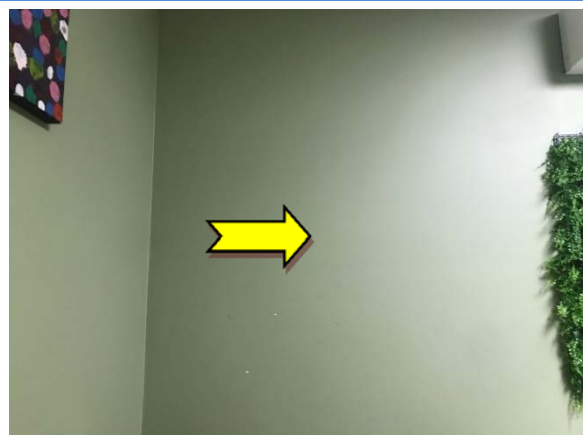
**Photo 18.** Interior, throughout, walls – suspected lead-containing dark green upper paint system

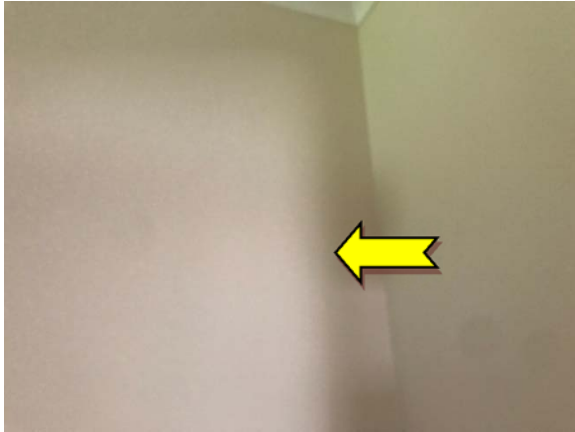
**Photo 19.** Interior, toilet 1, throughout, walls – suspected lead-containing light yellow upper paint system.

Interior, ground level	Playroom, throughout	Walls	Green (dark) - upper coloured paint system	Lead Paint - Swab	-	Suspected Positive	-	Low	Good	Low	40 m <sup>2</sup>	Confirm status by quantitative test method, maintain in current condition, over paint with a lead-free paint as part of ongoing maintenance. Remove under controlled conditions in accordance with AS 4361.2:2017 Guide to hazardous paint management prior to renovation or demolition works.	-	-	18
Interior, ground level	Toilet 1, throughout	Walls	Yellow (light) - upper coloured paint system	Lead Paint - Swab	-	Suspected Positive	-	Low	Good	Low	40 m <sup>2</sup>	Confirm status by quantitative test method, maintain in current condition, over paint with a lead-free paint as part of ongoing maintenance. Remove under controlled conditions in accordance with AS 4361.2:2017 Guide to hazardous paint management prior to renovation or demolition works.	-	-	19
