# Hazardous Building Materials Assessment

## Dulwich Hill Library

12-14 Seaview Street,  
Dulwich Hill NSW 2203

Inner West Council  
April 2018

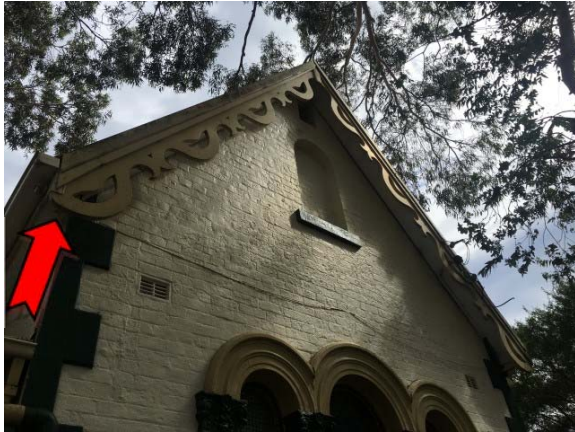
**Photo 1.** Exterior, throughout, eaves – suspected asbestos-containing fibre cement sheeting.

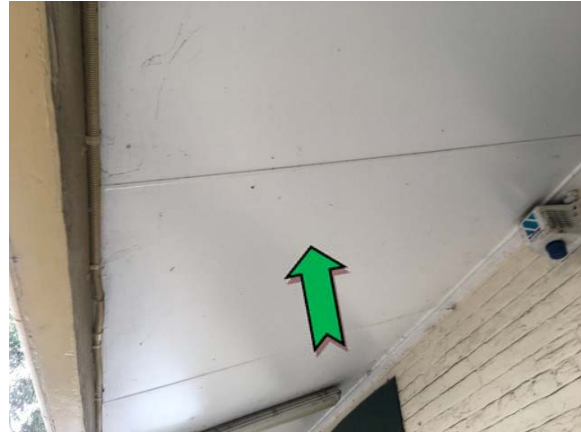
**Photo 2.** Exterior, entrance verandah, awning – non asbestos-containing fibre cement sheeting.

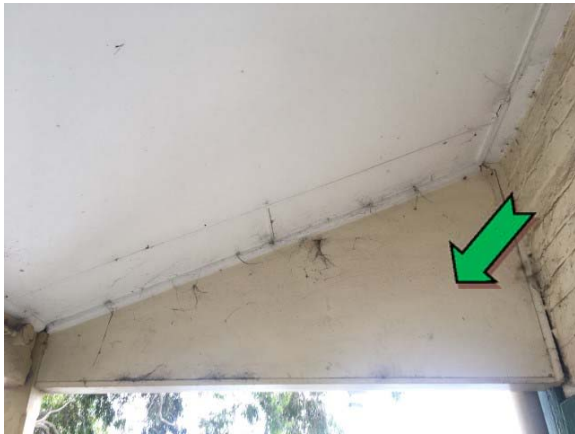
**Photo 3.** Exterior, entrance verandah, upstand panel – non asbestos-containing fibre cement sheeting.

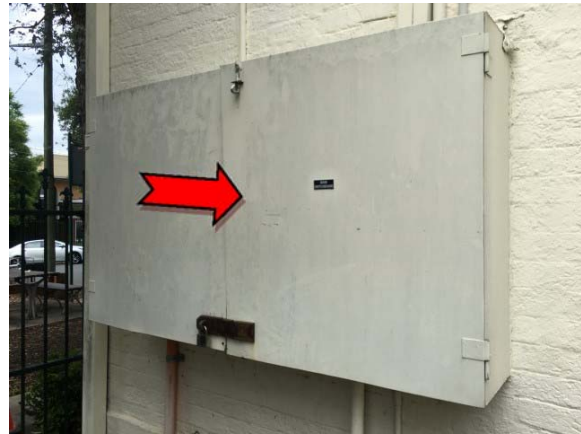
**Photo 4.** Exterior, north-east elevation, electrical backing board – suspected asbestos-containing bituminous backing board.

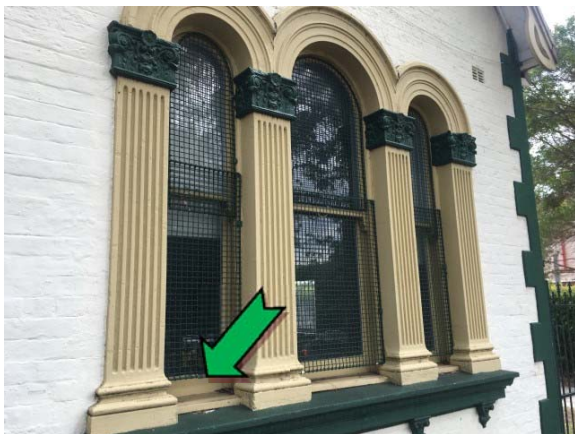
**Photo 5.** Exterior, throughout, window frames – non asbestos-containing window caulking.

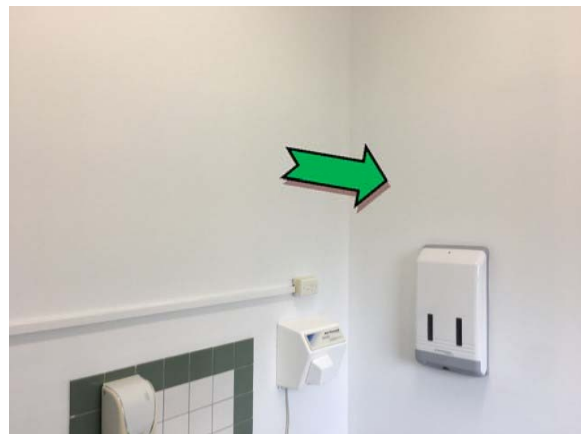
**Photo 6.** Interior, throughout, disabled toilet, wall lining – non asbestos containing fibre cement sheeting.

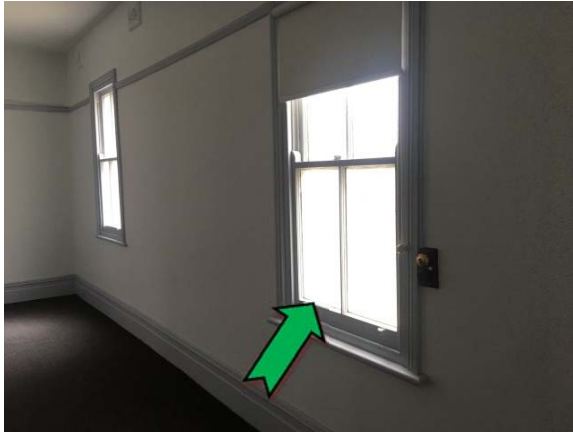
**Photo 7.** Interior, throughout, windows and window frames – non asbestos-containing window caulking.

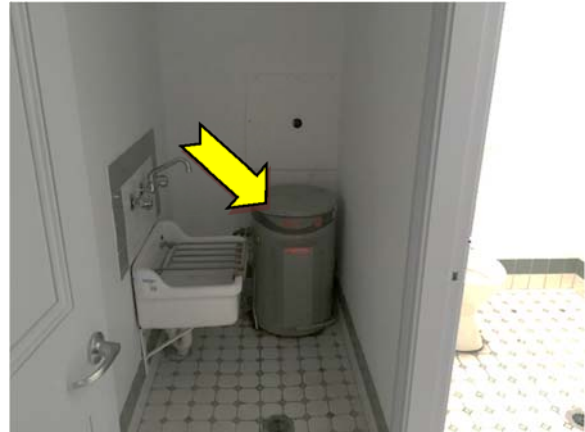
**Photo 8.** Interior, toilet, hot water heater – suspected SMF internal insulation material.

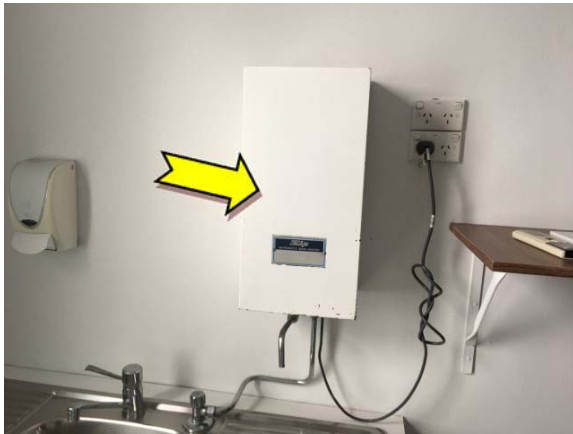
**Photo 9.** Interior, staff room, hot water boiler – suspected SMF internal insulation material.

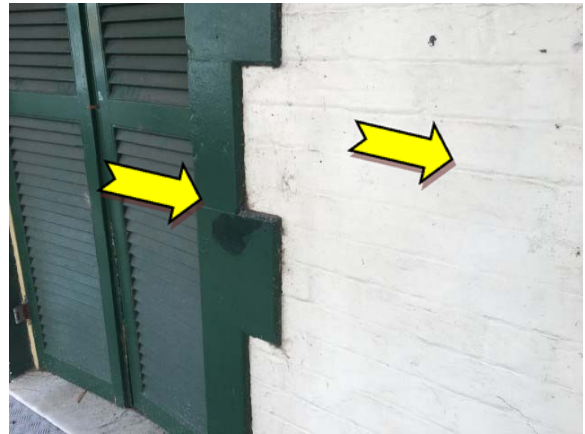
**Photo 10.** Exterior, throughout, walls and frames – suspected lead-containing cream and green upper coloured paint systems.

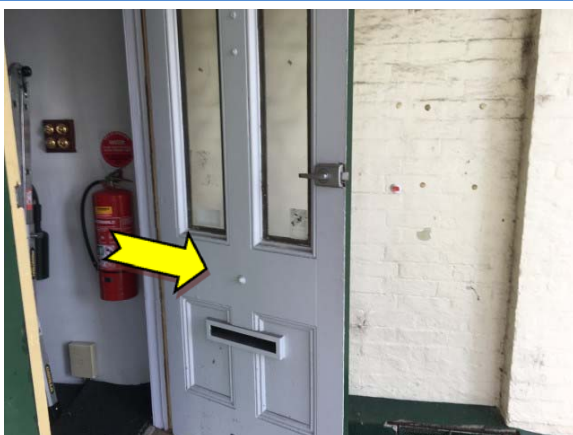
**Photo 11.** Interior, entrance lobby, door – suspected lead-containing grey upper paint system.

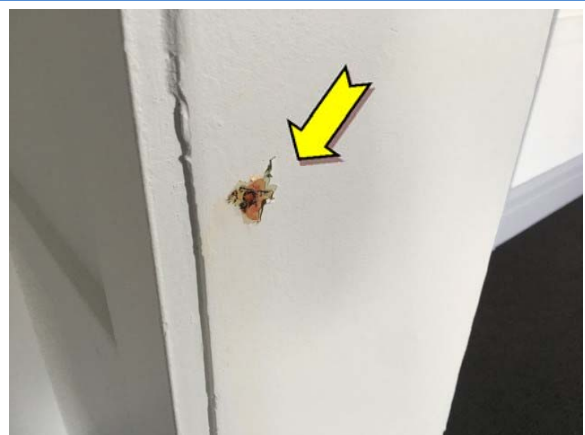
**Photo 12.** Interior, throughout, walls – lead-containing light green lower paint system.
