# Hazardous Building Materials Assessment Dulwich Hill Language School 12A Seaview Street, Dulwich Hill NSW 2203

Inner West Council  
April 2018

Job No.: 57722-050

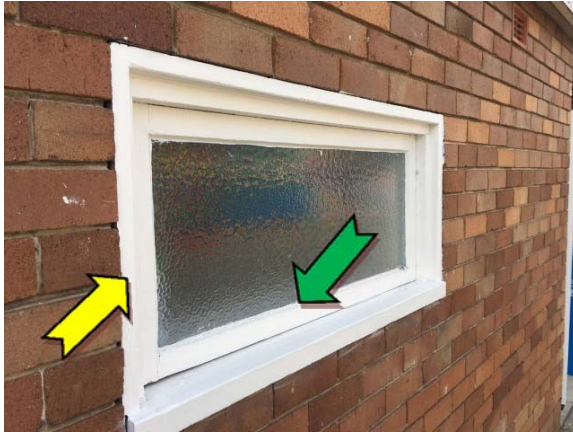
**Photo 1.** Exterior, throughout, window frames – non asbestos-containing window caulking and suspected lead-containing white upper paint system.

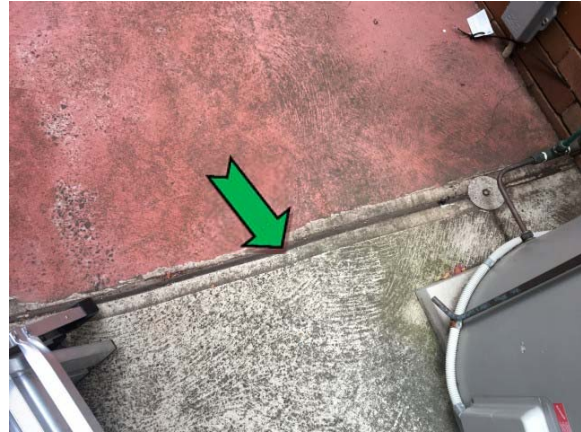
**Photo 2.** Exterior, north-west elevation, expansion joint – non asbestos-containing construction mastic.

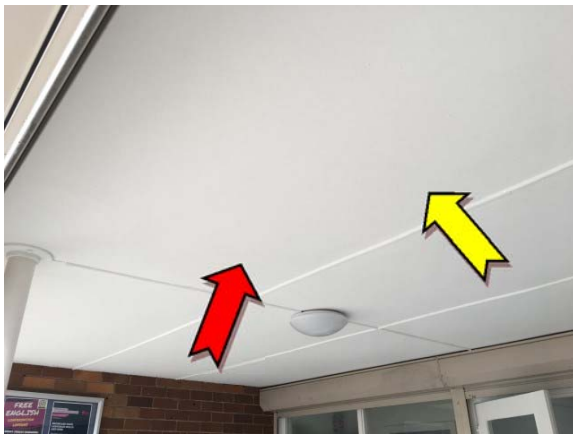
**Photo 3.** Exterior, courtyard entrance, awning – asbestos-containing fibre cement sheeting and suspected lead-containing white upper paint systems.

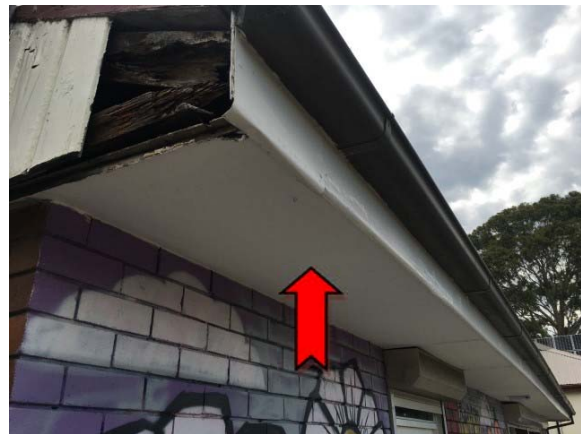
**Photo 4.** Exterior, throughout, eaves – asbestos-containing fibre cement sheeting.

- Encapsulate exposed sections of the asbestos-containing fibre cement sheeting throughout the eaves of the building.
- When asbestos removal works are required, the person that commissions the works must ensure that this is undertaken by an appropriately licensed asbestos contractor. The asbestos removal works must be conducted under controlled asbestos removal working conditions.

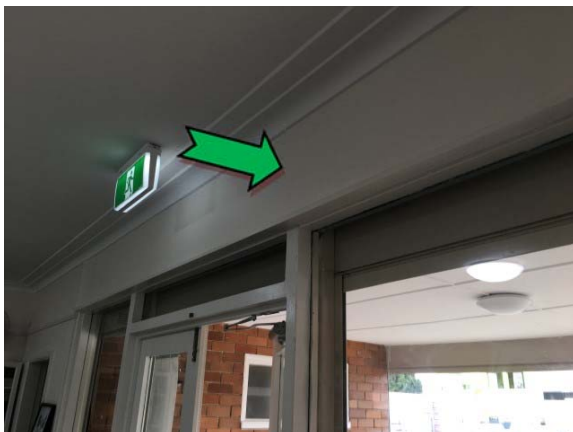
**Photo 5.** Interior, above entrance, infill panel – non asbestos-containing fibre cement sheeting.

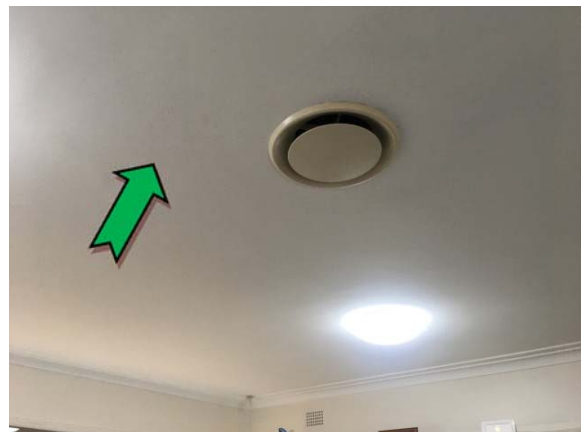
**Photo 6.** Interior, throughout, ceiling – non asbestos-containing fibre cement sheeting.

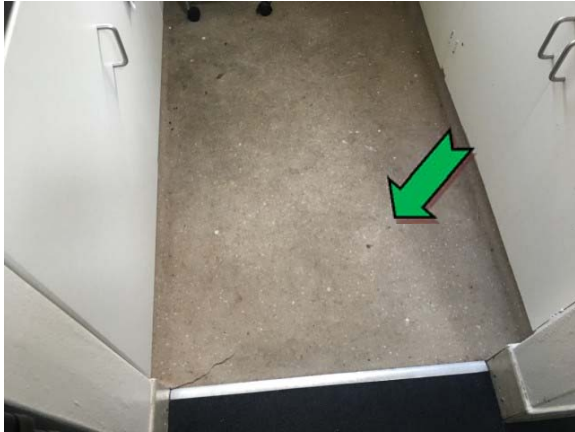
**Photo 7.** Interior, kitchen, beige floor coverings – non asbestos-containing sheet vinyl.

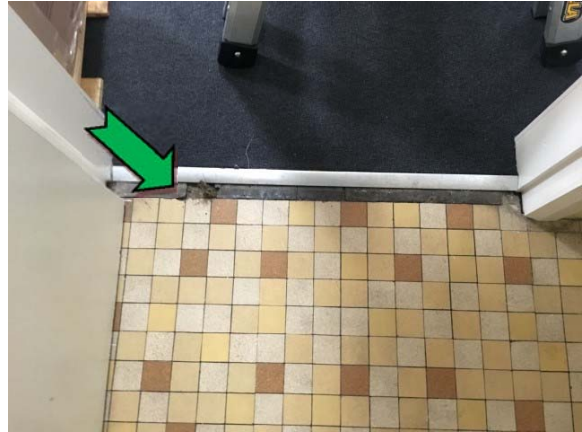
**Photo 8.** Interior, bathroom, floor coverings, dark grey – non asbestos-containing vinyl floor tiles.

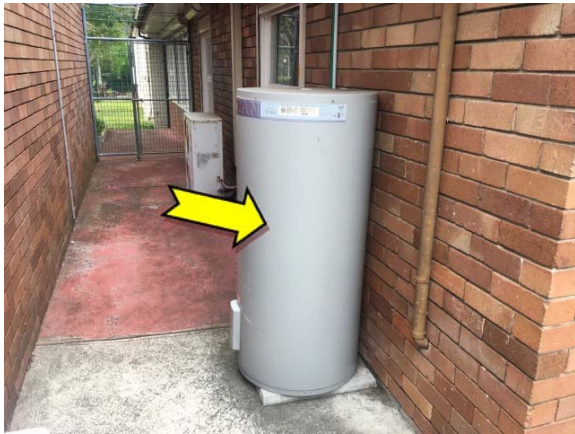
**Photo 9.** Exterior, north elevation, hot water heater – suspected SMF internal insulation material.

- SMF materials that are likely to be disturbed during any proposed demolition/refurbishment works should be handled in accordance with the *Code of Practice for the Safe Use of Synthetic Mineral Fibres* [NOHSC:2006(1990)]. If these materials are impacted upon by accident or by pre-planned works, the Inner West Council must be informed via the contact detailed within Section 7: *Accidental Disturbance of Known or Suspected Hazardous Building Materials*. Following disturbance, inspection by a competent person should be undertaken.

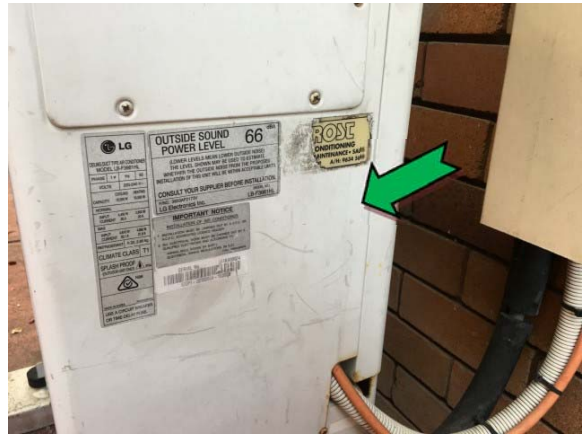
**Photo 10.** Exterior, north-west elevation, air conditioning unit – suspected non ODS-containing unknown refrigerant.
