Hazardous Building Materials Assessment

Seaview Street Hall

14 Seaview Street,
Dulwich Hill NSW 2203

Inner West Council
April 2018

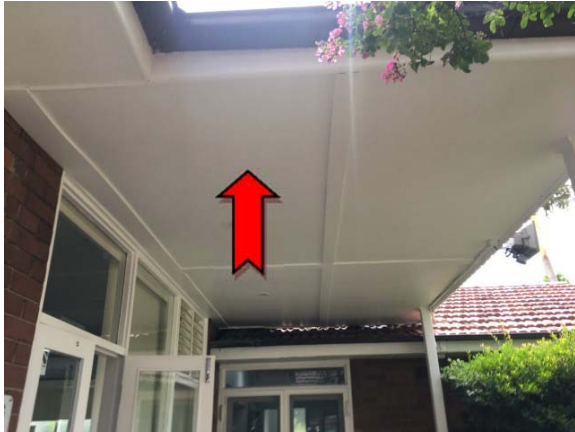
Photo 1. Exterior, throughout, awning – suspected asbestos-containing fibre cement sheeting.

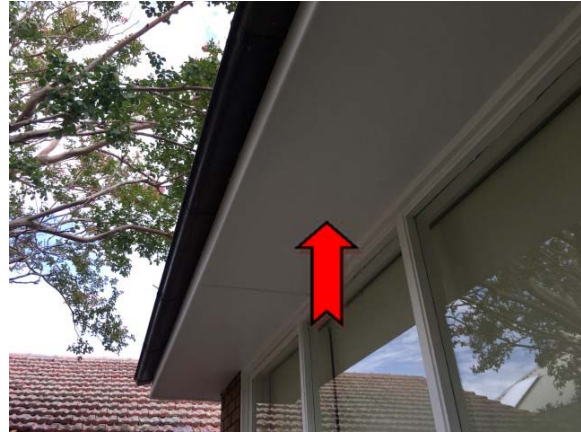
Photo 2. Exterior, throughout, eaves – suspected asbestos-containing fibre cement sheeting.

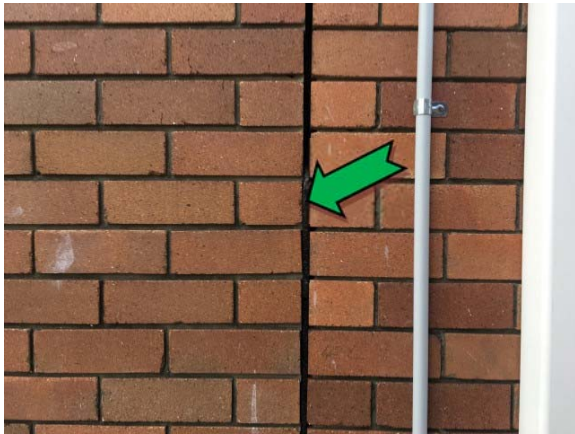
Photo 3. Exterior, northern elevation, between walls, expansion joint – non asbestos-containing construction mastic.

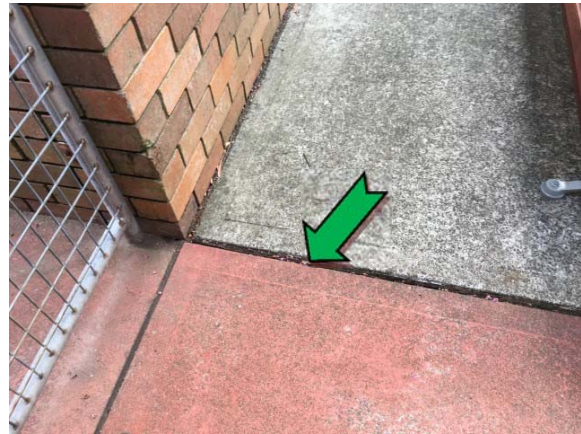
Photo 4. Exterior, throughout, floor, expansion joints – non asbestos-containing construction mastic.

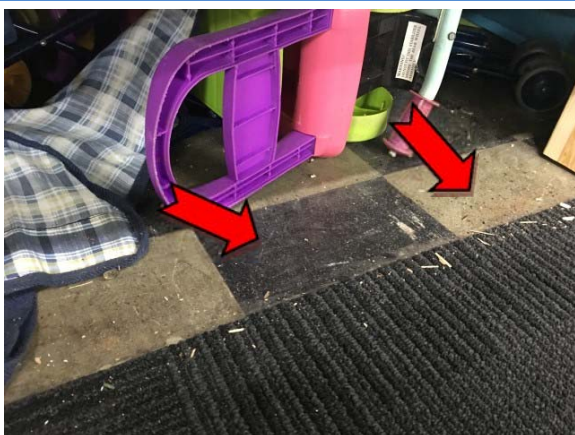
Photo 5. Interior, main hall, stage, subfloor, floor coverings black and grey – asbestos-containing vinyl floor tiles.

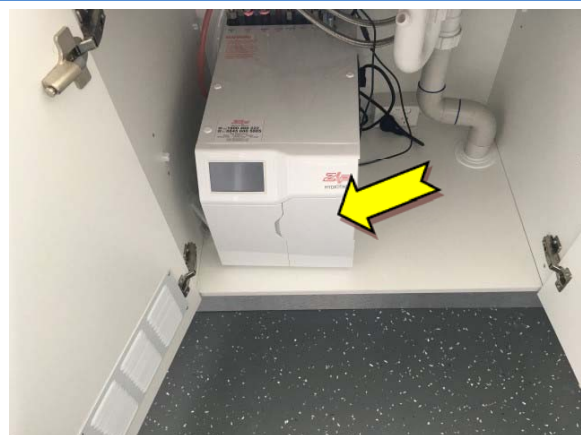
Photo 6. Interior, kitchen, below sinks, hot water boiler – suspected SMF internal insulation material.

- SMF internal insulation was suspected within the hot water boiler found in the kitchen under the sink during the Assessment.

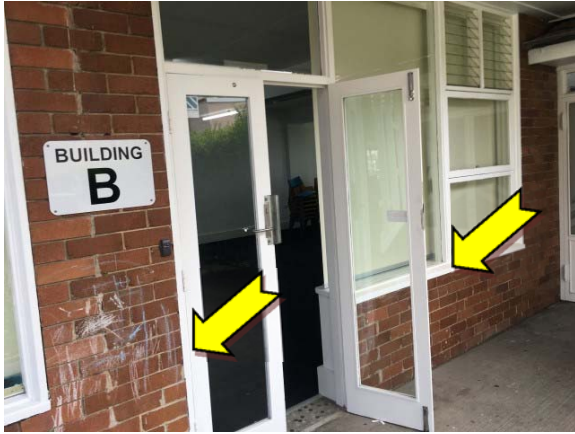
Photo 7. Exterior, throughout, window and door frames – suspected lead-containing white upper paint systems.

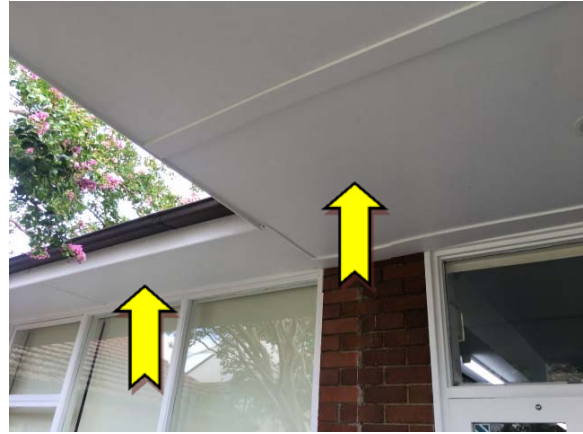
Photo 8. Exterior, throughout, awning and eaves – suspected lead-containing white upper paint systems.

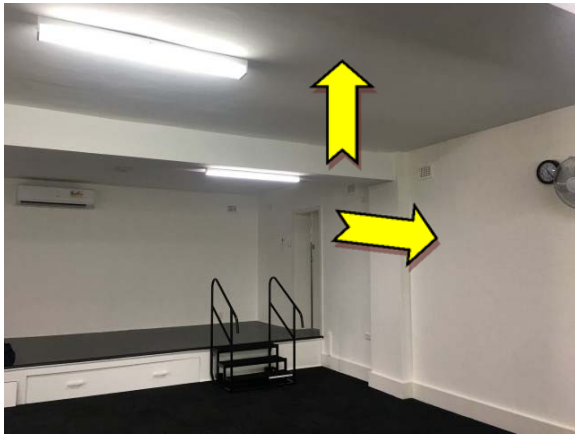
Photo 9. Interior, throughout, walls and ceiling – suspected lead-containing white upper paint systems.

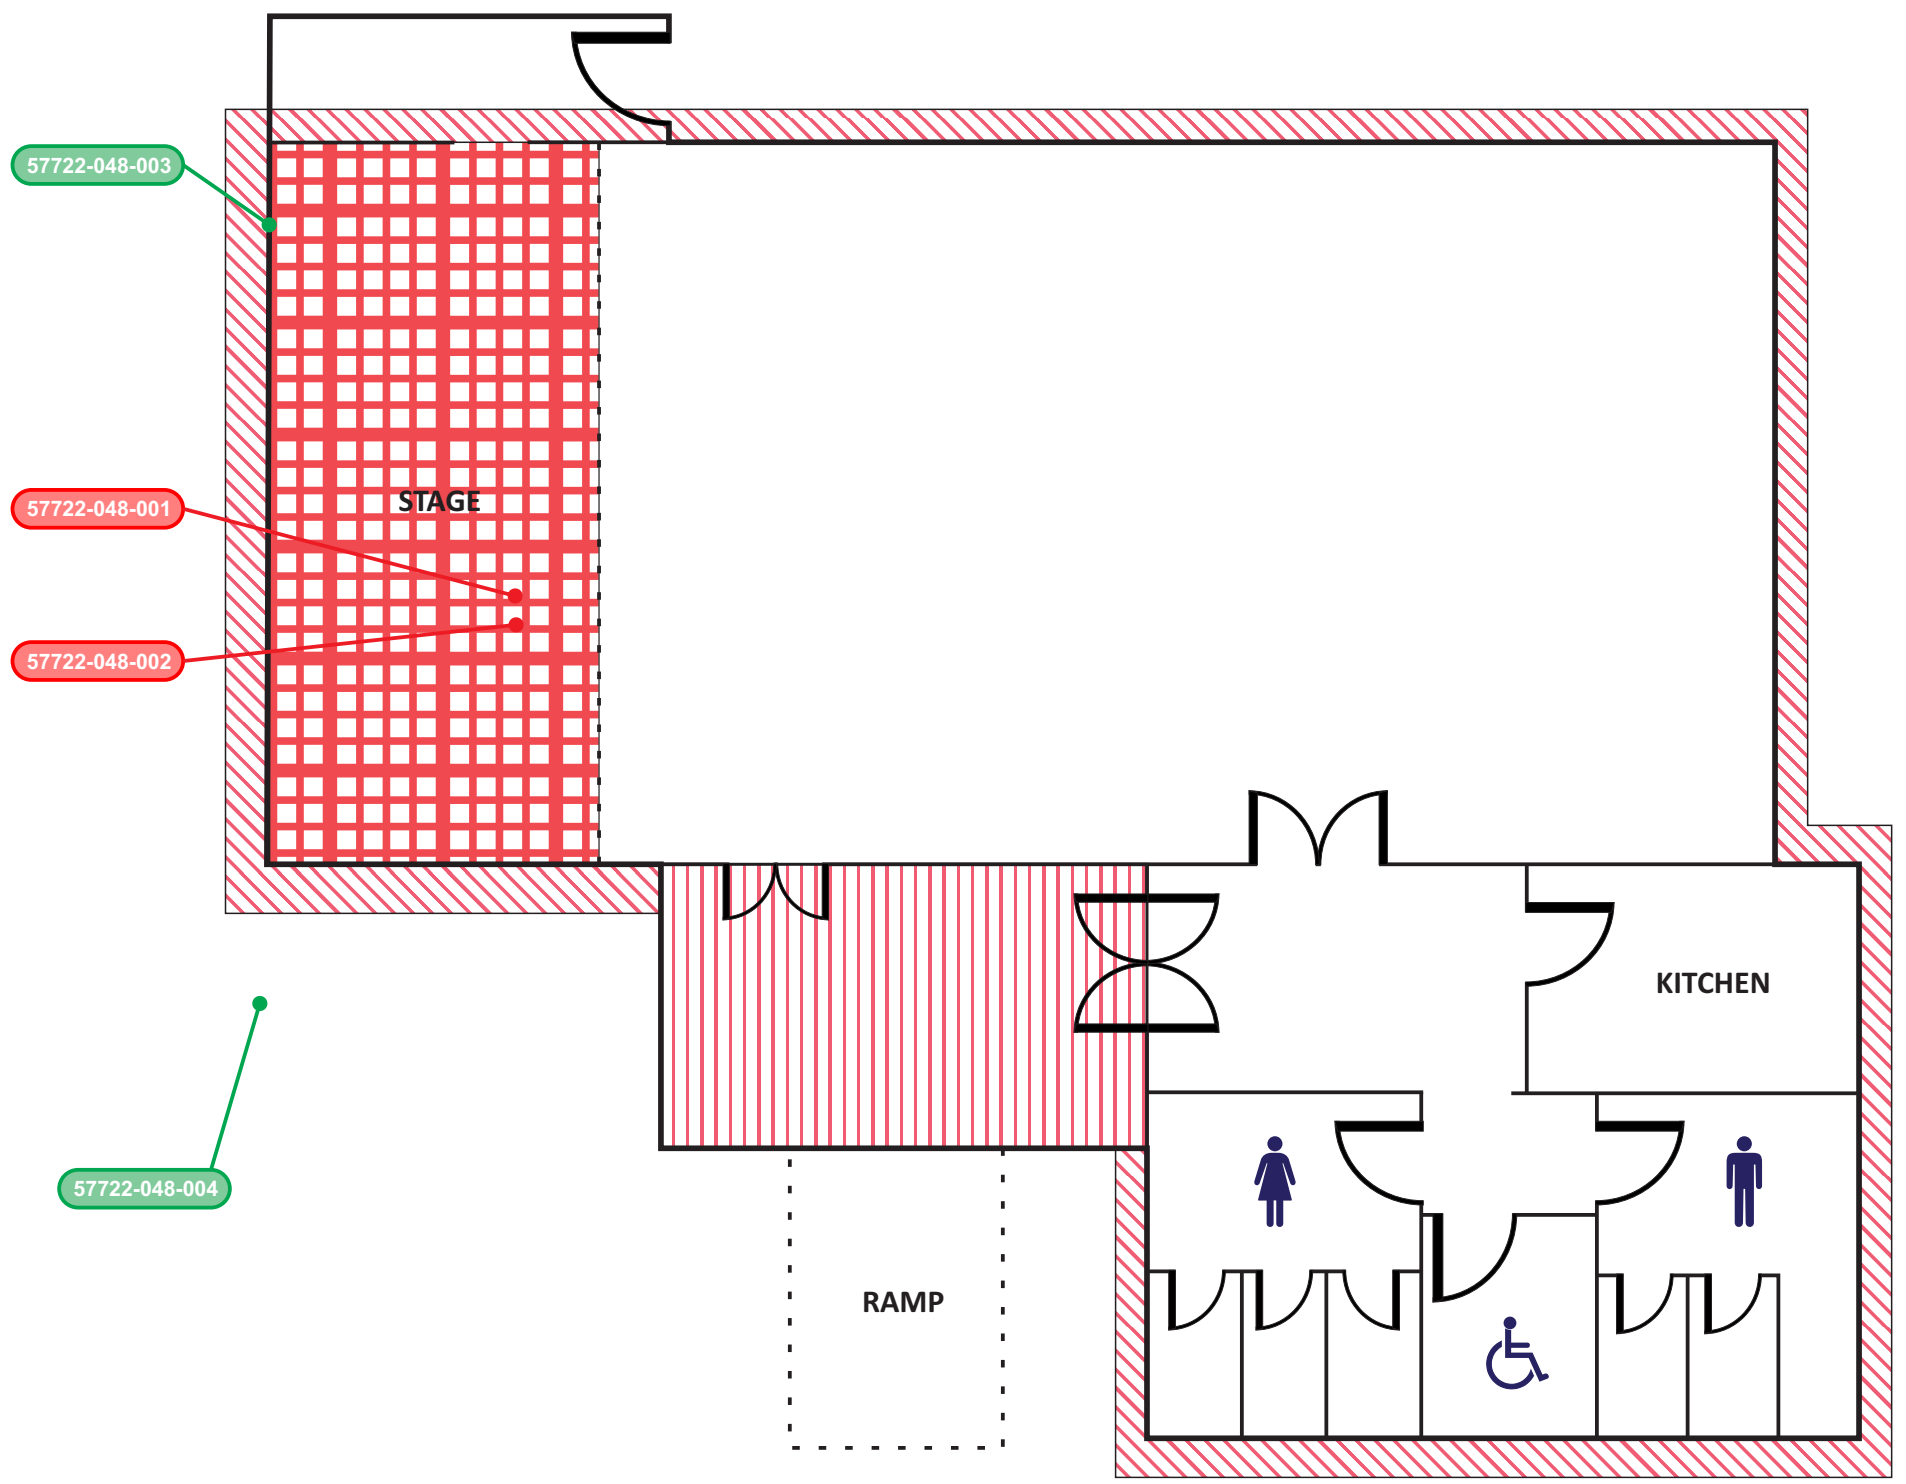
Seaview Street Hall, Dulwich Hill Ground Level

**NOTE: SUSPECT FRIABLE ASBESTOS
INSULATED PIPEWORK IN CEILING SPACE.**
