Hazardous Building Materials Assessment Arlington Recreational Reserve – Amenities Building Williams Parade Dulwich Hill NSW 2203

Inner West Council
April 2018

Job No.: 57722-041

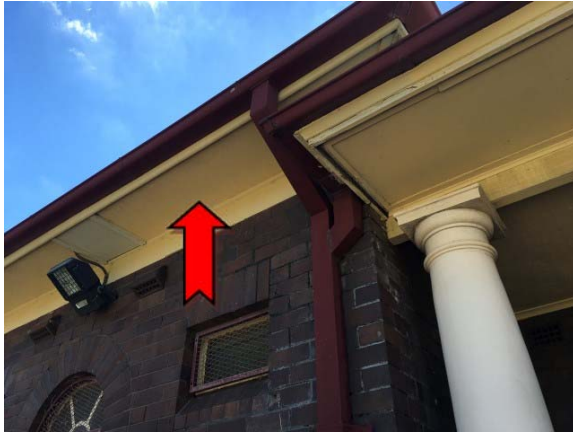
Photo 1. Exterior, eaves – suspected asbestos-containing fibre cement sheeting.

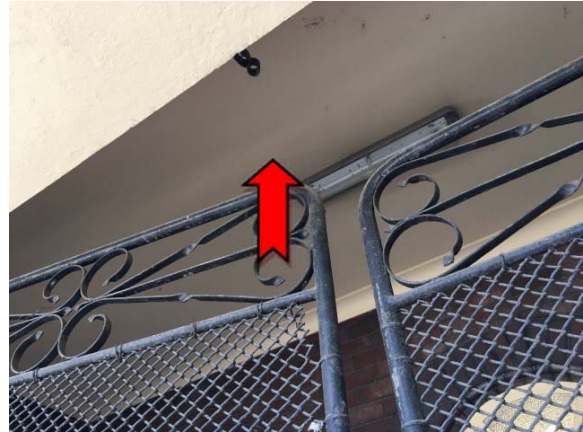
Photo 2. Exterior, east elevation, awning – suspected asbestos-containing fibre cement sheeting.

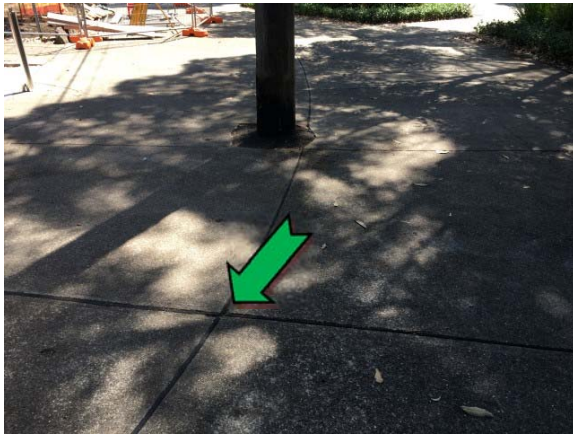
Photo 3. Exterior, east elevation, expansion joint – non asbestos-containing construction mastic.

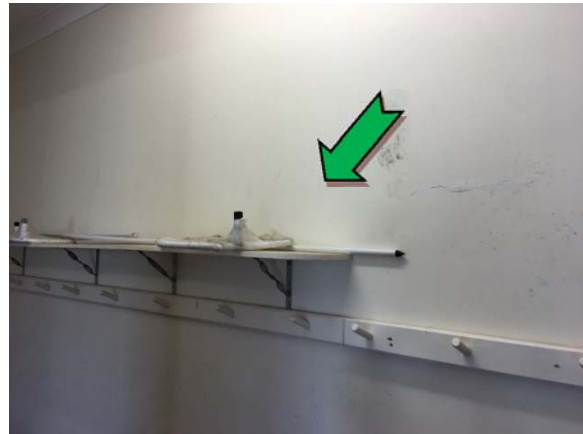
Photo 4. Interior, away change room, walls – non asbestos-containing fibre cement sheeting.

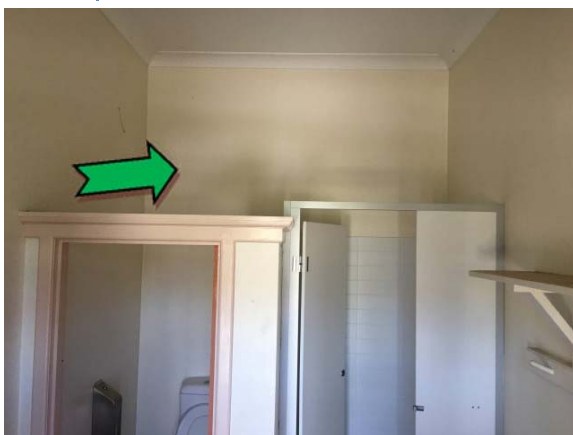
Photo 5. Interior, referee room, east elevation, wall – non asbestos-containing fibre cement sheeting.

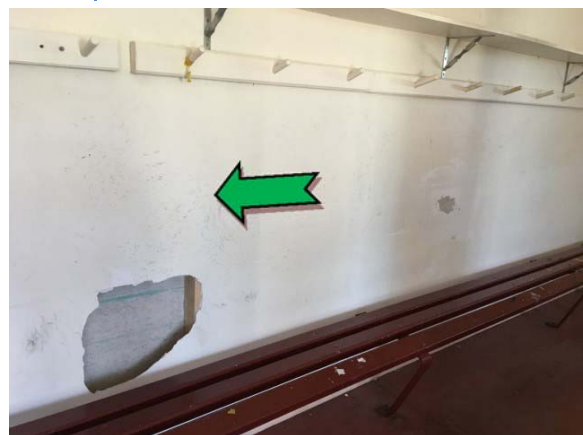
Photo 6. Interior, home change room, walls – non asbestos-containing fibre cement sheeting.

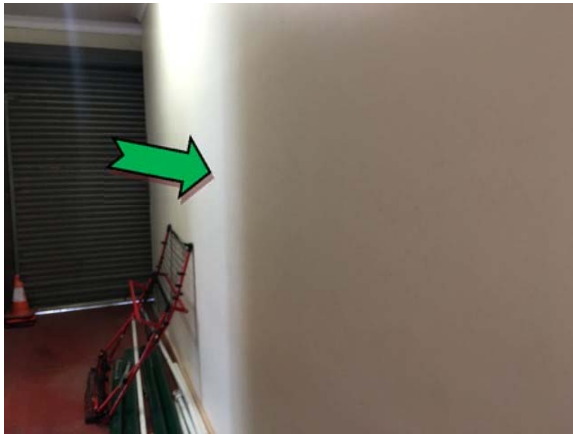
Photo 7. Interior, storage corridor, west elevation, wall – non asbestos-containing fibre cement sheeting.

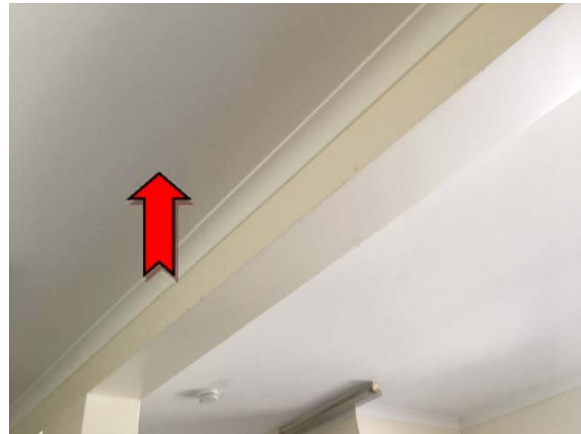
Photo 8. Interior, throughout, ceiling – suspected asbestos-containing fibre cement sheeting.

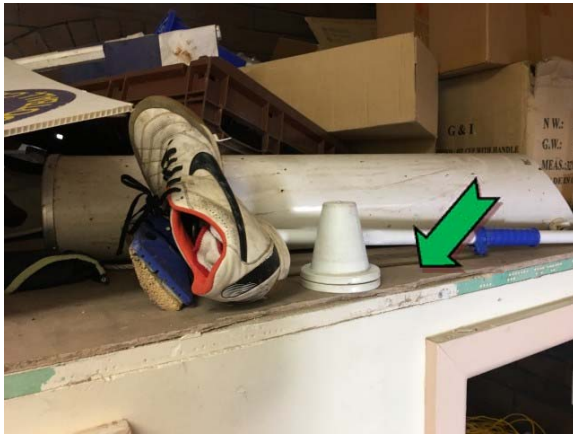
Interior, ground level	Store 1-4	Upper Ceiling	Fibre cement sheeting	Asbestos	57722-041-006	Negative	-	-	-	-	-	-	-	-	9
Interior, ground level	Store 1-4	Lower Ceiling	Fibre cement sheeting	Asbestos	57722-041-007	Negative	-	-	-	-	-	-	-	-	10
Interior, ground level	Throughout	Window frames	Window caulking	Asbestos	57722-041-001	Negative	-	-	-	-	-	-	-	-	11
Interior, ground level	Storage corridor, north end, east wall	Electrical backing board	Bituminous backing board	Asbestos	Not sampled: Electrical hazard	Suspected Negative	-	-	-	-	-	Suspected negative due to age and appearance.	-	-	12

Photo 9. Interior, stores 1-4, upper ceiling – non asbestos-containing fibre cement sheeting.

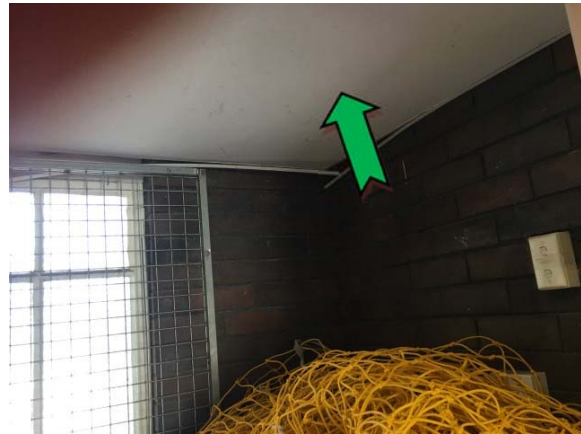
Photo 10. Interior, stores 1-4, lower ceiling – non asbestos-containing fibre cement sheeting.

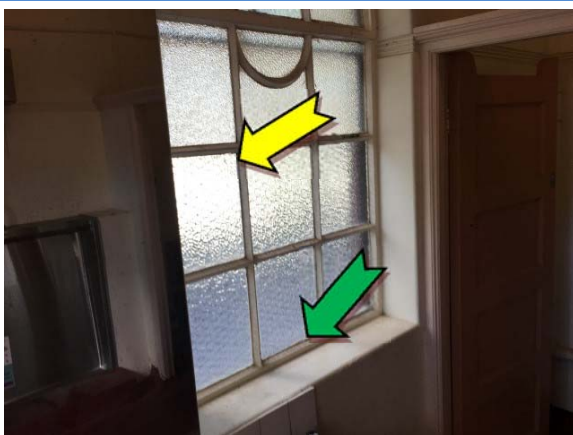
Photo 11. Interior, throughout, window frames – non asbestos-containing window caulking and suspected lead-containing beige upper paint systems.

- Remove flaking lead containing paint to window surrounds throughout the property in accordance with AS4361.2-2017 Guide to Hazardous Paint Management and relevant legislation.

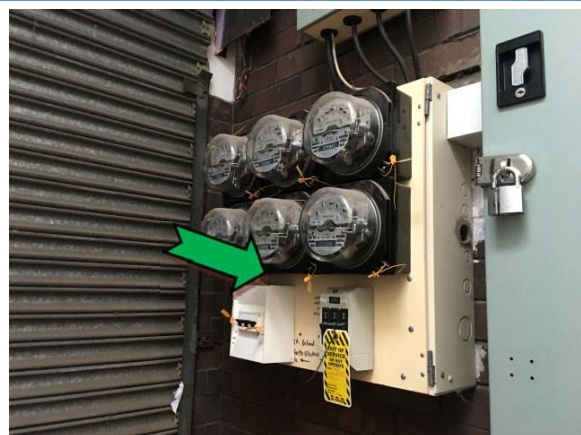
Photo 12. Interior, storage corridor, north end, east wall, electrical board – suspected non asbestos-containing bituminous material.

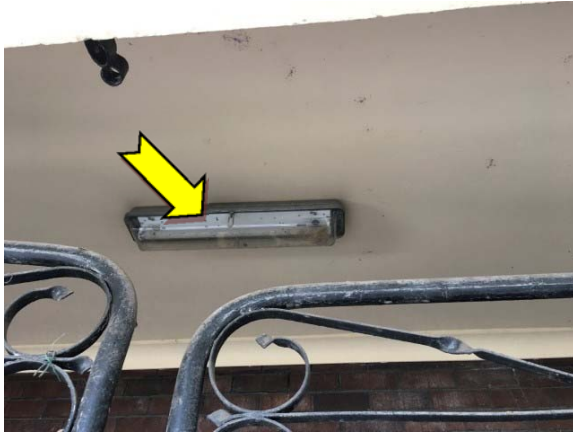
Photo 13. Exterior, east elevation, single tube fluorescent light fitting – suspected PCB-containing capacitor.

- Electrical fittings suspected of containing PCB oil capacitors should be treated as containing PCB oils until such time as evidence suggest otherwise e.g. further assessed.
- Electrical fittings that contain or suspected to contain PCB oil-containing capacitors should be removed as hazardous/regulated waste under controlled working conditions prior to the demolition or refurbishment works in accordance with the *Polychlorinated Biphenyls Management Plan, Revised Edition April 2003*.

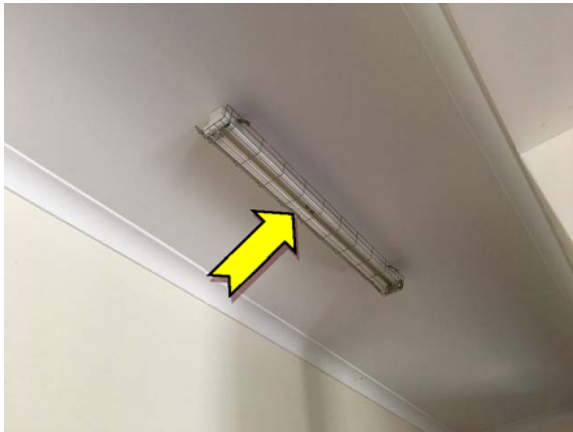
Photo 15. Interior, throughout, double tube fluorescent light fitting – suspected PCB-containing capacitor.

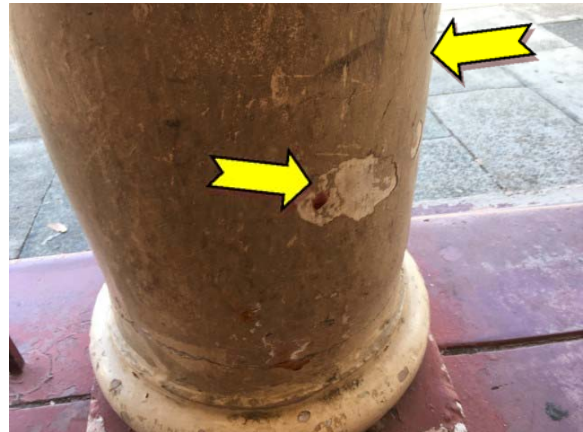
Exterior, ground level	Throughout	Walls - external	White - upper coloured paint system	Lead Paint - Swab	-	Suspected Positive	-	Low	Good	Low	20 m ²	Confirm status by quantitative test method, maintain in current condition, over paint with a lead-free paint as part of ongoing maintenance. Remove under controlled conditions in accordance with AS 4361.2:2017 Guide to hazardous paint management prior to renovation or demolition works.	-	-	17
Exterior, ground level	Throughout	Floor	Red - upper coloured paint system	Lead Paint - Swab	-	Suspected Positive	-	Low	Good	Low	12 m ²	Confirm status by quantitative test method, maintain in current condition, over paint with a lead-free paint as part of ongoing maintenance. Remove under controlled conditions in accordance with AS 4361.2:2017 Guide to hazardous paint management prior to renovation or demolition works.	-	-	17
Exterior, ground level	Throughout	Column	Yellow - lower coloured paint system	Lead Paint - Swab	-	Positive	-	Low	Good	Low	8 m ²	Maintain in current condition, over paint with a lead-free paint as part of ongoing maintenance. Remove under controlled conditions in accordance with AS 4361.2:2017 Guide to hazardous paint management prior to renovation or demolition works.	-	-	16

Photo 16. Exterior, columns – lead-containing white and yellow lower coloured paint systems and suspected lead-containing beige upper paint system.

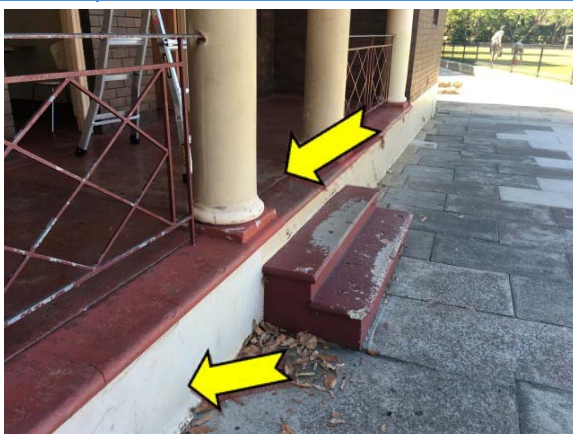
Photo 17. Exterior, throughout lower level walls and floor – suspected lead-containing red and white upper coloured paint systems.
