Hazardous Building Materials Assessment Arlington Recreational Reserve - Grandstand Williams Parade Dulwich Hill NSW 2203

Inner West Council
April 2018

Job No.: 57722-042

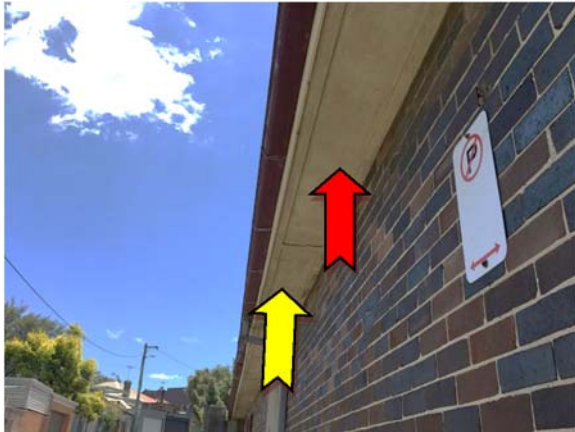
Exterior	West elevation	Eaves	Cream - upper coloured paint system	Lead Paint - Swab	-	Suspected Positive	-	Low	Good	Low	10 m ²	Confirm status by quantitative test method, maintain in current condition, over paint with a lead-free paint as part of ongoing maintenance. Remove under controlled conditions in accordance with AS 4361.2:2017 Guide to hazardous paint management prior to renovation or demolition works.	-	-	1
Exterior	Throughout	Walls	Cream - upper coloured paint system	Lead Paint - Swab	-	Suspected Positive	-	Low	Good	Low	150 m ²	Confirm status by quantitative test method, maintain in current condition, over paint with a lead-free paint as part of ongoing maintenance. Remove under controlled conditions in accordance with AS 4361.2:2017 Guide to hazardous paint management prior to renovation or demolition works.	-	-	8
Exterior	Upper height	Walls	Green (dark) - upper coloured paint system	Lead Paint - Swab	-	Suspected Positive	-	Low	Good	Low	80 m ²	Confirm status by quantitative test method, maintain in current condition, over paint with a lead-free paint as part of ongoing maintenance. Remove under controlled conditions in accordance with AS 4361.2:2017 Guide to hazardous paint management prior to renovation or demolition works.	-	-	9

Photo 1. Exterior, west elevation, eaves – suspected asbestos-containing fibre cement sheeting and suspected lead-containing cream upper paint system.

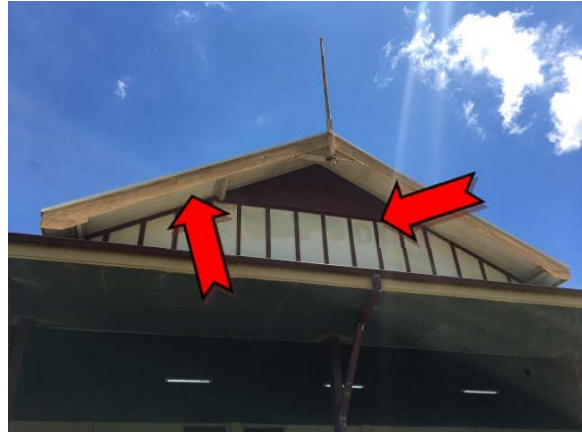
Exterior	East elevation	Eaves	Fibre cement sheeting	Asbestos	Not sampled: Height restrictions	Suspected Positive	Non-friable	Low	Good	Low	10 m ²	Confirm status, label as containing asbestos and maintain in current condition if to remain in-situ. Remove under controlled non-friable asbestos removal conditions prior to refurbishment or demolition works by a Class B (non-friable) licensed asbestos removal contractor.	P4	Feb-23	2
Exterior	South elevation	Gable	Fibre cement sheeting	Asbestos	Not sampled: Height restrictions	Suspected Positive	Non-friable	Low	Good	Low	20 m ²	Confirm status, label as containing asbestos and maintain in current condition if to remain in-situ. Remove under controlled non-friable asbestos removal conditions prior to refurbishment or demolition works by a Class B (non-friable) licensed asbestos removal contractor.	P4	Feb-23	3
Exterior	North elevation	Gable	Fibre cement sheeting	Asbestos	Not sampled: Height restrictions	Suspected Positive	Non-friable	Low	Fair	Medium	20 m ²	Confirm status, encapsulate exposed sections, label as containing asbestos and maintain in a good condition if to remain in-situ. Remove under controlled non-friable asbestos removal conditions prior to refurbishment or demolition works by a Class B (non-friable) licensed asbestos removal contractor.	P2	Feb-23	4

Photo 2. Exterior, east elevation, façade and eaves – suspected asbestos-containing fibre cement sheeting.

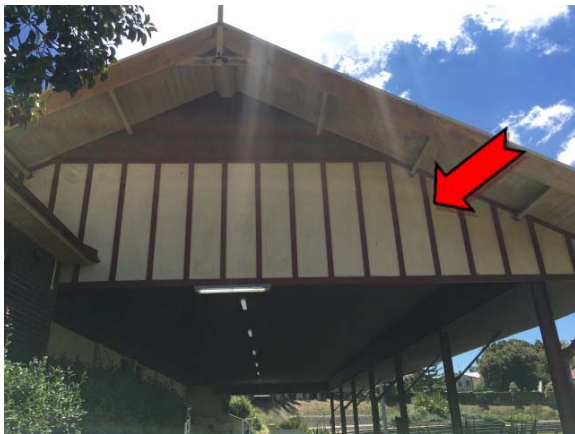
Photo 3. Exterior, south elevation, gable end – suspected asbestos-containing fibre cement sheeting.

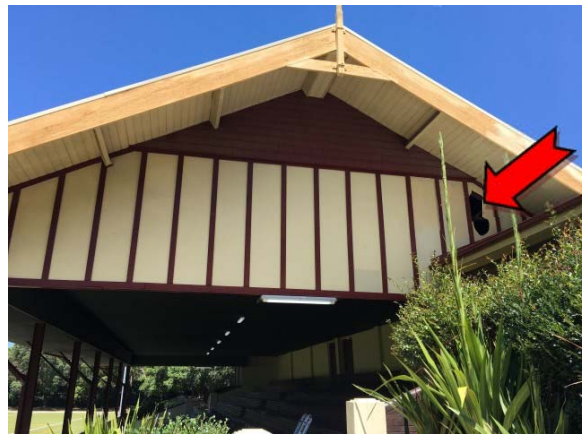
Photo 4. Exterior, north elevation, gable end – exposed suspected asbestos-containing fibre cement sheeting.

- Remove or encapsulate the broken fibre cement sheeting to the north gable end under controlled non-friable asbestos removal conditions. Works should be undertaken by a Class B (non-friable) licensed asbestos removal contractor.

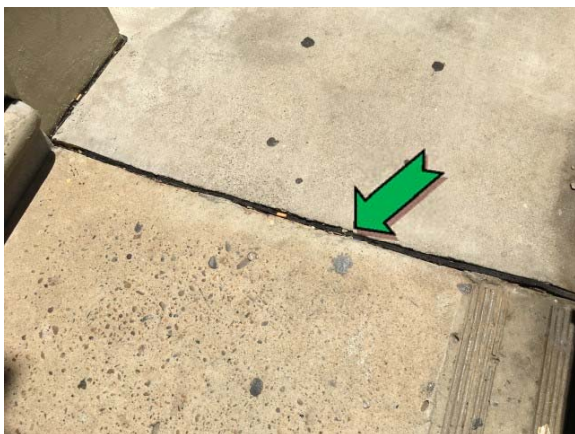
Photo 5. Exterior, throughout, ground, expansion joints – suspected non asbestos-containing construction mastic.

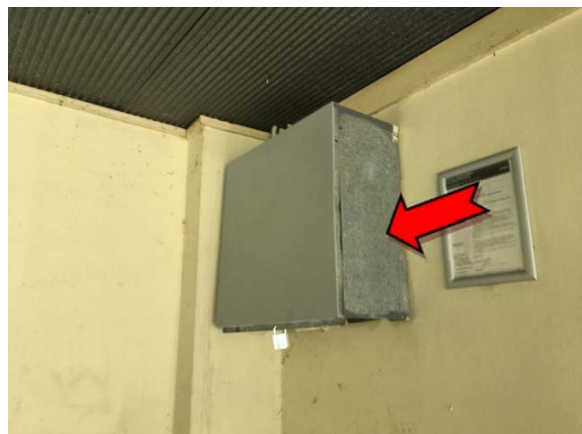
Photo 6. Exterior, north-west elevation, electrical board – suspected asbestos-containing bituminous backing board.

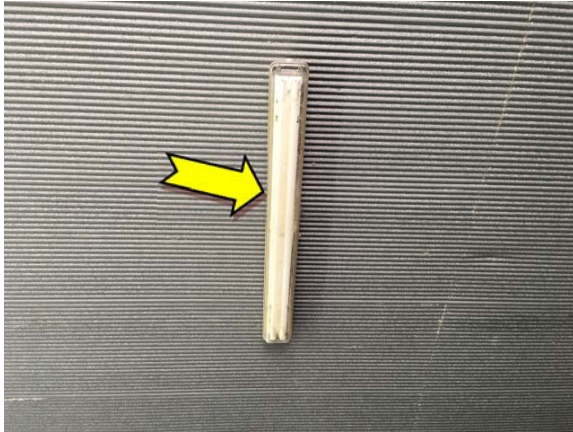
Photo 7. Exterior, throughout, double tube fluorescent light fitting – suspected PCB-containing capacitor.

- Electrical fittings suspected of containing PCB oil capacitors should be treated as containing PCB oils until such time as evidence suggest otherwise e.g. further assessed.
- Electrical fittings that contain or suspected to contain PCB oil-containing capacitors should be removed as hazardous/regulated waste under controlled working conditions prior to the

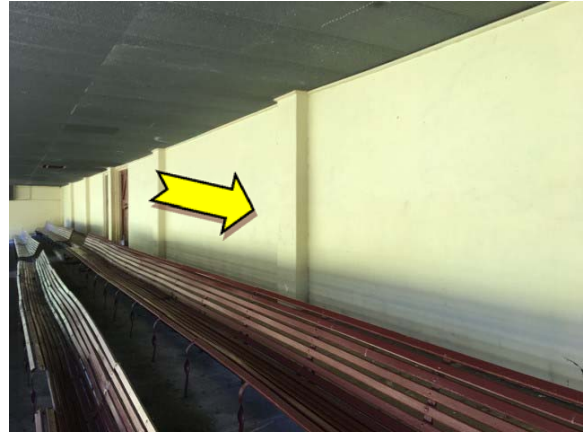
Photo 8. Exterior, throughout, walls – suspected lead-containing cream upper paint system.

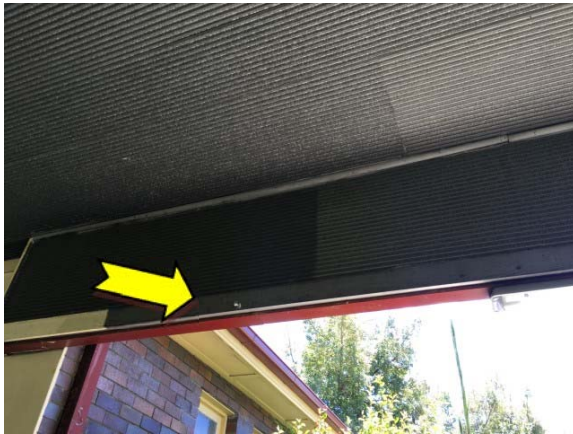
Photo 9. Exterior, upper height walls – suspected lead-containing upper green paint system.

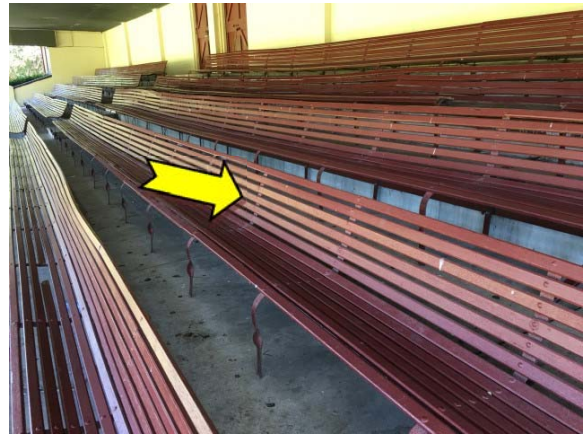
Exterior	Grandstand	Seats, doors & support columns	Red - upper coloured paint system	Lead Paint - Swab	-	Suspected Positive	-	Low	Good	Low	150 m ²	Confirm status by quantitative test method, maintain in current condition, over paint with a lead-free paint as part of ongoing maintenance. Remove under controlled conditions in accordance with AS 4361.2:2017 Guide to hazardous paint management prior to renovation or demolition works.	-	-	10

Photo 10. Exterior, grandstand, seats, doors and support columns – suspected lead-containing red upper paint system.
