Hazardous Building Materials Assessment

Enmore Children Centre

303-305 Enmore road,
Enmore NSW 2042

Inner West Council
April 2018

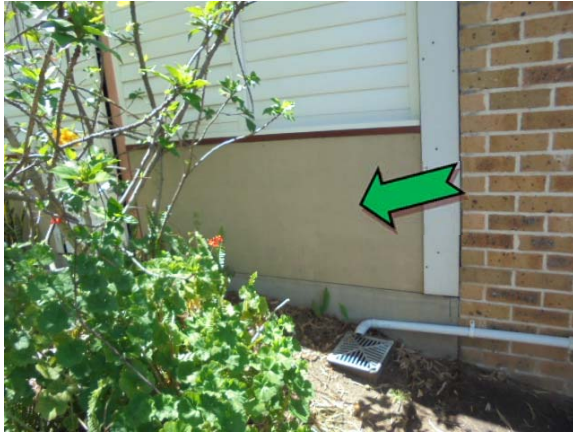
Photo 1. Exterior, rear of building, low level wall panels – non asbestos-containing fibre cement sheeting.

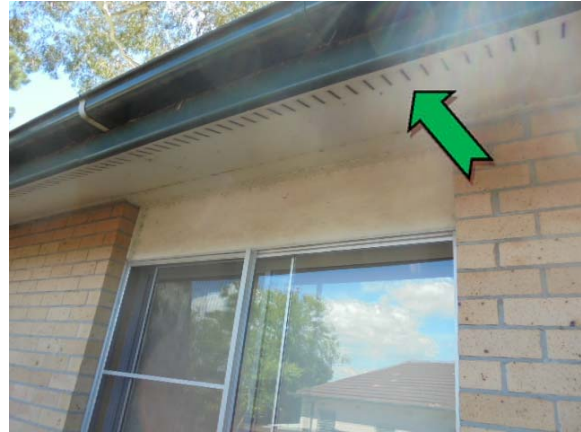
Photo 2. Exterior, throughout, eaves – non asbestos-containing fibre cement sheeting.

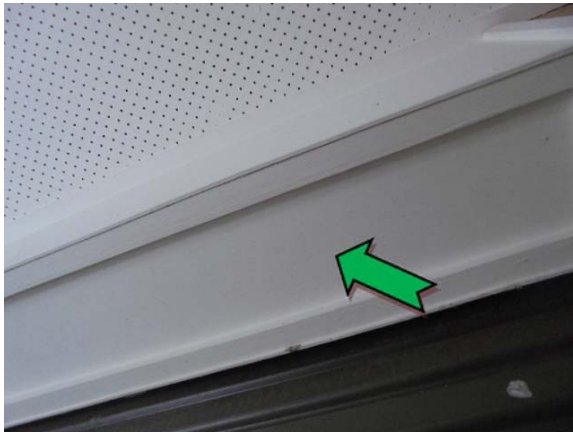
Photo 3. Interior, outside store, panel above metal shutter – non asbestos-containing fibre cement sheeting.

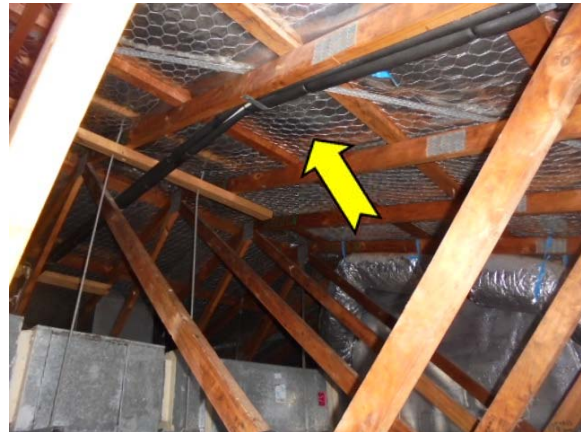
Photo 4. Interior, roof voids, underside of roof – suspected SMF sarking insulation.

- Suspected SMF sarking insulation was located to the underside of the ceiling in the roof voids throughout the site.

- SMF materials that are likely to be disturbed during any proposed demolition/refurbishment works should be handled in accordance with the *Code of Practice for the Safe Use of Synthetic Mineral Fibres* [NOHSC:2006(1990)]. If these materials are impacted upon by accident or by pre-planned works, the Inner West Council must be informed via the contact detailed within Section 7: *Accidental Disturbance of Known or Suspected Hazardous Building Materials*. Following disturbance, inspection by a competent person should be undertaken.
