# Hazardous Building Materials Assessment Hawthorne Canal Reserve Café Bones 1 Canal Road, Leichhardt NSW 2040

Inner West Council  
April 2018

Count ID: CID: 160

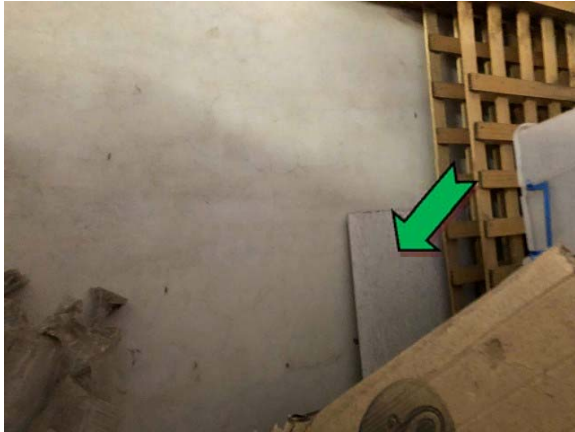
**Photo 1.** Interior, north elevation, store room, stored material – non asbestos-containing fibre cement sheeting.

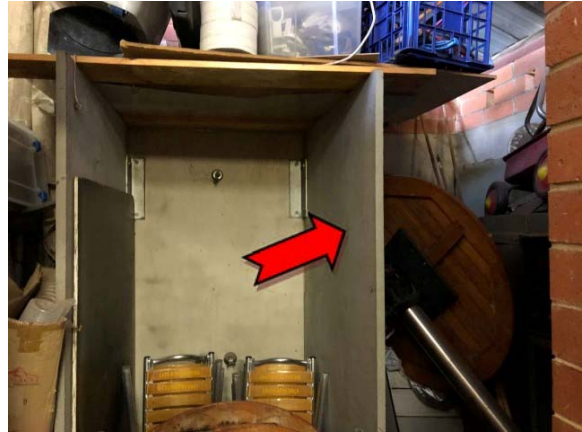
**Photo 2.** Interior, north elevation, store room, shower partitions – asbestos-containing fibre cement.

- Non-friable asbestos was identified in the form of fibre cement sheeting to the shower partitions in the storeroom.

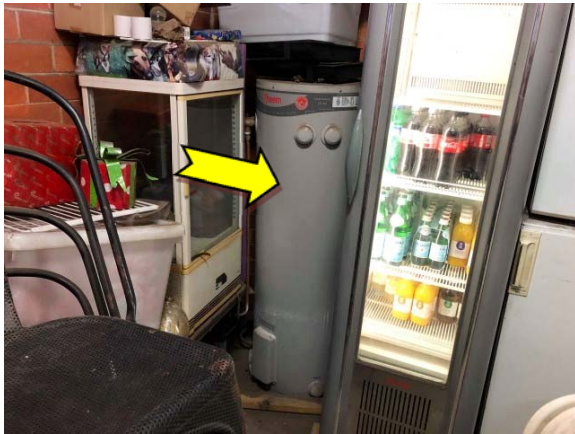
**Photo 3.** Interior, south-east elevation, store room, hot water heater – suspected SMF internal insulation material.

- SMF internal insulation material was suspected within the hot water heater located at south-east elevation in the storeroom.

- SMF materials that are likely to be disturbed during any proposed demolition/refurbishment works should be handled in accordance with the *Code of Practice for the Safe Use of Synthetic Mineral Fibres* [NOHSC:2006(1990)]. If these materials are impacted upon by accident or by pre-planned works, the Inner West Council must be informed via the contact detailed within Section 7: *Accidental Disturbance of Known or Suspected Hazardous Building Materials*. Following disturbance, inspection by a competent person should be undertaken.

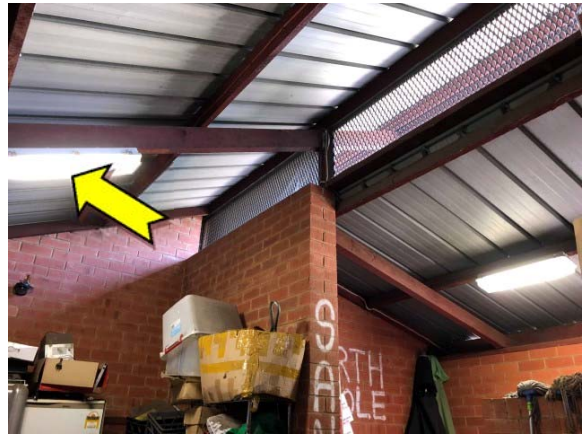
**Photo 4.** Interior, store room, double tubed fluorescent light fittings – suspected PCB-containing capacitors.

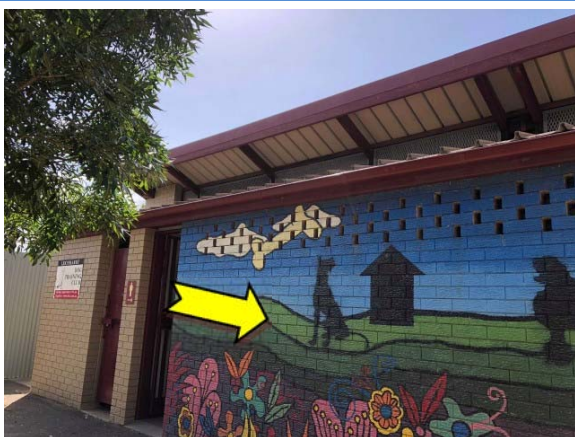
**Photo 5.** Exterior, throughout, graffiti wall – suspected lead-containing various upper coloured paint systems.

- LCP was suspected in the form of various upper coloured paint systems throughout the building.

- The *LeadCheck* paint swab method can detect lead in paint at concentrations of 0.5% and above, and may indicate lead in some paint films as low as 0.2%. As paint with a lead content greater than 0.1% by dry weight is now considered to be lead-containing, Prensa recommends confirming status of suspected LCP identified during the Assessment by quantitative test method.

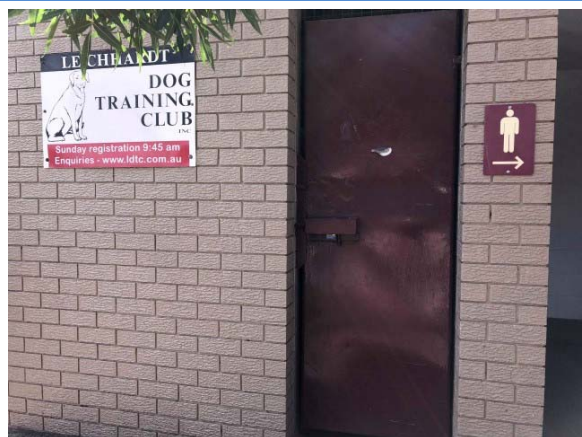
**Photo 6.** Interior, store room – no access at the time of the Assessment.
