Hazardous Building Materials Assessment Blackmore Park – Amenities B Canal Road, Leichhardt NSW 2040

Inner West Council
April 2018

Executive Summary

Prensa Pty Ltd (Prensa) was engaged by Inner West Council (IWC) to conduct a Hazardous Building Materials Assessment (Assessment) of Blackmore Park - Amenities B located at Canal Road, Leichhardt NSW 2040 (the site). Charly Golding and Jessica Wood of Prensa conducted the Assessment on 2nd March 2018 at the request of Rick Jarvis of IWC.

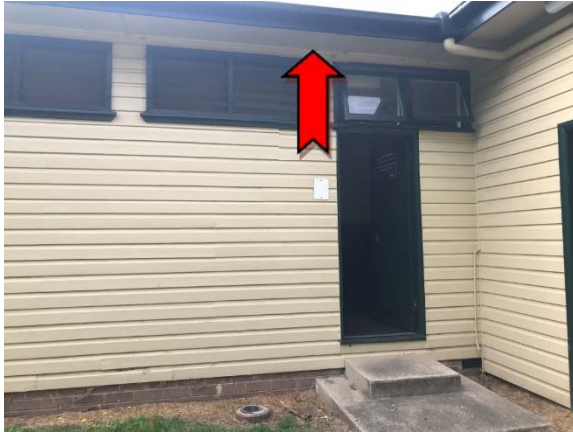
Photo 1. Exterior, throughout, eaves – asbestos-containing fibre cement sheeting.

- Non-friable asbestos was identified in the form of fibre cement sheeting throughout the eaves of the building.
- Non-friable asbestos was identified in the form of 2 m² fibre cement debris found on the ground spread across approximately 10 m² area surrounding the site.

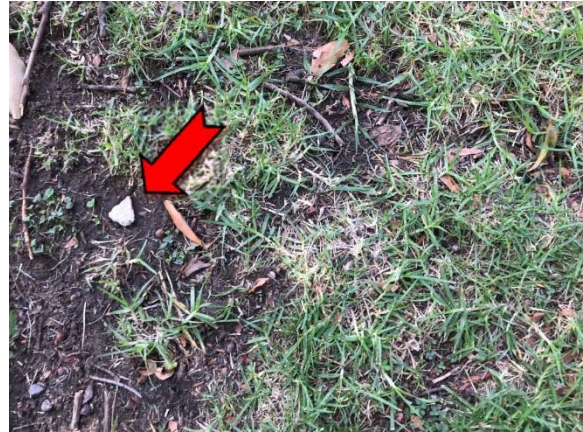
Photo 2. Exterior, throughout, ground – asbestos-containing fibre cement debris.

- Asbestos-containing fibre cement debris found to the exterior of the building throughout the ground should be removed as soon as possible under controlled Class B (non-friable) licensed asbestos removal contractor.

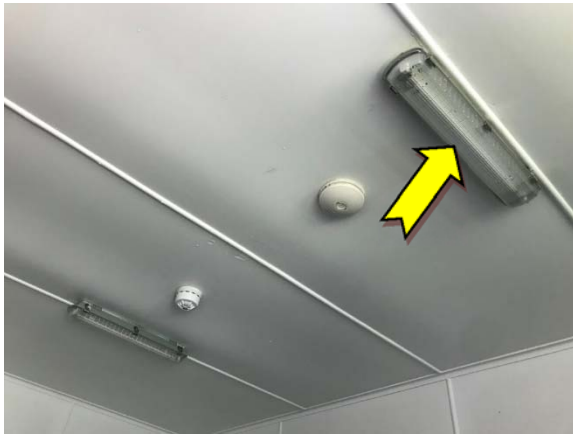
Photo 3. Interior, throughout, single tube fluorescent light fittings – suspected PCB-containing capacitors.

- PCBs were suspected within the capacitors of the single tubed fluorescent light fittings throughout the interior of the building.

- Electrical fittings suspected of containing PCB oil capacitors should be treated as containing PCB oils until such time as evidence suggest otherwise e.g. further assessed.
- Electrical fittings that contain or suspected to contain PCB oil-containing capacitors should be removed as hazardous/regulated waste under controlled working conditions prior to the demolition or refurbishment works in accordance with the *Polychlorinated Biphenyls Management Plan, Revised Edition April 2003*.

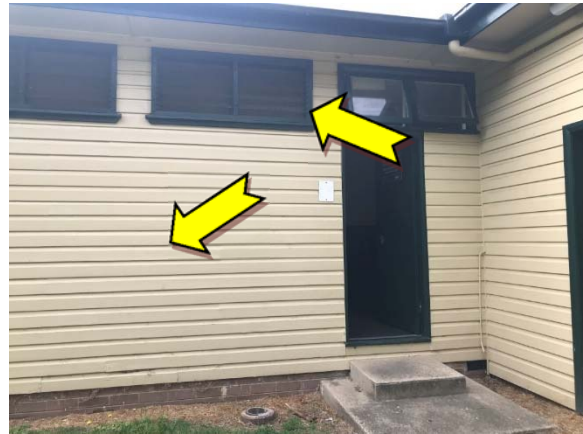
Photo 4. Exterior throughout, walls, window and door frames – suspected lead-containing yellow and green upper coloured paint systems.

- LCP was suspected in the form of green, yellow and white upper coloured paint systems throughout the building.

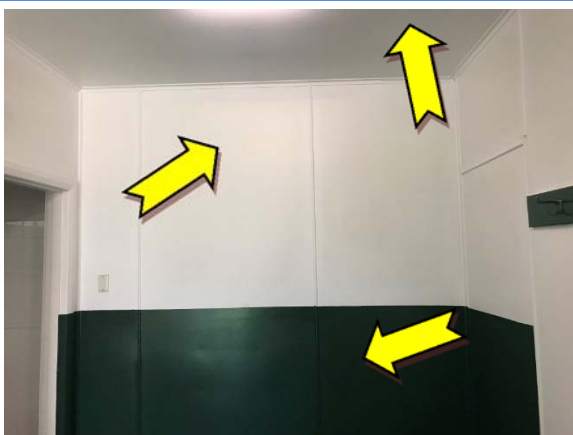
Interior	Throughout, lower levels	Walls	Green - upper coloured paint system	Lead Paint - Swab	-	Suspected Positive	-	Low	Good	Low	20 m ²	Confirm status by quantitative test method, maintain in current condition, over paint with a lead-free paint as part of ongoing maintenance. Remove under controlled conditions in accordance with AS 4361.2:2017 Guide to hazardous paint management prior to renovation or demolition works.	-	-	5
Interior	Throughout, upper levels	Walls	White - upper coloured paint system	Lead Paint - Swab	-	Suspected Positive	-	Low	Good	Low	40 m ²	Confirm status by quantitative test method, maintain in current condition, over paint with a lead-free paint as part of ongoing maintenance. Remove under controlled conditions in accordance with AS 4361.2:2017 Guide to hazardous paint management prior to renovation or demolition works.	-	-	5
Interior	Throughout	Ceiling	White - upper coloured paint system	Lead Paint - Swab	-	Suspected Positive	-	Low	Good	Low	50 m ²	Confirm status by quantitative test method, maintain in current condition, over paint with a lead-free paint as part of ongoing maintenance. Remove under controlled conditions in accordance with AS 4361.2:2017 Guide to hazardous paint management prior to renovation or demolition works.	-	-	5

Photo 5. Interior, throughout, walls and ceiling – suspected lead-containing white and green upper coloured paint systems.

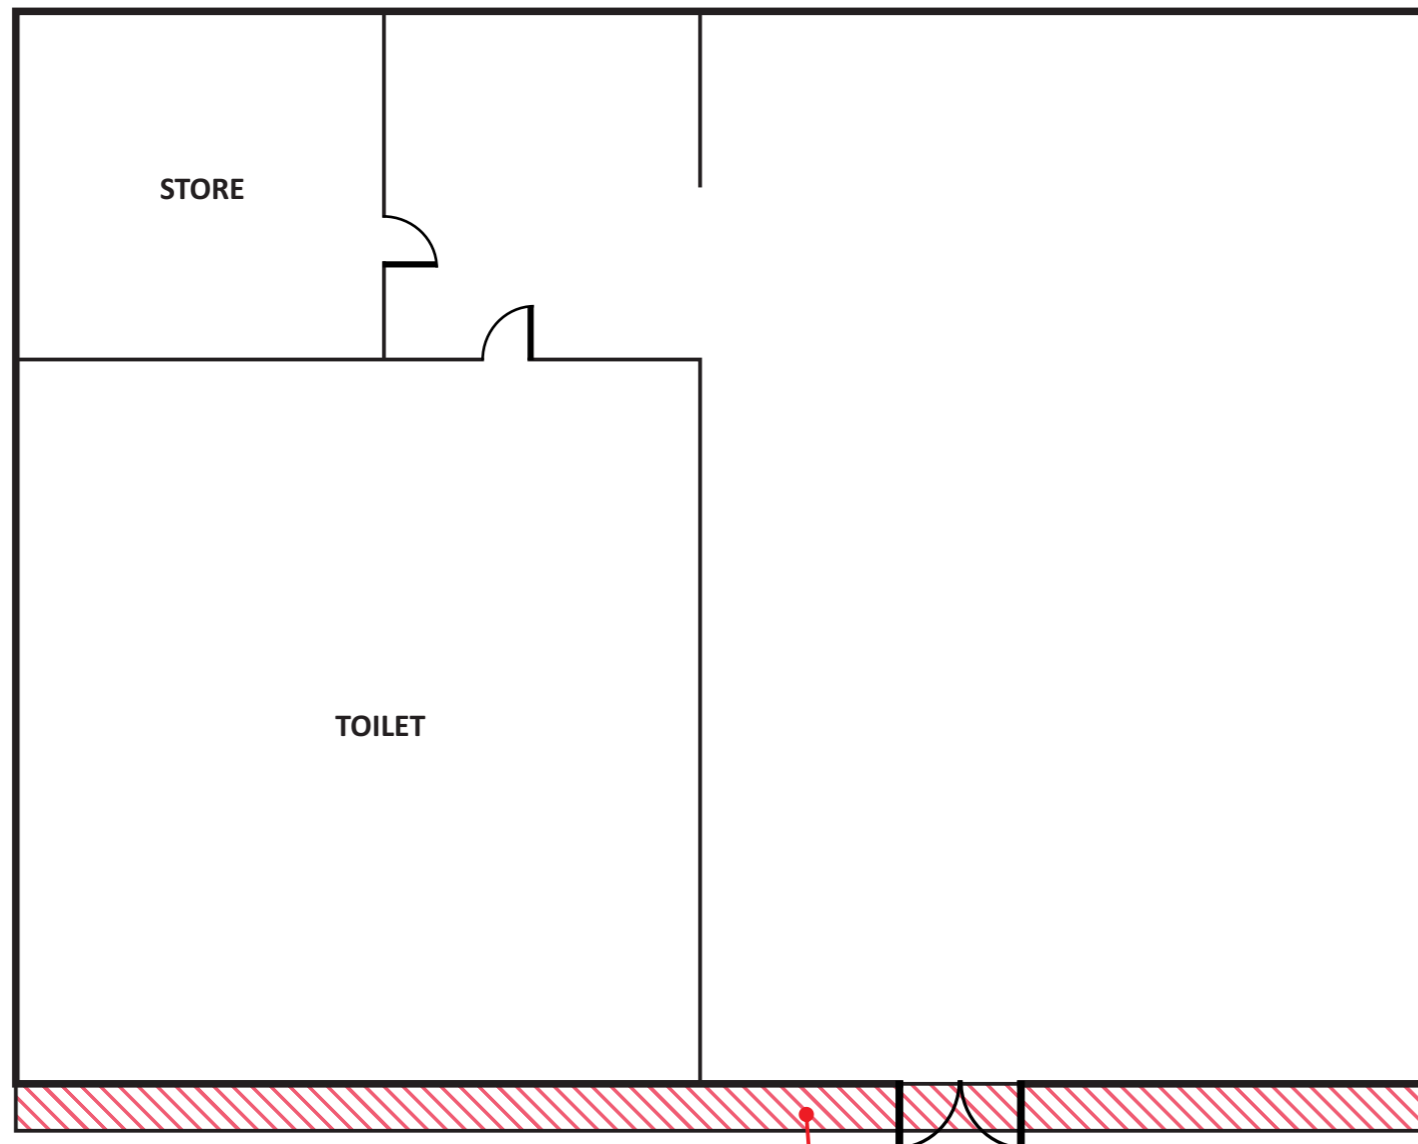
Drawing Title:
Blackmore Park Amenities Block B

Eaves

Debris

57722-175-001

57722-175-002
