Hazardous Building Materials Assessment Blackmore Park – Amenities A Canal Road, Leichhardt NSW 2040

Inner West Council
April 2018

Job No.: 57722-179

Count ID: CID: 73

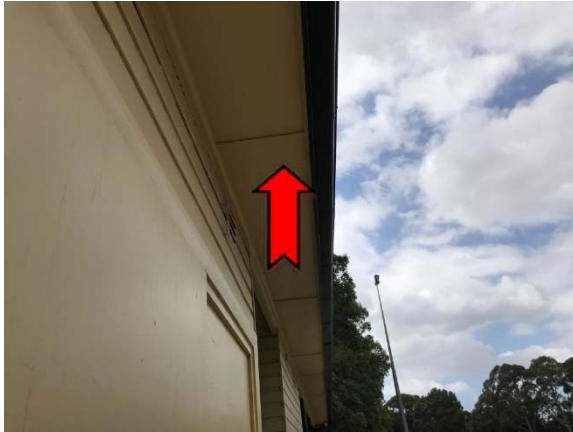
Photo 1. Exterior, throughout, eaves – asbestos-containing fibre cement sheeting.

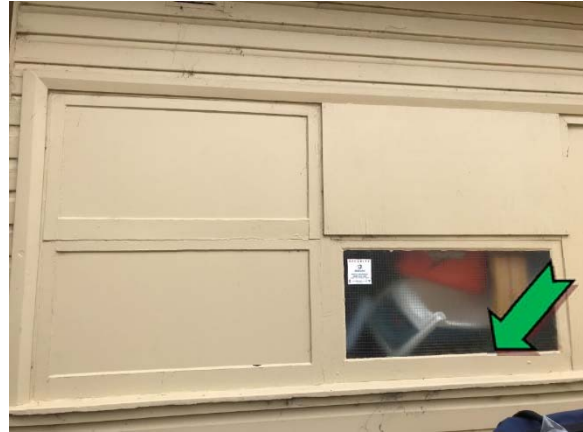
Photo 2. Exterior, throughout, window frames – non asbestos-containing window caulking.

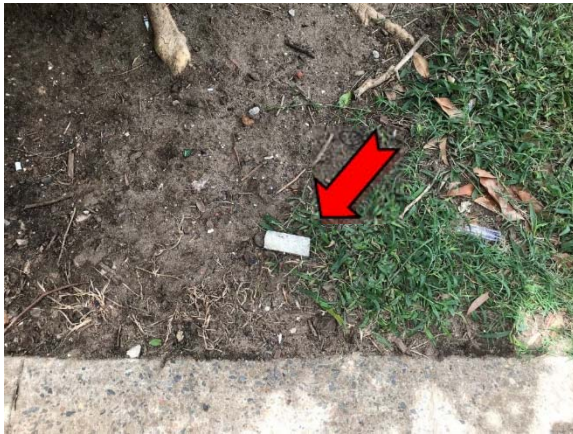
Area / Level	Room & Location	Feature	Item Description	Hazard Type	Sample No.	Sample Status	Friability	Disturb. Potential	Condition	Risk Status	Approx. Quantity	Recommendations & Comments	Control Priority	Reinspect Date	Photo No.
Exterior	Throughout	Eaves	Fibre cement sheeting	Asbestos	57722-179-001	Positive	Non-friable	Low	Good	Low	30 m ²	Label as containing asbestos and maintain in current condition if to remain in-situ. Remove under controlled non-friable asbestos removal conditions prior to refurbishment or demolition works by a Class B (non-friable) licensed asbestos removal contractor.	P4	Mar-23	1
Exterior	Throughout	Window frames	Window caulking	Asbestos	57722-179-002	Negative	-	-	-	-	-	-	-	-	2
Exterior	Ground, throughout	Debris	Fibre cement sheeting	Asbestos	57722-179-003	Positive	Non-friable	High	Poor	High	2 m ²	Remove under controlled non-friable asbestos removal conditions prior to refurbishment or demolition works by a Class B (non-friable) licensed asbestos removal contractor.	P2	Mar-19	3

Photo 3. Exterior, throughout, ground – asbestos-containing fibre cement debris.

- Asbestos-containing fibre cement debris found to the exterior of the building throughout the ground should be removed as soon as possible under controlled Class B (non-friable) licensed asbestos removal contractor.

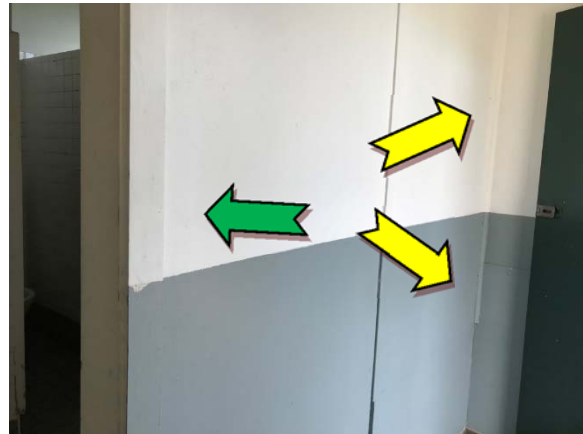
Interior	Mens toilet, throughout	Walls	Fibre cement sheeting	Asbestos	57722-179-004	Negative	-	-	-	-	-	-	-	-	4
Interior	Home change room	Ceiling	Fibre cement sheeting	Asbestos	57722-179-005	Negative	-	-	-	-	-	-	-	-	5
Interior	Home change room	Walls	Fibre cement sheeting	Asbestos	Same as: 57722-179-004	Assumed Negative	-	-	-	-	-	-	-	-	6
Interior	Hallway	Ceiling	Fibre cement sheeting	Asbestos	57722-179-006	Positive	Non-friable	Low	Good	Low	10 m ²	Label as containing asbestos and maintain in current condition if to remain in-situ. Remove under controlled non-friable asbestos removal conditions prior to refurbishment or demolition works by a Class B (non-friable) licensed asbestos removal contractor.	P4	Mar-23	-
Interior	Away changeroom, showers, throughout	Ceiling	Fibre cement sheeting	Asbestos	Same as: 57722-179-006	Assumed Positive	Non-friable	Low	Good	Low	10 m ²	Label as containing asbestos and maintain in current condition if to remain in-situ. Remove under controlled non-friable asbestos removal conditions prior to refurbishment or demolition works by a Class B (non-friable) licensed asbestos removal contractor.	P4	Mar-23	-

Photo 4. Interior, men's toilet, wall – non asbestos-containing fibre cement sheeting and suspected lead-containing white and blue upper coloured paint systems.

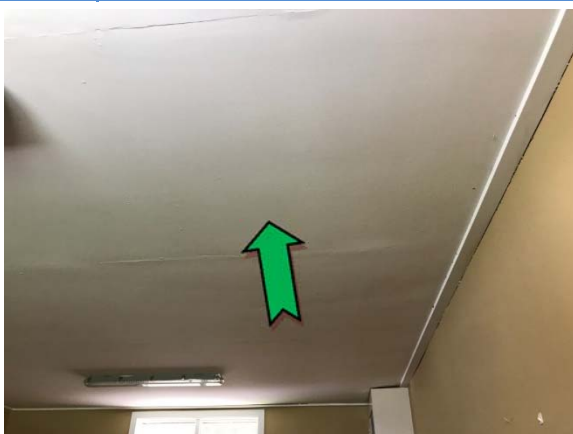
Photo 5. Interior, home change room, ceiling – non asbestos-containing fibre cement sheeting.

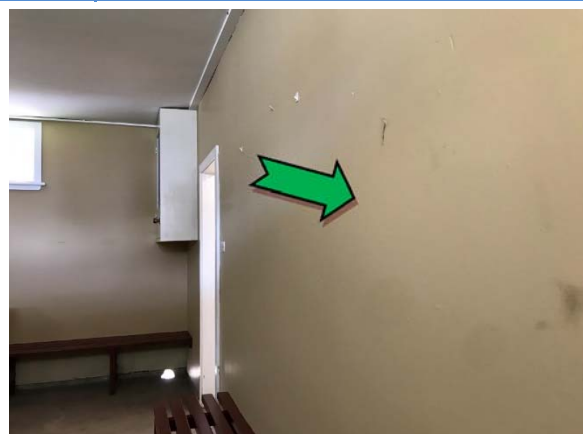
Photo 6. Interior, home change room, wall – assumed non asbestos-containing fibre cement sheeting.

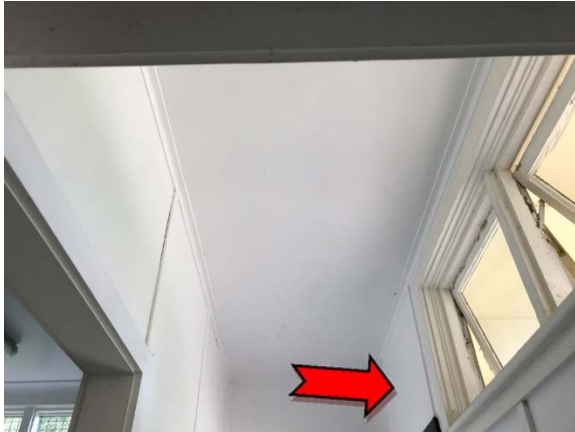
Interior	Mens toilet & lobby, throughout	High level infill panel	Fibre cement sheeting	Asbestos	Same as: 57722-179-006	Assumed Positive	Non-friable	Low	Good	Low	6 m ²	Label as containing asbestos and maintain in current condition if to remain in-situ. Remove under controlled non-friable asbestos removal conditions prior to refurbishment or demolition works by a Class B (non-friable) licensed asbestos removal contractor.	P4	Mar-23	7
Interior	Home change room, showers	Ceiling	Fibre cement sheeting	Asbestos	Same as: 57722-179-006	Assumed Positive	Non-friable	Low	Good	Low	10 m ²	Label as containing asbestos and maintain in current condition if to remain in-situ. Remove under controlled non-friable asbestos removal conditions prior to refurbishment or demolition works by a Class B (non-friable) licensed asbestos removal contractor.	P4	Mar-23	-
Interior	Disabled toilets	Walls	Fibre cement sheeting	Asbestos	Same as: 57722-179-004	Assumed Negative	-	-	-	-	-	-	-	-	-

Photo 7. Interior, men's toilet lobby, high level infill panel – assumed asbestos-containing fibre cement sheeting.

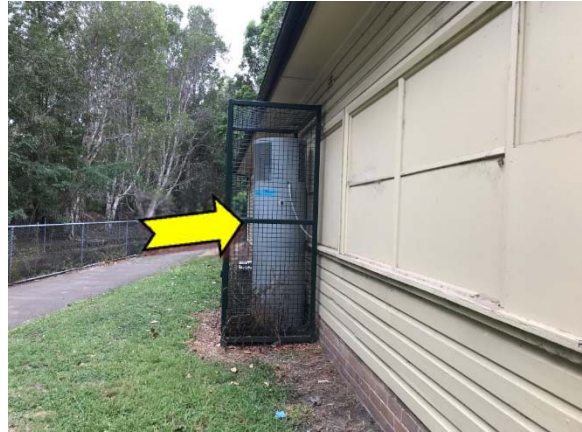
Photo 8. Exterior, north elevation, hot water heater – suspected SMF internal insulation material.

- SMF materials that are likely to be disturbed during any proposed demolition/refurbishment works should be handled in accordance with the *Code of Practice for the Safe Use of Synthetic Mineral Fibres* [NOHSC:2006(1990)]. If these materials are impacted upon by accident or by pre-planned works, the Inner West Council must be informed via the contact detailed within Section 7: *Accidental Disturbance of Known or Suspected Hazardous Building Materials*. Following disturbance, inspection by a competent person should be undertaken.

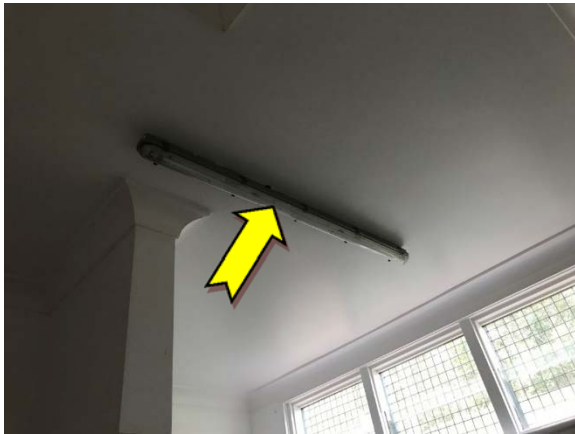
Photo 9. Interior, throughout, single tube fluorescent light fitting – suspected PCB-containing capacitors.

- Electrical fittings suspected of containing PCB oil capacitors should be treated as containing PCB oils until such time as evidence suggest otherwise e.g. further assessed.
- Electrical fittings that contain or suspected to contain PCB oil-containing capacitors should be removed as hazardous/regulated waste under controlled working conditions prior to the demolition or refurbishment works in accordance with the *Polychlorinated Biphenyls Management Plan, Revised Edition April 2003*.

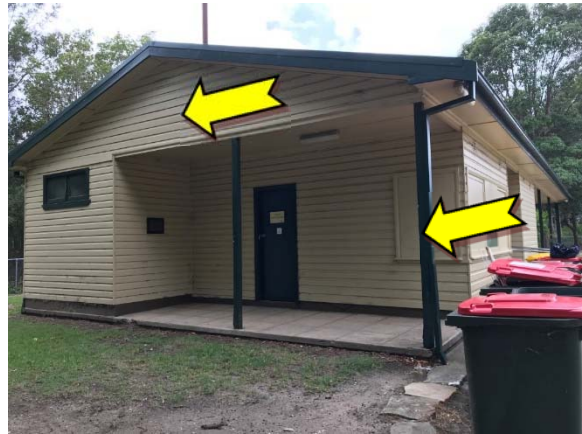
Interior	Throughout	Fluorescent light fitting - single tube	Capacitor	PCBs	-	Suspected Positive	-	Low	Good	Low	8 units	PCB-containing capacitors are suspected due to age & appearance of electrical fittings. Remove and dispose of in accordance with the Polychlorinated Biphenyls Management Plan, Revised Edition April 2003.	-	-	9
Exterior	Throughout	Walls	Yellow - upper coloured paint system	Lead Paint - Swab	-	Suspected Positive	-	Low	Good	Low	250 m ²	Confirm status by quantitative test method, maintain in current condition, over paint with a lead-free paint as part of ongoing maintenance. Remove under controlled conditions in accordance with AS 4361.2:2017 Guide to hazardous paint management prior to renovation or demolition works.	-	-	10
Exterior	Throughout	Beams	Green - upper coloured paint system	Lead Paint - Swab	-	Suspected Positive	-	Low	Good	Low	20 m ²	Confirm status by quantitative test method, maintain in current condition, over paint with a lead-free paint as part of ongoing maintenance. Remove under controlled conditions in accordance with AS 4361.2:2017 Guide to hazardous paint management prior to renovation or demolition works.	-	-	10

Photo 10. Exterior, throughout, walls and features – suspected lead-containing cream and green upper coloured paint systems.

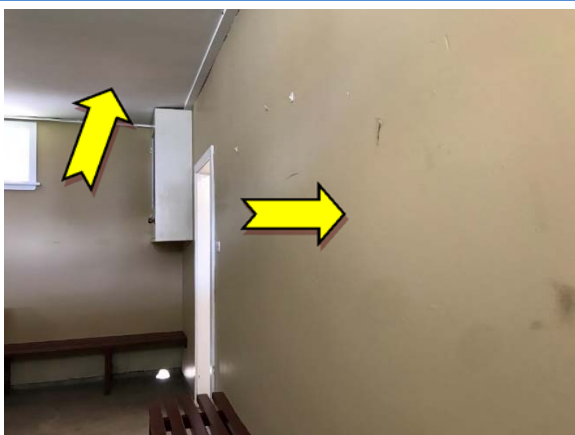
Interior	Mens toilet	Ceiling	White - upper coloured paint system	Lead Paint - Swab	-	Suspected Positive	-	Low	Good	Low	10 m ²	Confirm status by quantitative test method, maintain in current condition, over paint with a lead-free paint as part of ongoing maintenance. Remove under controlled conditions in accordance with AS 4361.2:2017 Guide to hazardous paint management prior to renovation or demolition works.	-	-	-
Interior	Home changeroom	Walls	Yellow (dark) - upper coloured paint system	Lead Paint - Swab	-	Suspected Positive	-	Low	Good	Low	40 m ²	Confirm status by quantitative test method, maintain in current condition, over paint with a lead-free paint as part of ongoing maintenance. Remove under controlled conditions in accordance with AS 4361.2:2017 Guide to hazardous paint management prior to renovation or demolition works.	-	-	11
Interior	Home changeroom	Ceiling	White - upper coloured paint system	Lead Paint - Swab	-	Suspected Positive	-	Low	Good	Low	24 m ²	Confirm status by quantitative test method, maintain in current condition, over paint with a lead-free paint as part of ongoing maintenance. Remove under controlled conditions in accordance with AS 4361.2:2017 Guide to hazardous paint management prior to renovation or demolition works.	-	-	11

Photo 11. Interior, home change room, walls and ceiling – suspected lead-containing dark yellow and white upper coloured paint systems.

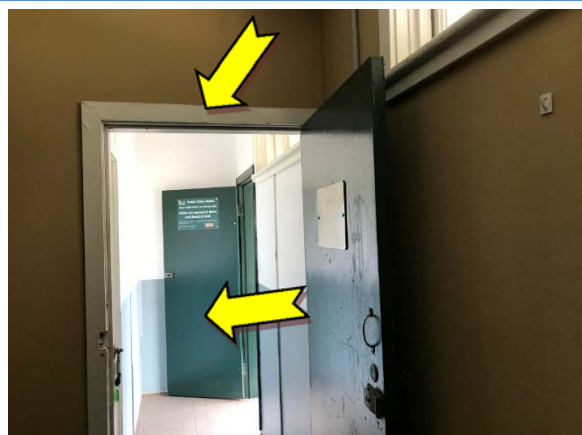
Interior	Throughout	Door frame	White - upper coloured paint system	Lead Paint - Swab	-	Suspected Positive	-	Low	Good	Low	25 m ²	Confirm status by quantitative test method, maintain in current condition, over paint with a lead-free paint as part of ongoing maintenance. Remove under controlled conditions in accordance with AS 4361.2:2017 Guide to hazardous paint management prior to renovation or demolition works.	-	-	12
Interior	Mens shed	Walls	White - upper coloured paint system	Lead Paint - Swab	-	Suspected Positive	-	Low	Good	Low	80 m ²	Confirm status by quantitative test method, maintain in current condition, over paint with a lead-free paint as part of ongoing maintenance. Remove under controlled conditions in accordance with AS 4361.2:2017 Guide to hazardous paint management prior to renovation or demolition works.	-	-	12

Photo 12. Interior, throughout, door frames and doors – suspected lead-containing white and green upper coloured paint systems.
