# Hazardous Building Materials Assessment Blackmore Park – Caretakers Cottage Canal Road, Leichhardt NSW 2040

Inner West Council  
April 2018

Job No.: 57722-176

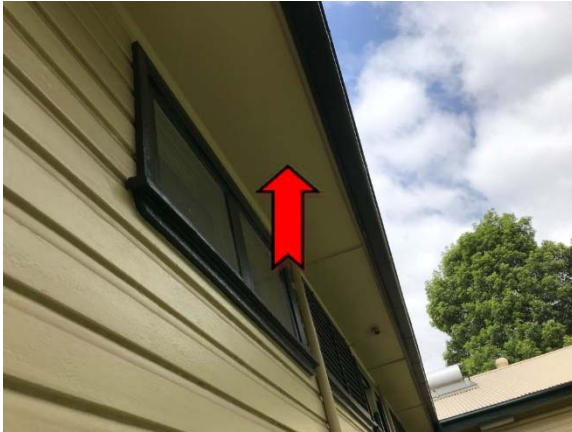
**Photo 1.** Exterior, throughout, eaves – asbestos-containing fibre cement sheeting.

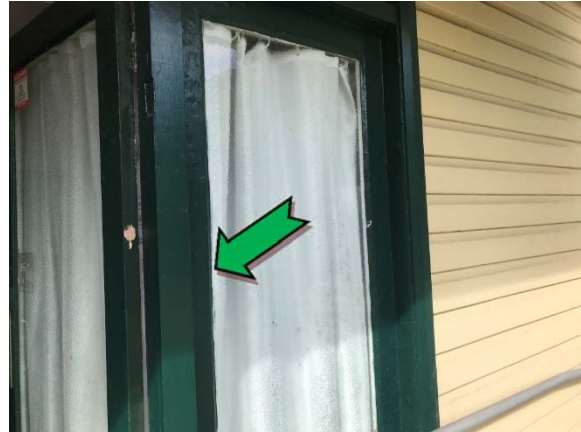
**Photo 2.** Exterior, throughout, window frames – non asbestos-containing window caulking.

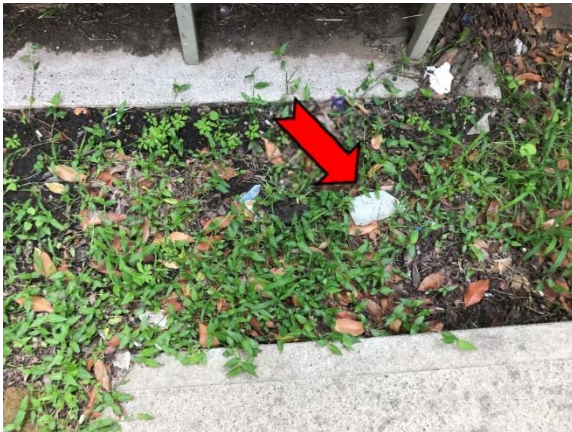
**Photo 3.** Exterior, throughout, ground – asbestos-containing fibre cement debris.

- Asbestos-containing fibre cement debris found to the exterior of the building throughout the ground should be removed as soon as possible under controlled Class B (non-friable) licensed asbestos removal contractor.

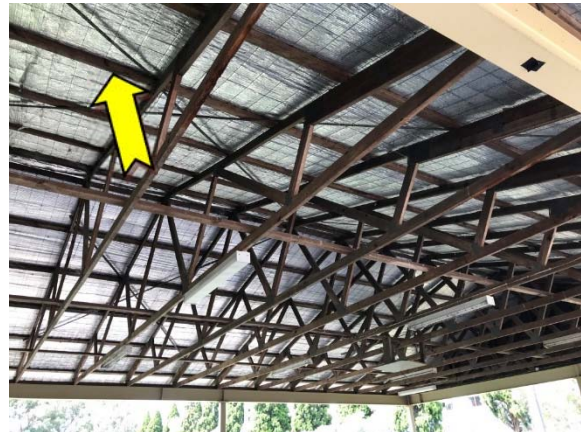
**Photo 4.** Exterior, south-east elevation, underside of awning – suspected SMF sarking insulation material.

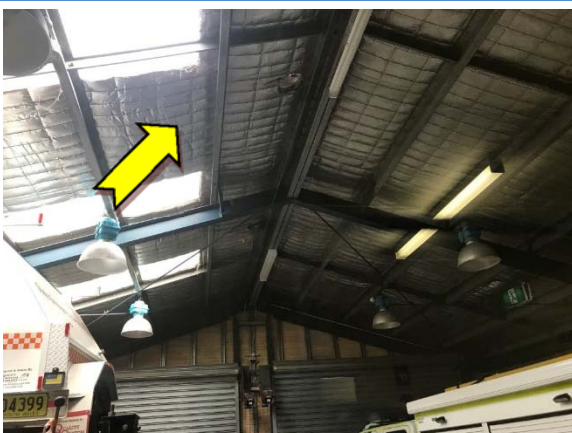
**Photo 5.** Exterior, garage, underside of roof – suspected SMF sarking insulation material.

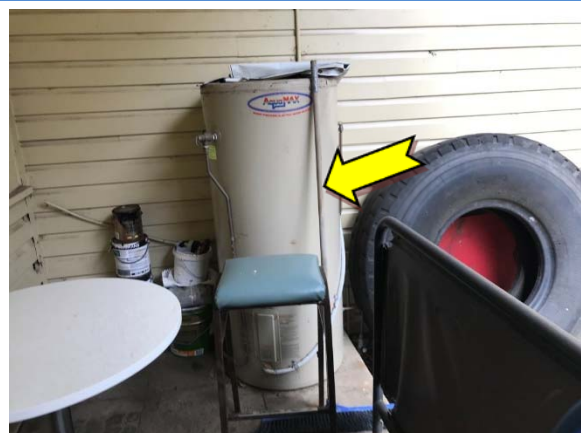
Exterior	South-east elevation	Awning	Sarking insulation	SMF	-	Suspected Positive	Bonded	Low	Good	Low	150 m <sup>2</sup>	Maintain in current condition if to remain in-situ. Remove under controlled SMF conditions as per the Code of Practice for the Safe Use of Synthetic Mineral Fibres [NOHSC: 2006 (1990)].	-	-	4
Exterior	Garage	Roof	Sarking insulation	SMF	-	Suspected Positive	Bonded	Low	Good	Low	150 m <sup>2</sup>	Maintain in current condition if to remain in-situ. Remove under controlled SMF conditions as per the Code of Practice for the Safe Use of Synthetic Mineral Fibres [NOHSC: 2006 (1990)].	-	-	5
Exterior	South-west elevation	Hot water heater	Insulation material - internal	SMF	-	Suspected Positive	Bonded	Low	Good	Low	1 unit	Maintain in current condition if to remain in-situ. Remove under controlled SMF conditions as per the Code of Practice for the Safe Use of Synthetic Mineral Fibres [NOHSC: 2006 (1990)].	-	-	6

**Photo 6.** Exterior, south-west elevation, hot water heater – suspected SMF internal insulation material.

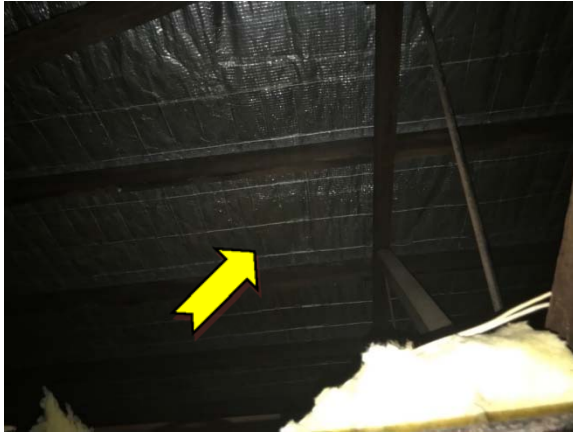
**Photo 7.** Interior, throughout, underside of roof – suspected SMF sarking insulation material.

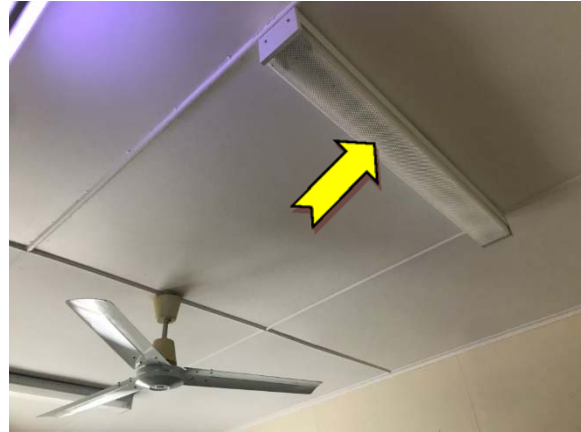
**Photo 8.** Interior, throughout, fluorescent double tubed light fitting – suspected non PCB-containing capacitors.

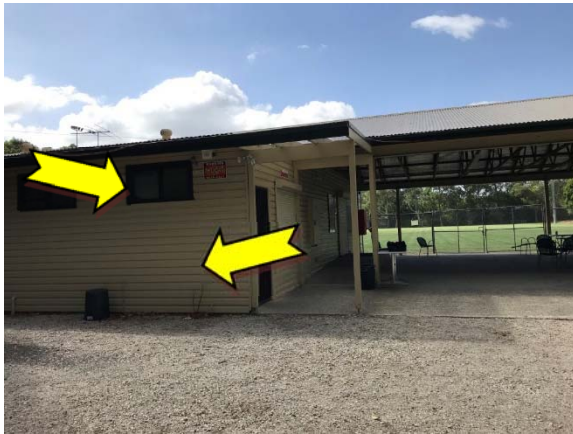
**Photo 9.** Exterior, throughout, walls and features – suspected lead-containing yellow and green upper coloured paint systems.

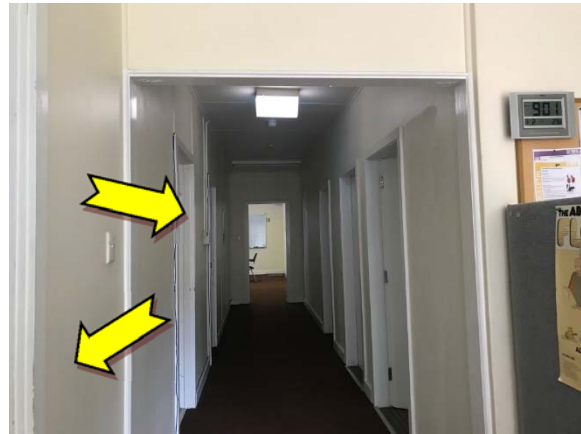
Interior	Throughout	Walls	Yellow (light) - upper coloured paint system	Lead Paint - Swab	-	Suspected Positive	-	Low	Good	Low	15 m <sup>2</sup>	Confirm status by quantitative test method, maintain in current condition, over paint with a lead-free paint as part of ongoing maintenance. Remove under controlled conditions in accordance with AS 4361.2:2017 Guide to hazardous paint management prior to renovation or demolition works.	-	-	10
Interior	Throughout	Ceiling	White - upper coloured paint system	Lead Paint - Swab	-	Suspected Positive	-	Low	Good	Low	15 m <sup>2</sup>	Confirm status by quantitative test method, maintain in current condition, over paint with a lead-free paint as part of ongoing maintenance. Remove under controlled conditions in accordance with AS 4361.2:2017 Guide to hazardous paint management prior to renovation or demolition works.	-	-	-
Interior	Throughout	Door frame	White - upper coloured paint system	Lead Paint - Swab	-	Suspected Positive	-	Low	Good	Low	15 m <sup>2</sup>	Confirm status by quantitative test method, maintain in current condition, over paint with a lead-free paint as part of ongoing maintenance. Remove under controlled conditions in accordance with AS 4361.2:2017 Guide to hazardous paint management prior to renovation or demolition works.	-	-	10

**Photo 10.** Interior, throughout, walls and door frames – suspected lead-containing light yellow and white upper coloured paint systems.
