Hazardous Building Materials Assessment Leichhardt Depot Amenities Block 229 Catherine Street Leichhardt NSW 2040

Inner West Council
April 2018

Job No: 57722-036

Count ID: CID: 195

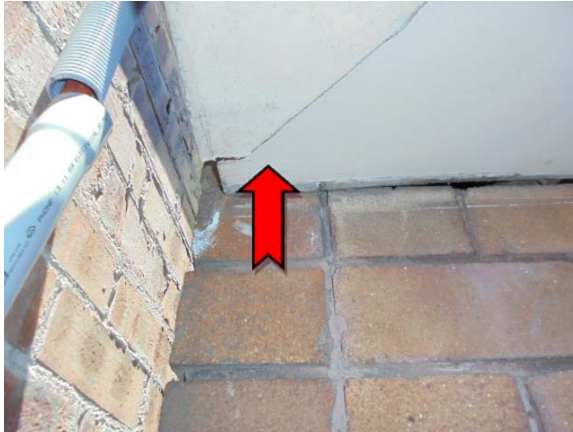
Photo 1. Exterior, north north-eastern elevations, eaves –asbestos-containing fibre cement sheeting.

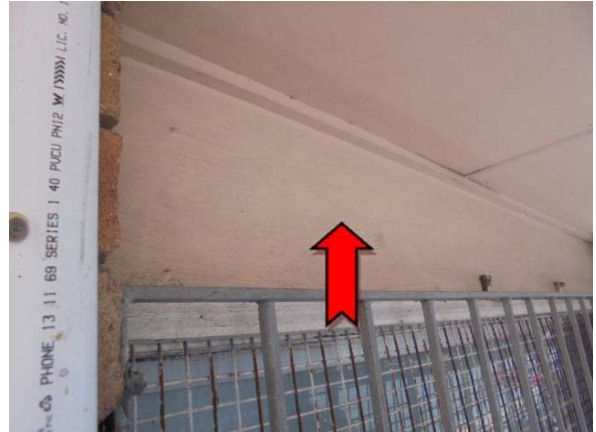
Photo 2. Exterior, north elevation, Infill panels – asbestos-containing fibre cement sheeting.

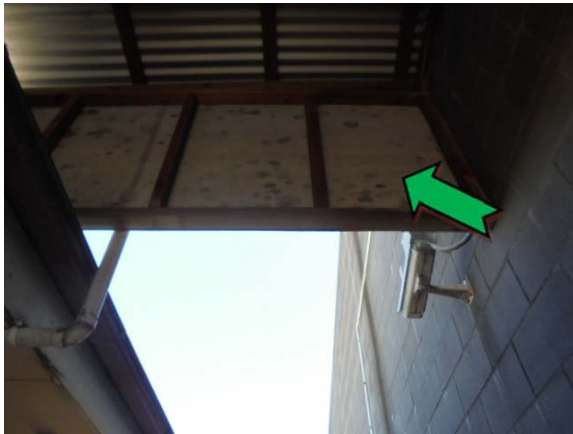
Photo 3. Exterior, western elevation, Infill panels high level – non asbestos-containing fibre cement sheeting.

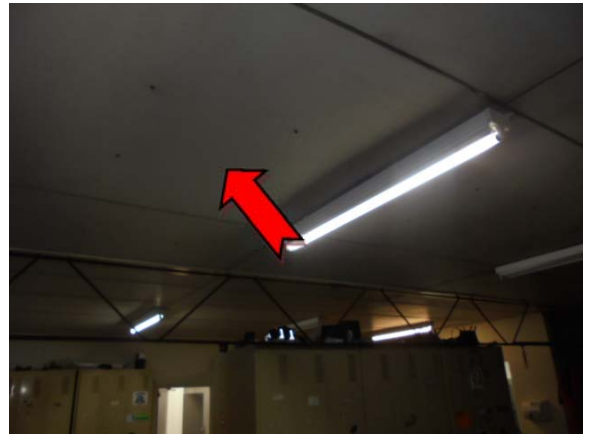
Photo 4. Interior, ground level, change room, ceiling – asbestos-containing fibre cement sheeting.

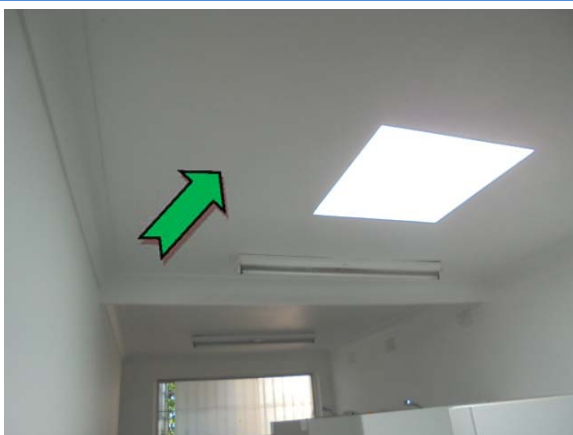
Photo 5. Interior, ground level, Shower and male toilets, ceiling – non asbestos-containing fibre cement sheeting.

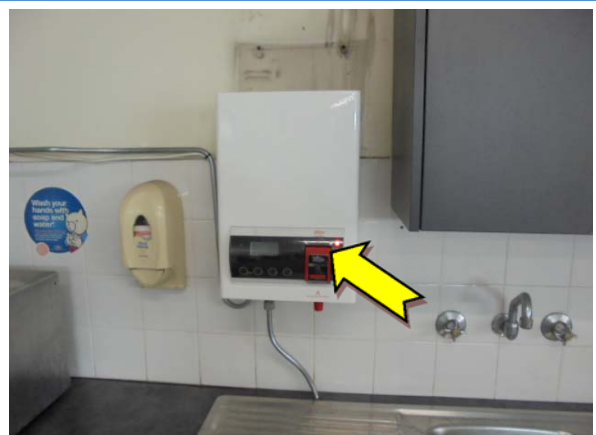
Photo 6. Interior, ground level, kitchen, hot water heater – suspected SMF internal insulation.

- Suspected SMF was present in the form of internal insulation to the hot water heater located in the kitchen.

- SMF materials that are likely to be disturbed during any proposed demolition/refurbishment works should be handled in accordance with the *Code of Practice for the Safe Use of Synthetic Mineral Fibres* [NOHSC:2006(1990)]. If these materials are impacted upon by accident or by pre-planned works, the Inner West Council must be informed via the contact detailed within Section 7: *Accidental Disturbance of Known or Suspected Hazardous Building Materials*. Following disturbance, inspection by a competent person should be undertaken.

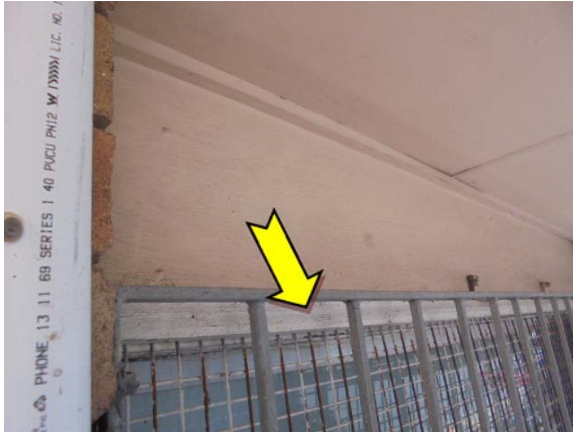
Photo Exterior, throughout, window frames –
7. suspected lead-containing white upper paint system.

- LCP was suspected in white upper coloured paint systems to window frames located throughout the exterior of the building.
- LCP was also suspected within the white upper coloured paint system throughout all walls off the building.

- The *LeadCheck* paint swab method can detect lead in paint at concentrations of 0.5% and above, and may indicate lead in some paint films as low as 0.2%. As paint with a lead content greater than 0.1% by dry weight is now considered to be lead-containing, Prensa recommends confirming status of suspected LCP identified during the Assessment by quantitative test method.

- The safest method of dealing with LCP is to replace or remove the items in their entirety that have LCP on them and replace them with new items that do not contain lead. This allows the items to be disposed of as regular building or demolition unsegregated waste in accordance with the NSW Environment Protection Authority (EPA) *Waste Classification Guidelines 2014 Part 1 – Classifying Waste*. The advantage of this method is the reduction in labour requirements to remove the lead paint and also this reduces the risk to workers from exposure to lead dust or fumes. If the removal of the LCP or coatings is the preferred or required option this may generate significant amounts of potential hazardous waste. This waste must be removed, collected and disposed of by an appropriately licensed contractor under controlled conditions that minimises the release to air, water and soil. Disposal of lead waste must be disposed of as hazardous waste at an approved waste facility.
