Hazardous Building Materials Assessment Leichhardt Depot Female Amenities Block 229 Catherine Street Leichhardt NSW 2040

Inner West Council
April 2018

Job No.: 57722-171

Count ID: CID: 201

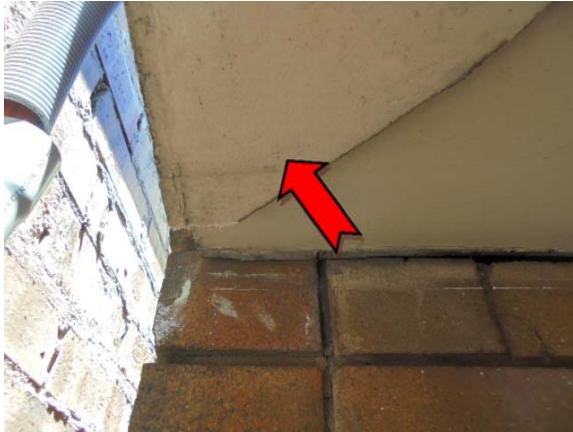
Photo 1. Exterior, female toilet, eaves – asbestos-containing fibre cement sheeting.

- Non-friable asbestos was identified in the form of fibre cement sheeting throughout the eaves and high level infill panels above windows to the northern elevation of the female amenities.
- Non-friable asbestos was suspected in the form of fibre cement sheeting throughout the ceiling to the interior of the female amenities.

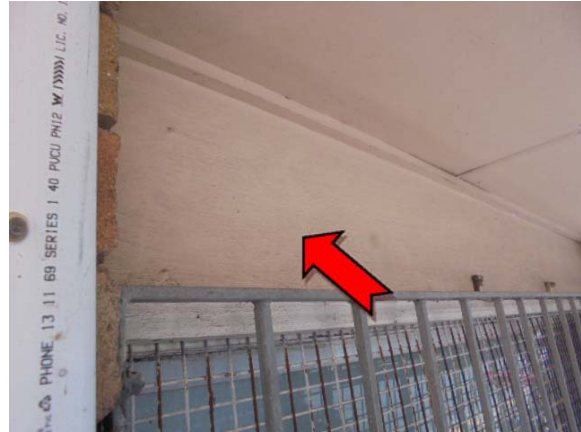
Photo 2. Exterior, northern windows, infill panels – asbestos-containing fibre cement sheeting.

Area / Level	Room & Location	Feature	Item Description	Hazard Type	Sample No.	Sample Status	Friability	Disturb. Potential	Condition	Risk Status	Approx. Quantity	Recommendations & Comments	Control Priority	Reinspect Date	Photo No.
Exterior	Amenities block	Eaves	Fibre cement sheet	Asbestos	57722-036-001	Positive	Non-friable	Low	Good	Low	20 m ²	Maintain in current condition if to remain in-situ. Remove under controlled non-friable asbestos removal conditions prior to refurbishment or demolition works by a Class B (non-friable) licensed asbestos removal contractor.	P4	Feb-23	1
Exterior	Northern windows	Infill panels	Fibre cement sheet	Asbestos	57722-036-002	Positive	Non-friable	Low	Good	Low	20 m ²	Maintain in current condition if to remain in-situ. Remove under controlled non-friable asbestos removal conditions prior to refurbishment or demolition works by a Class B (non-friable) licensed asbestos removal contractor.	P4	Feb-23	2

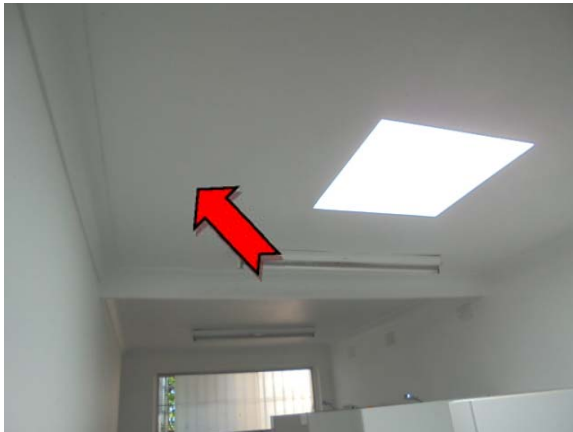
Interior, Ground level	Female toilet	Ceiling	Fibre cement sheet	Asbestos	Same as: 57722-036-004	Assumed Positive	Non-friable	Low	Good	Low	10 m ²	Previously sampled by Prensa CJG Feb-2018. Maintain in current condition if to remain in-situ. Remove under controlled non-friable asbestos removal conditions prior to refurbishment or demolition works by a Class B (non-friable) licensed asbestos removal contractor.	P4	Feb-23	3
Throughout	-	-	-	SMF	-	-	-	-	-	-	-	No suspect SMF material identified at the time of the assessment.	-	-	-
Throughout	-	-	-	PCBs	-	-	-	-	-	-	-	No suspect PCB-containing capacitors identified at the time of the assessment.	-	-	-
Exterior	Windows	Window frames	White - upper coloured paint system	Lead Paint - Swab	-	Suspected Positive	-	-	-	-	10m	Maintain in current condition, over paint with a lead-free paint as part of ongoing maintenance. Remove under controlled conditions in accordance with AS 4361.2:2017 Guide to hazardous paint management prior to renovation or demolition works.	-	-	-

Photo 3. Interior, ground level, female toilet, ceiling – assumed asbestos-containing fibre cement sheeting.

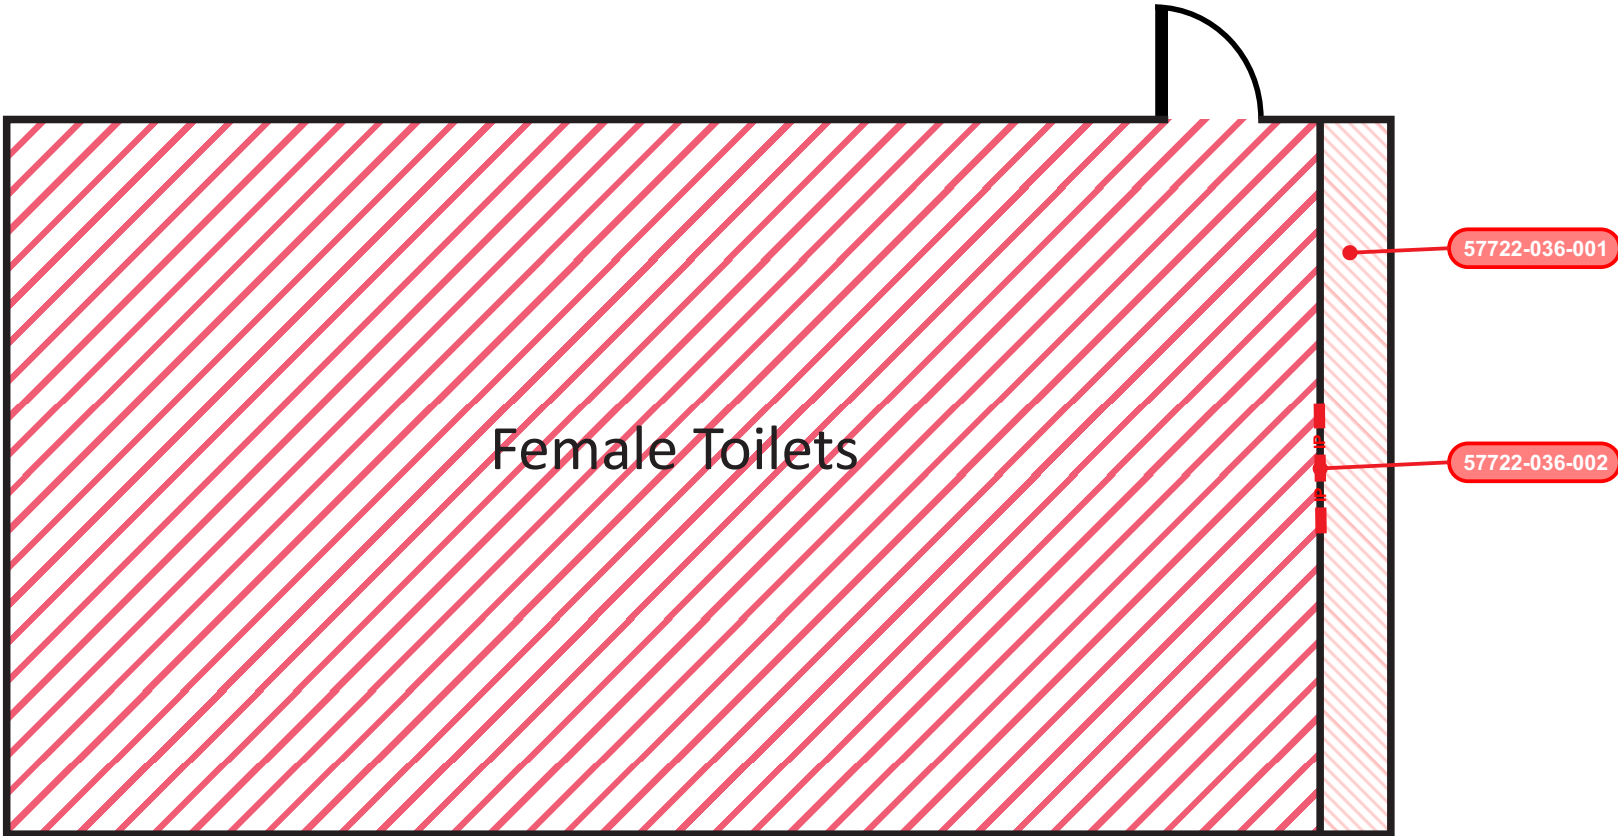
Leichhardt Depot Female Amenities

Positive Asbestos Sample
	Infill Panel
	Eaves
	Ceiling Lining
