Hazardous Building Materials Assessment Leichhardt Depot Improvements 229 Catherine Street Leichhardt NSW 2040

Inner West Council
April 2018

Job No.: 57722-075

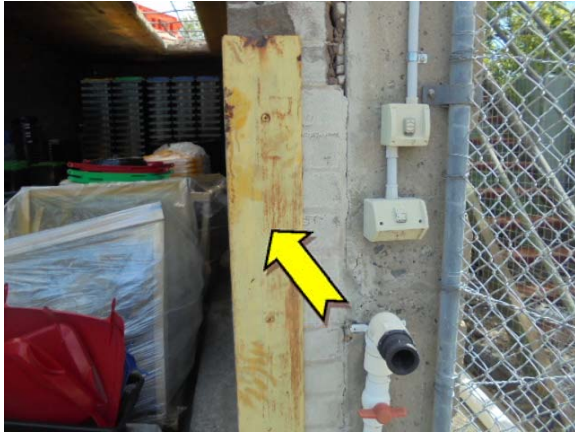
Photo Exterior, east elevation, metal framework –
1. suspected lead-containing yellow upper paint system.

- LCP was suspected in the form of yellow upper coloured paint systems located to metal framework to eastern elevation.

- The *LeadCheck* paint swab method can detect lead in paint at concentrations of 0.5% and above, and may indicate lead in some paint films as low as 0.2%. As paint with a lead content greater than 0.1% by dry weight is now considered to be lead-containing, Prensa recommends confirming status of suspected LCP identified during the Assessment by quantitative test method.

- The safest method of dealing with LCP is to replace or remove the items in their entirety that have LCP on them and replace them with new items that do not contain lead. This allows the items to be disposed of as regular building or demolition unsegregated waste in accordance with the NSW Environment Protection Authority (EPA) *Waste Classification Guidelines 2014 Part 1 – Classifying Waste*. The advantage of this method is the reduction in labour requirements to remove the lead paint and also this reduces the risk to workers from exposure to lead dust or fumes. If the removal of the LCP or coatings is the preferred or required option this may generate significant amounts of potential hazardous waste. This waste must be removed, collected and disposed of by an appropriately licensed contractor under controlled conditions that minimises the release to air, water and soil. Disposal of lead waste must be disposed of as hazardous waste at an approved waste facility.
