Hazardous Building Materials Assessment

Leichhardt Depot – Shed

229 Catherine Street
Leichhardt NSW 2040

Inner West Council
April 2018

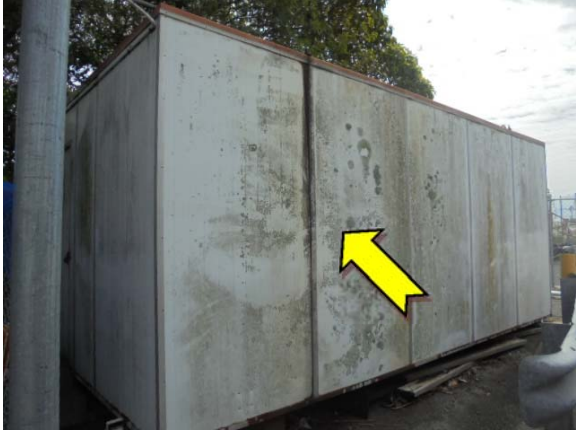
Photo Exterior, throughout, walls – suspected
1. lead-containing white upper paint system.

- LCP was suspected in the form of white upper coloured paint system to the exterior of the building.

- The *LeadCheck* paint swab method can detect lead in paint at concentrations of 0.5% and above, and may indicate lead in some paint films as low as 0.2%. As paint with a lead content greater than 0.1% by dry weight is now considered to be lead-containing, Prensa recommends confirming status of suspected LCP identified during the assessment by quantitative test method.

- The safest method of dealing with LCP is to replace or remove the items in their entirety that have LCP on them and replace them with new items that do not contain lead. This allows the items to be disposed of as regular building or demolition unsegregated waste in accordance with the NSW Environment Protection Authority (EPA) *Waste Classification Guidelines 2014 Part 1 – Classifying Waste*. The advantage of this method is the reduction in labour requirements to remove the lead paint and also this reduces the risk to workers from exposure to lead dust or fumes. If the removal of the LCP or coatings is the preferred or required option this may generate significant amounts of potential hazardous waste. This waste must be removed, collected and disposed of by an appropriately licensed contractor under controlled conditions that minimises the release to air, water and soil. Disposal of lead waste must be disposed of as hazardous waste at an approved waste facility.

- Advise all relevant site personnel and site contractors of the results of the LCP and the safe work procedures required and/or work practices to be avoided in the areas of confirmed LCP.

- Any remediation works that may generate dust or fumes (i.e. sanding, burning) must be performed under controlled conditions by a suitably resourced and experienced hazardous material/waste abatement contractor (e.g. a Class A licensed asbestos removal contractor).
