Hazardous Building Materials Assessment

Leichhardt Depot Wash Bay

229 Catherine Street
Leichhardt NSW 2040

Inner West Council
April 2018

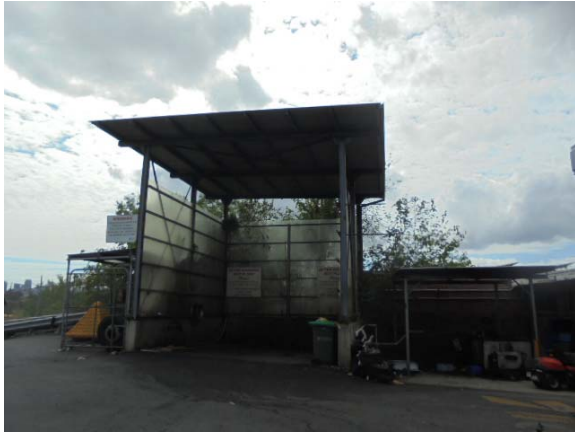
Photo 1. No hazardous materials suspected or identified at the time of assessment.
