Hazardous Building Materials Assessment War Memorial Park - Toilet Block Catherine Street, Leichhardt NSW 2040

Inner West Council
April 2018

Job No.: 57722-093

Count ID: CID: 382

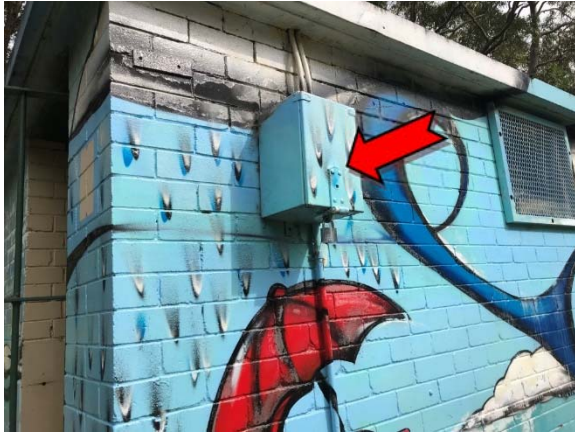
Photo 1. Exterior, south-east elevation, electrical backing board – suspected asbestos-containing bituminous backing board

- Non-friable asbestos was suspected in the form of a bituminous backing board to the south-east exterior of the building.

- ACM that may be disturbed should be removed prior to the commencement of any works.
- When asbestos removal works are required, the person that commissions the works must ensure that this is undertaken by an appropriately licensed asbestos contractor. The asbestos removal works must be conducted under controlled asbestos removal working conditions.

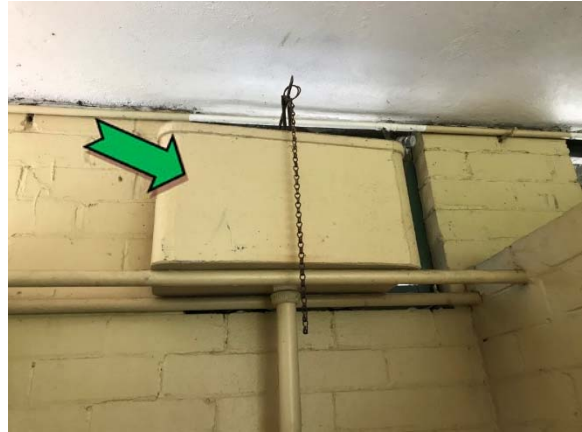
Photo 2. Interior, throughout, cistern – non asbestos-containing moulded fibre cement.

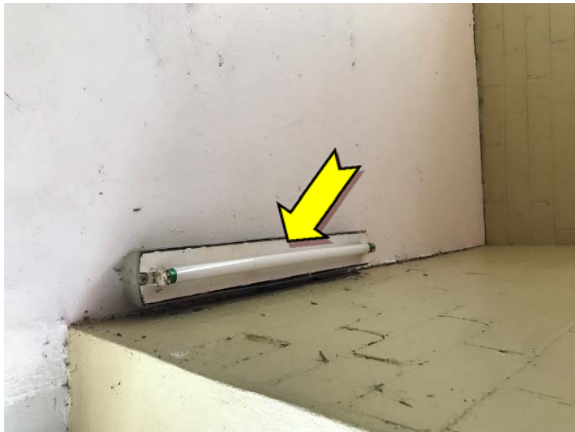
Photo 3. Interior, throughout, single tubed fluorescent light fittings – suspected PCB-containing capacitors.

- PCBs were suspected within the capacitors of the single tubed fluorescent light fittings throughout the building.

- Electrical fittings suspected of containing PCB oil capacitors should be treated as containing PCB oils until such time as evidence suggest otherwise e.g. further assessed.
- Electrical fittings that contain or suspected to contain PCB oil-containing capacitors should be removed as hazardous/regulated waste under controlled working conditions prior to the demolition or refurbishment works in accordance with the *Polychlorinated Biphenyls Management Plan, Revised Edition April 2003*.

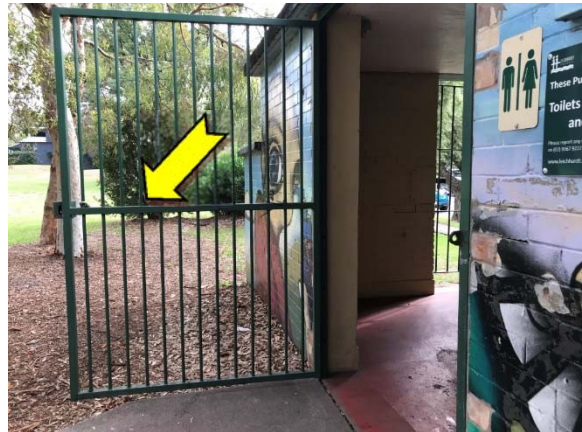
Photo 4. Exterior, throughout, door and frame – suspected lead-containing dark green upper paint systems.

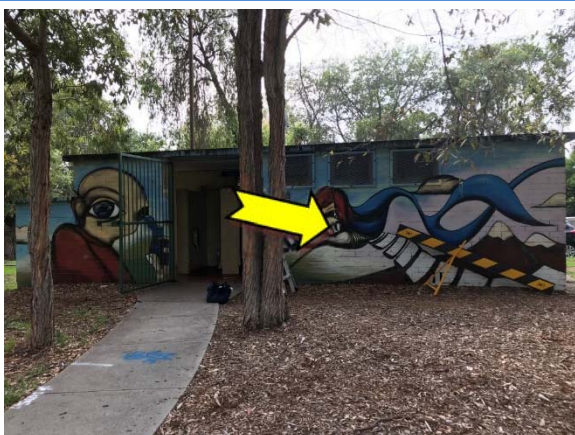
Photo 5. Exterior, throughout, walls, graffiti – suspected lead-containing various upper coloured paint systems.

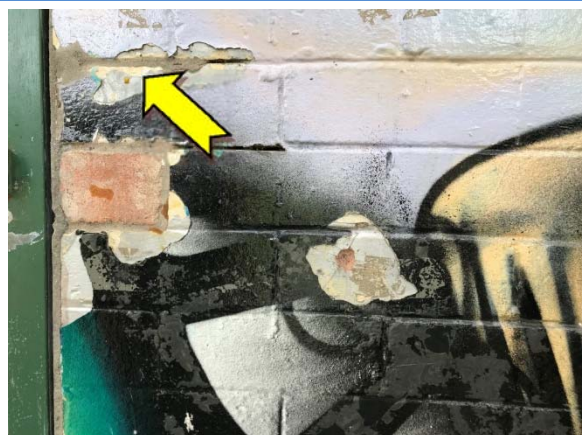
Photo 6. Exterior, throughout, walls – suspected lead-containing white and grey lower coloured paint systems.

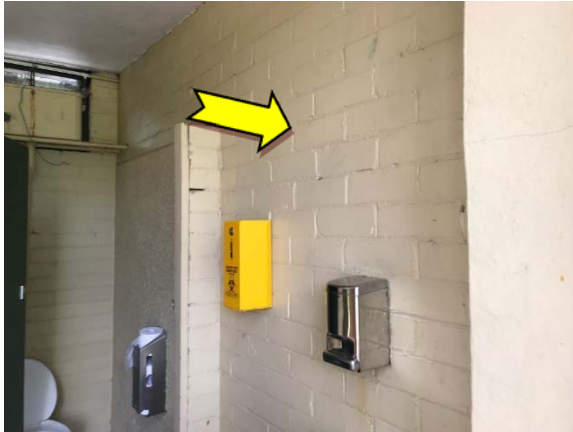
Photo 7. Interior, throughout, walls – suspected lead-containing light yellow upper paint systems.

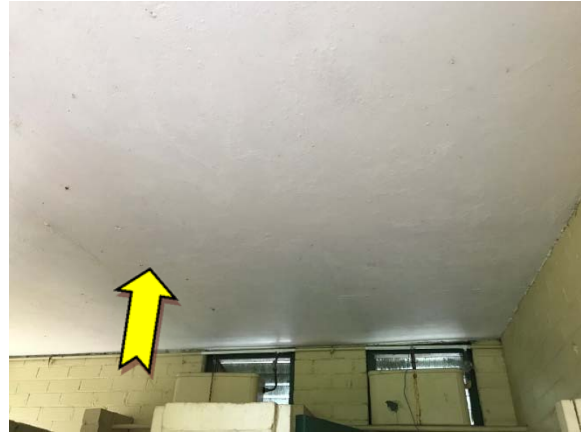
Photo 8. Interior, throughout, ceiling – suspected lead-containing white upper paint systems.

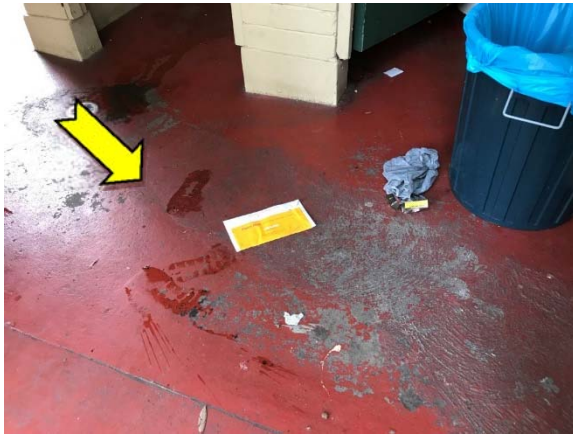
Photo 9. Interior, throughout, floor – suspected lead-containing red upper paint systems.

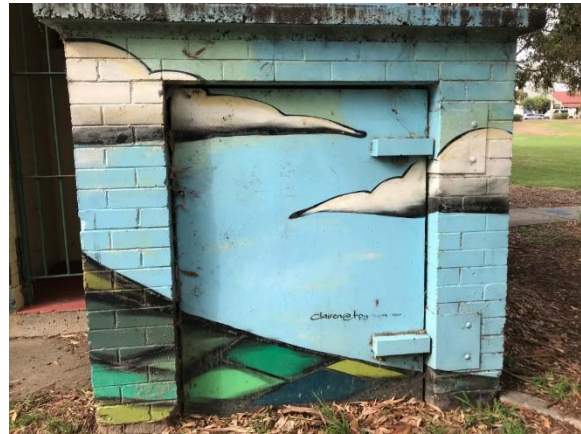
Photo 10. North elevation, storage – No access due to lock.
