Hazardous Building Materials Assessment Foster Street Family Day Care Centre – Store/Garage 22 Foster Street, Leichhardt NSW 2040

Inner West Council

April 2018

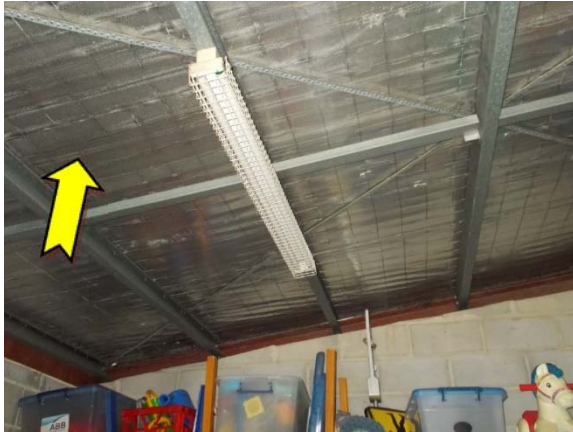
Photo 1. Interior, roof space, insulation – suspected SMF sarking insulation.

- SMF sarking insulation was suspected throughout the roof space.

- SMF materials that are likely to be disturbed during any proposed demolition/refurbishment works should be handled in accordance with the *Code of Practice for the Safe Use of Synthetic Mineral Fibres* [NOHSC:2006(1990)]. If these materials are impacted upon by accident or by pre-planned works, the Inner West Council must be informed via the contact detailed within Section 7: *Accidental Disturbance of Known or Suspected Hazardous Building Materials*. Following disturbance, inspection by a competent person should be undertaken.

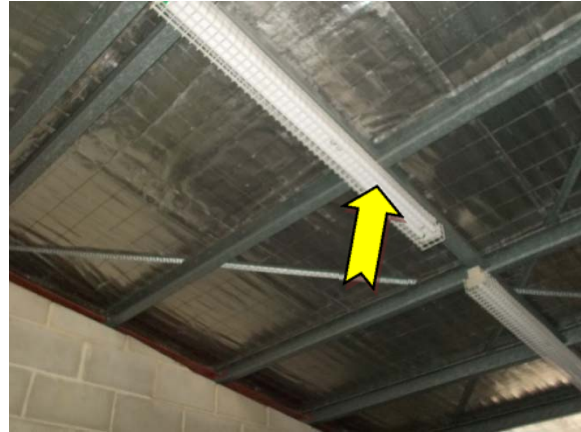
Area / Level	Room & Location	Feature	Item Description	Hazard Type	Sample No.	Sample Status	Friability	Disturb. Potential	Condition	Risk Status	Approx. Quantity	Recommendations & Comments	Control Priority	Reinspect Date	Photo No.
Throughout	-	-	-	Asbestos	-	-	-	-	-	-	-	No suspect asbestos material identified at the time of the assessment.	-	-	-
Interior	Roof space	Insulation	Sarking insulation	SMF	-	Suspected Positive	Bonded	Low	Good	Low	21 m ²	Maintain in current condition if to remain in-situ. Remove under controlled SMF conditions as per the Code of Practice for the Safe Use of Synthetic Mineral Fibres [NOHSC: 2006 (1990)].	-	-	1
Interior	Throughout	Fluorescent light fitting - double tube	Capacitor	PCBs	Not sampled: electrical hazard	Suspected Negative	-	-	-	-	-	PCB-containing capacitors are unlikely to be present due to age and appearance of light fittings. Confirm PCB status prior to refurbishment or demolition works.	-	-	2

Photo 2. Interior, fluorescent double tubed light fitting – suspected non PCB-containing capacitor.

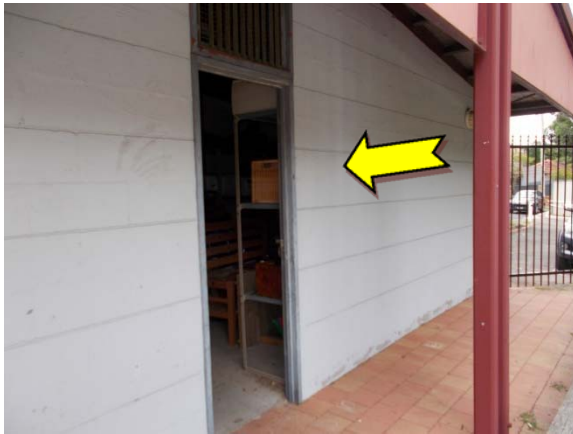
Photo 3. Exterior, throughout, walls and features – suspected lead-containing light blue and red upper coloured paint systems.

- LCP was suspected in the forms of light blue, red and yellow upper coloured paint systems to the exterior of the building.

- The *LeadCheck* paint swab method can detect lead in paint at concentrations of 0.5% and above, and may indicate lead in some paint films as low as 0.2%. As paint with a lead content greater than 0.1% by dry weight is now considered to be lead-containing, Prensa recommends confirming status of suspected LCP identified during the Assessment by quantitative test method.

- The safest method of dealing with LCP is to replace or remove the items in their entirety that have LCP on them and replace them with new items that do not contain lead. This allows the items to be disposed of as regular building or demolition unsegregated waste in accordance with the NSW Environment Protection Authority (EPA) *Waste Classification Guidelines 2014 Part 1 – Classifying Waste*. The advantage of this method is the reduction in labour requirements to remove the lead paint and also this reduces the risk to workers from exposure to lead dust or fumes. If the removal of the LCP or coatings is the preferred or required option this may generate significant amounts of potential hazardous waste. This waste must be removed, collected and disposed of by an appropriately licensed contractor under controlled conditions that minimises the release to air, water and soil. Disposal of lead waste must be disposed of as hazardous waste at an approved waste facility.

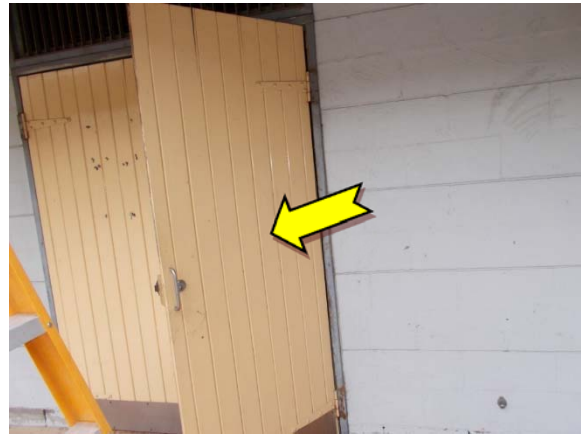
Exterior	Throughout	Walls	Blue (light) - upper coloured paint system	Lead Paint - Swab	-	Suspected Positive	-	Low	Good	Low	25 m ²	Confirm status by quantitative test method, maintain in current condition, over paint with a lead-free paint as part of ongoing maintenance. Remove under controlled conditions in accordance with AS 4361.2:2017 Guide to hazardous paint management prior to renovation or demolition works.	-	-	3
Exterior	Throughout	Column	Red - upper coloured paint system	Lead Paint - Swab	-	Suspected Positive	-	Low	Good	Low	5 m ²	Confirm status by quantitative test method, maintain in current condition, over paint with a lead-free paint as part of ongoing maintenance. Remove under controlled conditions in accordance with AS 4361.2:2017 Guide to hazardous paint management prior to renovation or demolition works.	-	-	3
Exterior	Throughout	Door	Yellow - upper coloured paint system	Lead Paint - Swab	-	Suspected Positive	-	Low	Good	Low	2 m ²	Confirm status by quantitative test method, maintain in current condition, over paint with a lead-free paint as part of ongoing maintenance. Remove under controlled conditions in accordance with AS 4361.2:2017 Guide to hazardous paint management prior to renovation or demolition works.	-	-	4

Photo 4. Exterior, throughout, door – suspected lead-containing yellow upper paint system.
