Hazardous Building Materials Assessment Foster Street Family Day Care Centre 22 Foster Street, Leichhardt NSW 2040

Inner West Council
April 2018

Executive Summary

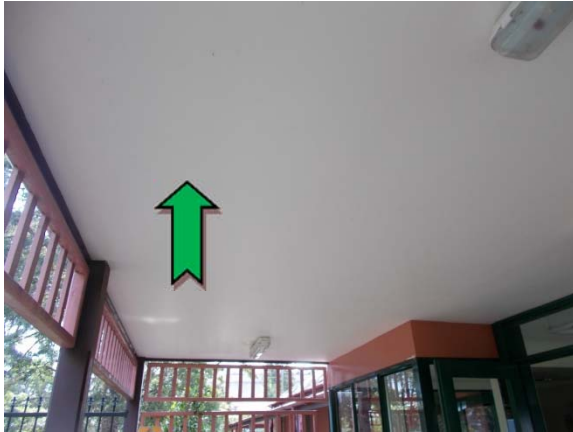
Photo 1. Exterior, throughout, awning – non asbestos-containing fibre cement sheeting.

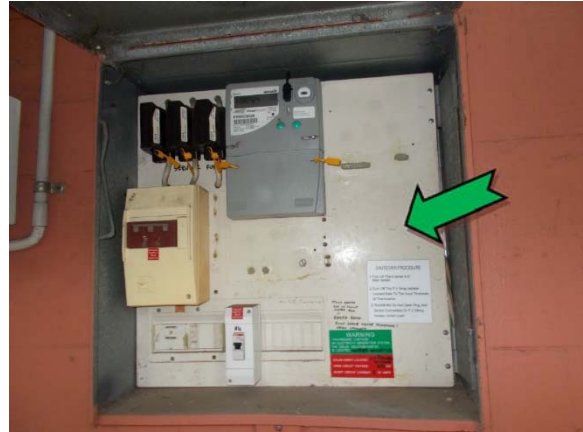
Photo 2. Exterior, south elevation, electrical board – suspected non asbestos-containing bituminous backing board.

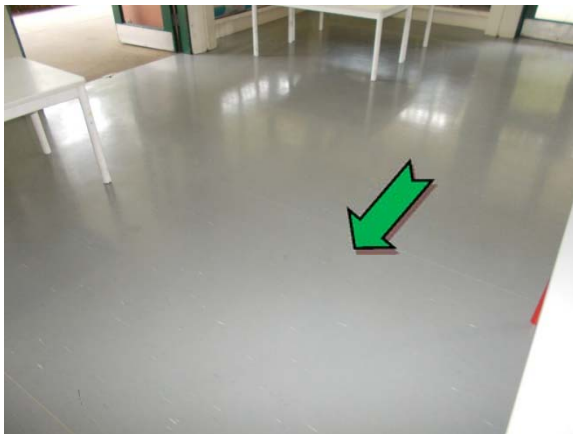
Photo 3. Interior, main room, floor coverings – suspected non asbestos-containing vinyl sheet.

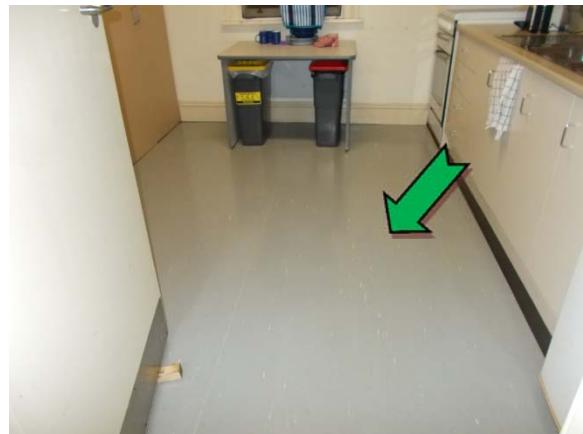
Photo 4. Interior, kitchen, floor coverings – suspected non asbestos-containing vinyl sheet.

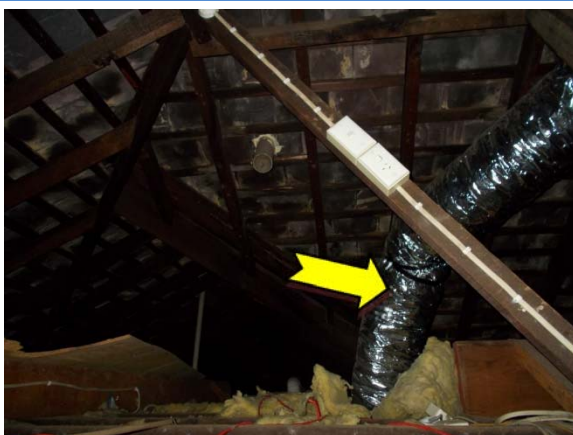
Area / Level	Room & Location	Feature	Item Description	Hazard Type	Sample No.	Sample Status	Friability	Disturb. Potential	Condition	Risk Status	Approx. Quantity	Recommendations & Comments	Control Priority	Reinspect Date	Photo No.
Exterior	Throughout	Awning	Fibre cement sheeting	Asbestos	57722-069-001	Negative	-	-	-	-	-	-	-	-	1
Exterior	South elevation	Electrical backing board	Bituminous material	Asbestos	Not sampled: age & appearance	Suspected Negative	-	-	-	-	-	Suspected negative due to age and appearance.	-	-	2
Interior	Main room	Floor coverings - blue	Sheet vinyl	Asbestos	Not sampled: age & appearance	Suspected Negative	-	-	-	-	-	Suspected negative due to age and appearance.	-	-	3
Interior	Kitchen	Floor coverings - blue	Sheet vinyl	Asbestos	Not sampled: age & appearance	Suspected Negative	-	-	-	-	-	Suspected negative due to age and appearance.	-	-	4
Interior	Ceiling space	Flexible ductwork	Insulation	SMF	-	Suspected Positive	Bonded	Low	Good	Low	50 m	Maintain in current condition if to remain in-situ. Remove under controlled SMF conditions as per the Code of Practice for the Safe Use of Synthetic Mineral Fibres [NOHSC: 2006 (1990)].	-	-	5

Photo 5. Interior, ceiling space, flexible ductwork – suspected SMF internal insulation material.

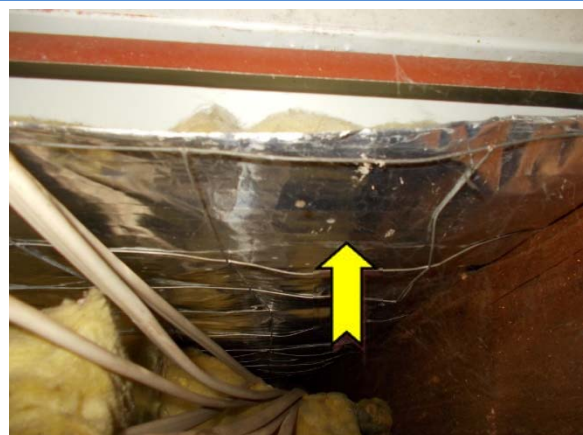
Photo 6. Interior, ceiling space, insulation – suspected SMF sarking insulation material.

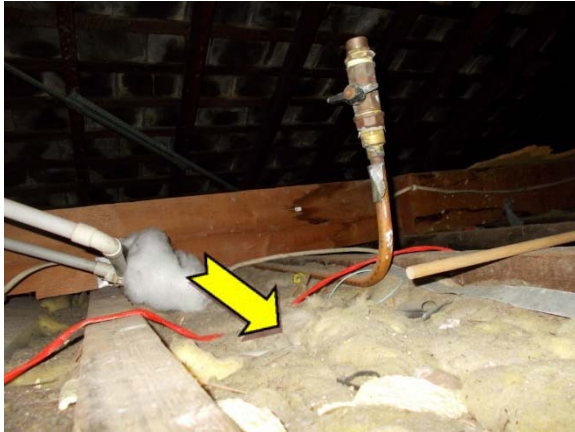
Photo 7. Interior, ceiling space, insulation – suspected SMF insulation batts.

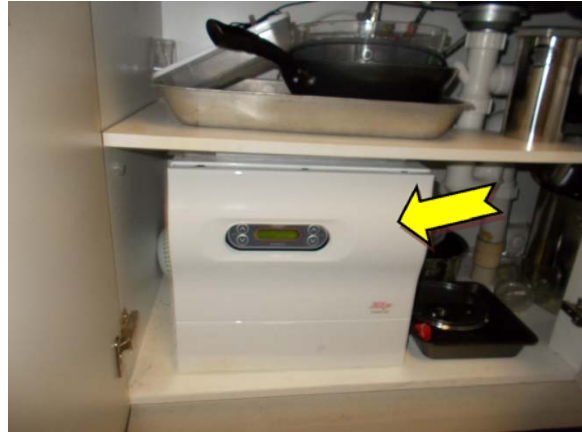
Photo 8. Interior, kitchen, hot water heater – suspected SMF internal insulation material.

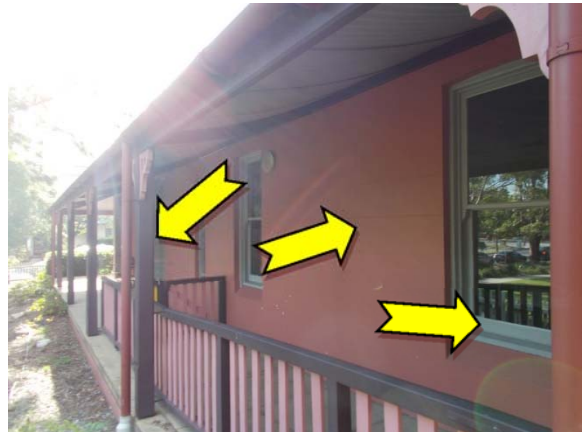
Exterior	Throughout	Walls	Pink - upper coloured paint system	Lead Paint - Swab	-	Suspected Positive	-	Low	Good	Low	200 m ²	Confirm status by quantitative test method, maintain in current condition, over paint with a lead-free paint as part of ongoing maintenance. Remove under controlled conditions in accordance with AS 4361.2:2017 Guide to hazardous paint management prior to renovation or demolition works.	-	-	10
Exterior	Throughout	Windows & door frames	Green (dark) - upper coloured paint system	Lead Paint - Swab	-	Suspected Positive	-	Low	Good	Low	15 m	Confirm status by quantitative test method, maintain in current condition, over paint with a lead-free paint as part of ongoing maintenance. Remove under controlled conditions in accordance with AS 4361.2:2017 Guide to hazardous paint management prior to renovation or demolition works.	-	-	10
Exterior	Throughout	Timber supports	Purple (dark) - upper coloured paint system	Lead Paint - Swab	-	Suspected Positive	-	Low	Good	Low	5 m ²	Confirm status by quantitative test method, maintain in current condition, over paint with a lead-free paint as part of ongoing maintenance. Remove under controlled conditions in accordance with AS 4361.2:2017 Guide to hazardous paint management prior to renovation or demolition works.	-	-	10

Photo 10. Exterior, throughout, walls and features – suspected pink, purple and green upper coloured paint systems.

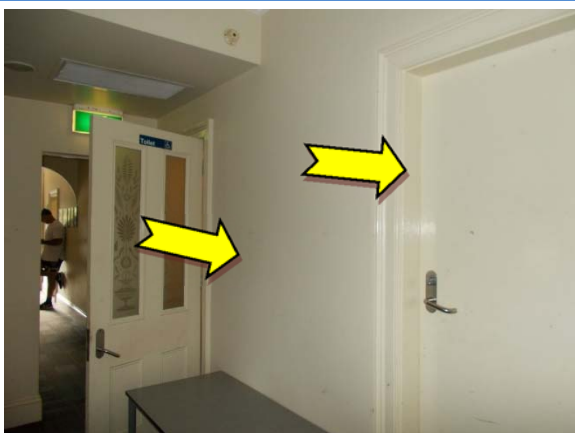
Interior	Throughout	Walls	Cream - upper coloured paint system	Lead Paint - Swab	-	Suspected Positive	-	Low	Good	Low	300 m ²	Confirm status by quantitative test method, maintain in current condition, over paint with a lead-free paint as part of ongoing maintenance. Remove under controlled conditions in accordance with AS 4361.2:2017 Guide to hazardous paint management prior to renovation or demolition works.	-	-	11

Photo 11. Interior, throughout, walls, doors and frames – suspected lead-containing cream upper paint systems.

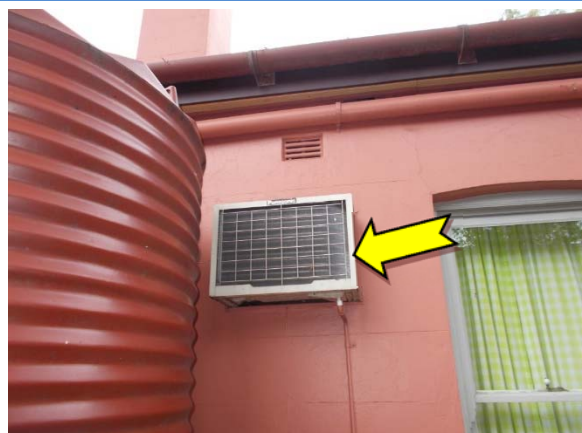
Area / Level	Room & Location	Feature	Item Description	Hazard Type	Sample No.	Sample Status	Friability	Disturb. Potential	Condition	Risk Status	Approx. Quantity	Recommendations & Comments	Control Priority	Reinspect Date	Photo No.
Interior	Throughout	Windows & door frames	Cream - upper coloured paint system	Lead Paint - Swab	-	Suspected Positive	-	Low	Good	Low	25 m	Confirm status by quantitative test method, maintain in current condition, over paint with a lead-free paint as part of ongoing maintenance. Remove under controlled conditions in accordance with AS 4361.2:2017 Guide to hazardous paint management prior to renovation or demolition works.	-	-	11
Exterior	South-west elevation	Air conditioning unit	Unknown refrigerant	Ozone Depleting Substances	-	Suspected Positive	-	Low	Good	Low	1 unit	No data was visible at the time of the assessment. Confirm status of suspected ozone depleting substances identified in the assessment.	-	-	12

Photo 12. Exterior, south-west elevation, air conditioning unit, unknown refrigerant – suspected ozone depleting substance.

- If the ozone depleting substances identified on-site unit require removal they should be appropriately decanted and disposed of by a licensed contractor in accordance with the *Ozone Protection and Synthetic Greenhouse Gas Management Amendment Regulation 2017* as amended from time to time.
- In accordance with the Commonwealth Ozone Protection Legislation, Prensa recommends, in line with Australia's commitment to phase out ODS-containing substances that units which are required to be replaced due to their age, damage or functionality, have their ODS-containing refrigerants replaced with a non-ODS alternative such as R410A.
- It is important to note that, if a system which utilises ODS-refrigerants is in good working order, there is no need to transition to an alternative refrigerant/system (until 2029).
