# Hazardous Building Materials Assessment Leichhardt Long Day Care Centre 19 Leichhardt Street, Leichhardt NSW 2040

Inner West Council  
April 2018

Job No.: 57722-101

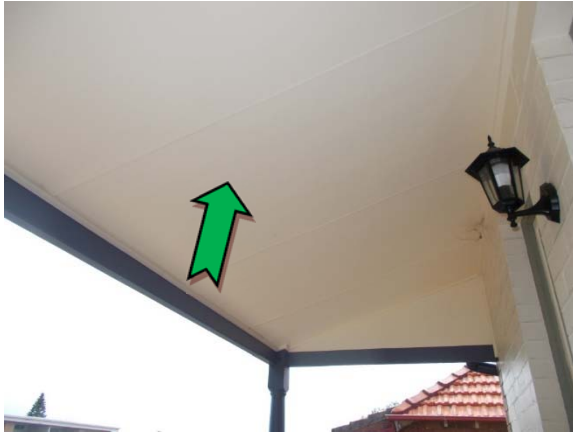
**Photo 1.** Exterior, level one, north elevation, awning – non asbestos-containing fibre cement sheeting.

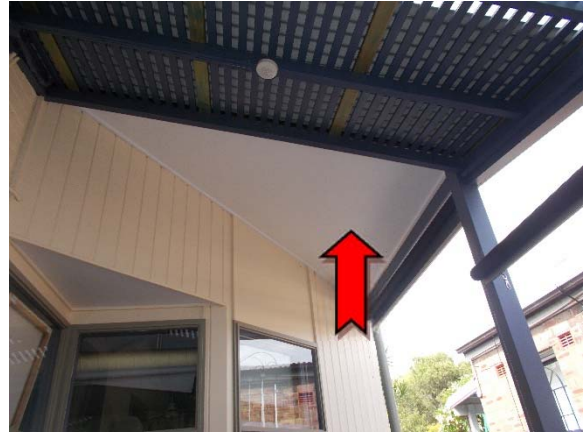
**Photo 2.** Exterior, ground level, south-west elevation, awning – suspected asbestos-containing fibre cement sheeting.

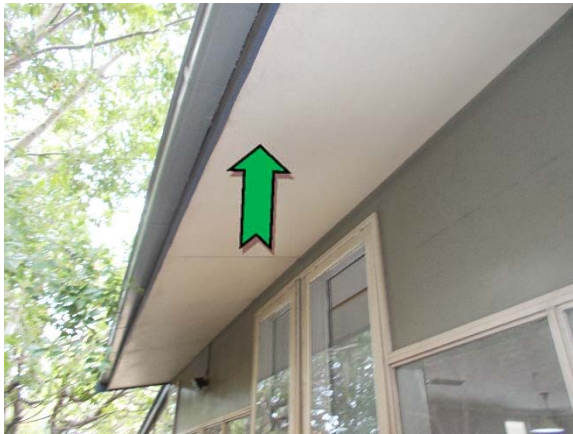
Area / Level	Room & Location	Feature	Item Description	Hazard Type	Sample No.	Sample Status	Friability	Disturb. Potential	Condition	Risk Status	Approx. Quantity	Recommendations & Comments	Control Priority	Reinspect Date	Photo No.
Exterior, level 1	North elevation	Awning	Fibre cement sheeting	Asbestos	57722-101-001	Negative	-	-	-	-	-	-	-	-	1
Exterior, ground level	South-west elevation	Awning	Fibre cement sheeting	Asbestos	Not sampled: Height restrictions	Suspected Positive	Non-friable	Low	Good	Low	2m <sup>2</sup>	Confirm status, label as containing asbestos and maintain in current condition if to remain in-situ. Remove under controlled non-friable asbestos removal conditions prior to refurbishment or demolition works by a Class B (non-friable) licensed asbestos removal contractor.	P4	Feb-23	2
Exterior, ground level	South-east elevation	Eaves	Fibre cement sheeting	Asbestos	57722-101-007	Negative	-	-	-	-	-	-	-	-	3

**Photo 3.** Exterior, ground level, south-east elevation, eaves – non asbestos-containing fibre cement sheeting.

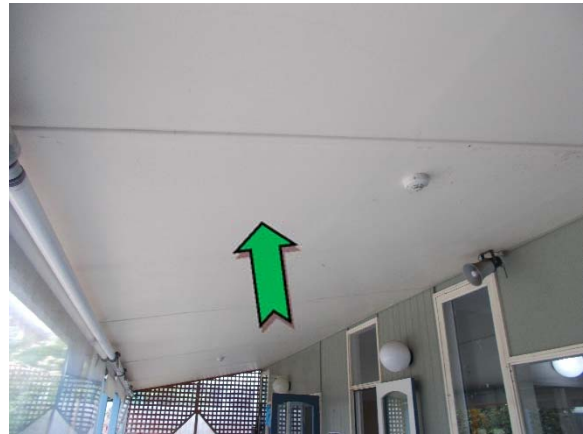
Exterior, ground level	South elevation	Awning	Fibre cement sheeting	Asbestos	57722-101-008	Negative	-	-	-	-	-	-	-	-	4
Interior, ground level	East elevation	Under staircase	Fibre cement sheeting	Asbestos	57722-101-002	Positive	Non-friable	Low	Fair	Low	2m <sup>2</sup>	Label as containing asbestos and maintain in current condition if to remain in-situ. Remove under controlled non-friable asbestos removal conditions prior to refurbishment or demolition works by a Class B (non-friable) licensed asbestos removal contractor.	P4	Feb-23	5
Interior, ground level	East elevation, adjacent small preschool room	Floor coverings - blue	Sheet vinyl	Asbestos	57722-101-003A	Negative	-	-	-	-	-	-	-	-	6
Interior, ground level	East elevation, adjacent small preschool room	Floor coverings - blue	Adhesive	Asbestos	57722-101-003B	Negative	-	-	-	-	-	-	-	-	-
Interior, ground level	East elevation, toilet	Floor coverings - blue (light)	Sheet vinyl	Asbestos	57722-101-004	Negative	-	-	-	-	-	-	-	-	7

**Photo 4.** Exterior, ground level, south elevation, awning – non asbestos-containing fibre cement sheeting.

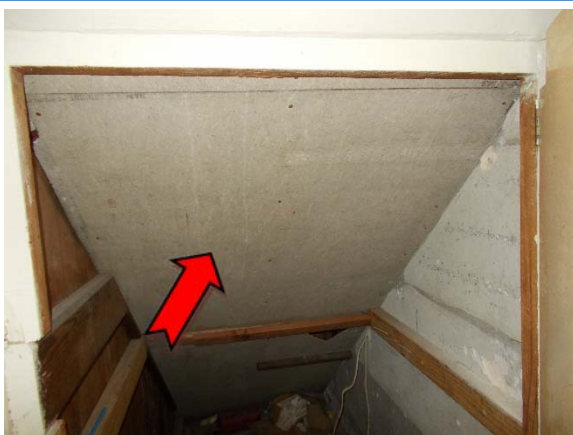
**Photo 5.** Interior, ground level, east elevation, under staircase – asbestos-containing fibre cement sheeting.

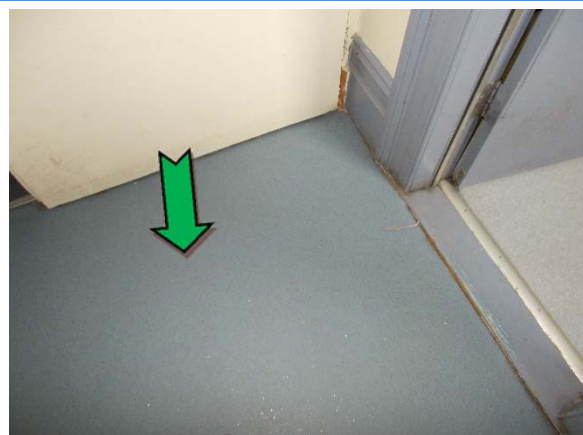
**Photo 6.** Interior, ground level, east elevation, adjacent small preschool room, blue floor coverings – non asbestos-containing sheet vinyl.

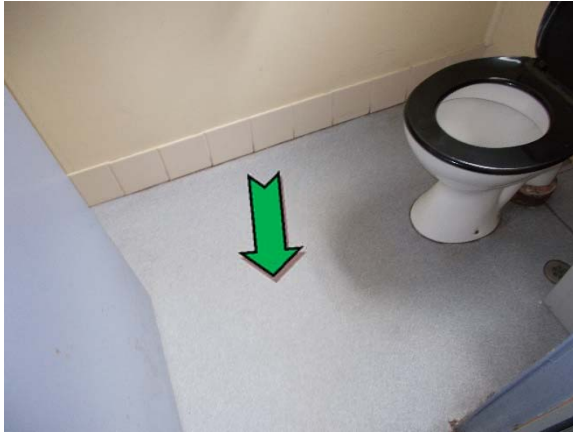
**Photo 7.** Interior, ground level, east elevation, toilet, light blue floor coverings – non asbestos-containing sheet vinyl.

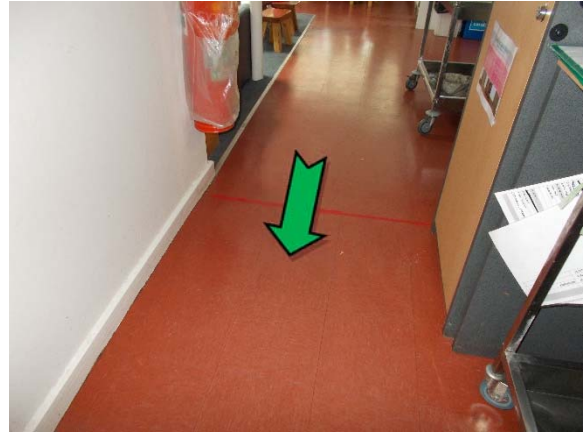
**Photo 8.** Interior, ground level, large preschool room, red floor coverings – non asbestos-containing vinyl floor tiles.

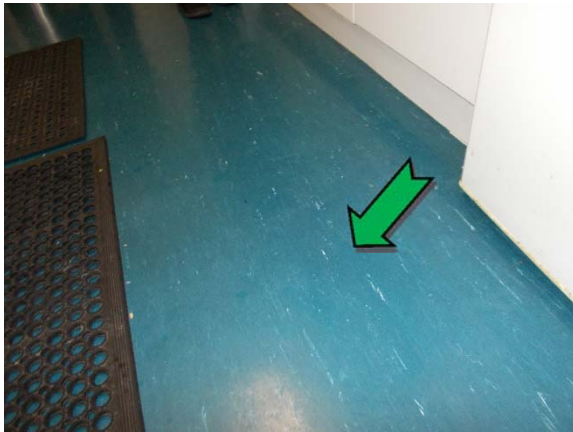
**Photo 9.** Interior, kitchen, blue floor coverings – non asbestos-containing sheet vinyl.

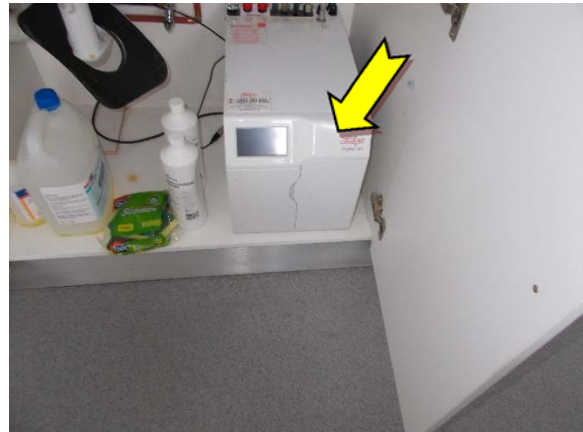
**Photo 10.** Interior, level one, kitchen, hot water boiler – suspected SMF internal insulation material.

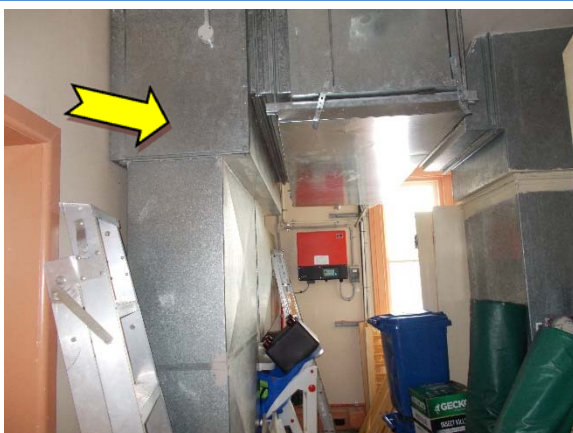
**Photo 11.** Interior, level one, throughout, ductwork – suspected SMF internal insulation material.

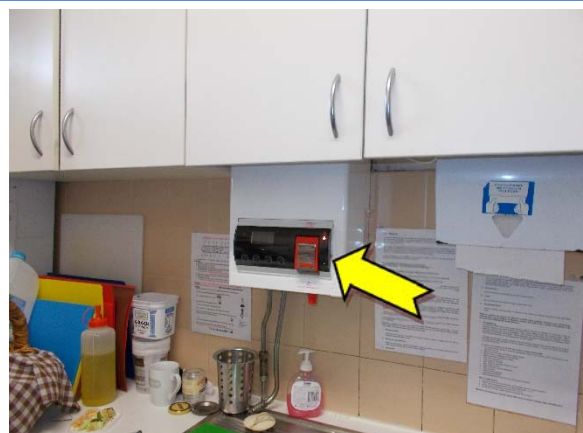
**Photo 12.** Interior, ground level, kitchen, hot water boiler – suspected SMF internal insulation material.

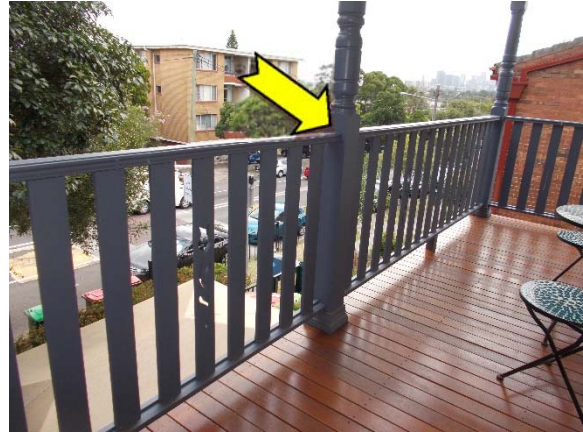
**Photo 14.** Exterior, level one, verandah, hand rails – suspected lead-containing blue upper coloured paint system.

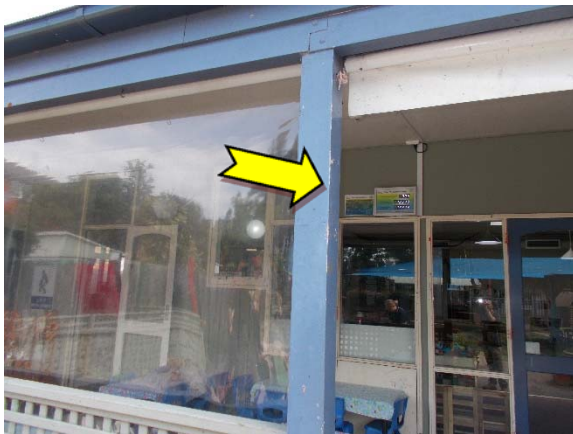
Exterior, ground level	Throughout	Frames & supports	Blue - upper coloured paint system	Lead Paint - Swab	-	Suspected Positive	-	Low	Fair	Low	8m	Confirm status by quantitative test method, maintain in current condition, over paint with a lead-free paint as part of ongoing maintenance. Remove under controlled conditions in accordance with AS 4361.2:2017 Guide to hazardous paint management prior to renovation or demolition works.	-	-	15
Exterior, ground level	Throughout	Frames & supports	Cream - lower coloured paint system	Lead Paint - Swab	-	Positive	-	Low	Fair	Low	8m	Remove flaking sections and over paint with a lead-free paint. Remove under controlled conditions in accordance with AS 4361.2:2017 Guide to hazardous paint management prior to renovation or demolition works.	-	-	15
Interior, level 1	Throughout	Skirting, windows & door frames	Orange (light) - upper coloured paint system	Lead Paint - Swab	-	Positive	-	Low	Fair	Medium	10m <sup>2</sup>	Remove flaking sections and over paint with a lead-free paint. Remove under controlled conditions in accordance with AS 4361.2:2017 Guide to hazardous paint management prior to renovation or demolition works.	-	-	16

**Photo 15.** Exterior, ground level, throughout, frames and support – lead-containing cream lower paint system and suspected lead-containing blue upper paint system.

- Remove flaking lead containing paint to timber frames and supports on the ground level and the timber skirting boards, windows, and door frames on level 1 in accordance with AS4361.2-2017 Guide to Hazardous Paint Management and relevant legislation.

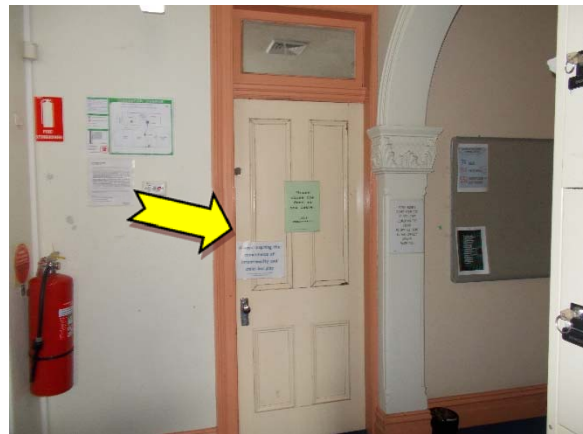
**Photo 16.** Interior, level one, throughout, skirting, window and door frames – lead-containing light orange upper paint systems.

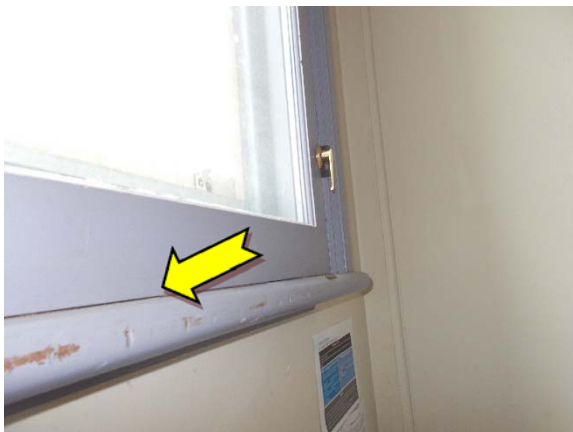
**Photo 17.** Interior, staircase, skirting and window frames – suspected lead-containing light purple upper paint systems.

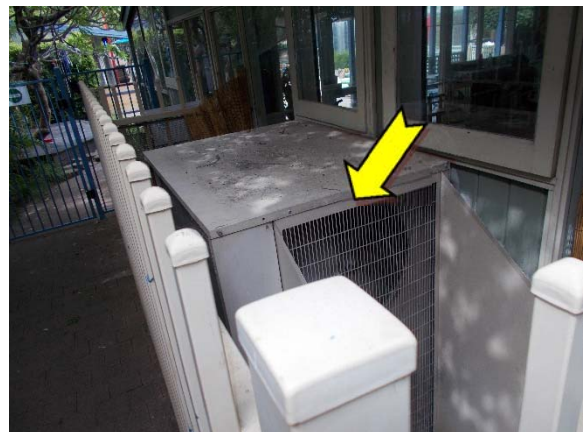
Area / Level	Room & Location	Feature	Item Description	Hazard Type	Sample No.	Sample Status	Friability	Disturb. Potential	Condition	Risk Status	Approx. Quantity	Recommendations & Comments	Control Priority	Reinspect Date	Photo No.
Interior, level 1	Staircase	Skirting & windows frames	Purple (light) - upper coloured paint system	Lead Paint - Swab	-	Suspected Positive	-	Low	Good	Low	5m	Confirm status by quantitative test method, maintain in current condition, over paint with a lead-free paint as part of ongoing maintenance. Remove under controlled conditions in accordance with AS 4361.2:2017 Guide to hazardous paint management prior to renovation or demolition works.	-	-	17
Exterior, ground level	East elevation	Air conditioning unit	R22 Hydrochlorofluorocarbon (HCFC)	Ozone Depleting Substances	-	Positive	-	-	-	-	1 unit	Hydrochlorofluorocarbon (HCFC), ozone depleting substances identified in the assessment that require removal during refurbishment or demolition works should be appropriately decanted and disposed of by a licensed contractor in accordance with the Ozone Protection and Synthetic Greenhouse Gas Management Amendment Regulation 2012.	-	-	18

**Photo 18.** Exterior, ground level, east elevation, air conditioning unit – ODS-containing R22 refrigerant gas.

- An ODS-containing air conditioning unit was identified to the exterior at ground level.

- If the ozone depleting substances identified on-site unit require removal they should be appropriately decanted and disposed of by a licensed contractor in accordance with the *Ozone Protection and Synthetic Greenhouse Gas Management Amendment Regulation 2017* as amended from time to time.
- In accordance with the Commonwealth Ozone Protection Legislation, Prensa recommends, in line with Australia's commitment to phase out ODS-containing substances that units which are required to be replaced due to their age, damage or functionality, have their ODS-containing refrigerants replaced with a non-ODS alternative such as R410A.
- It is important to note that, if a system which utilises ODS-refrigerants is in good working order, there is no need to transition to an alternative refrigerant/system (until 2029).
