Hazardous Building Materials Assessment Leichhardt Long Day Care Centre - Shed 19 Leichhardt Street, Leichhardt NSW 2040

Inner West Council
April 2018

Job No.: 57722-102

Count ID: CID: 204

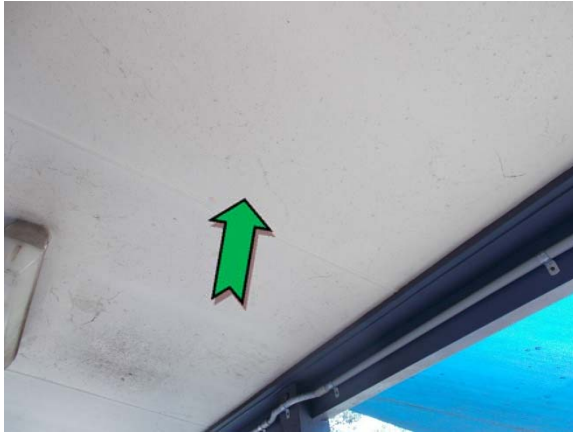
Photo 1. Exterior, west elevation, awning – suspected non asbestos-containing fibre cement sheeting.

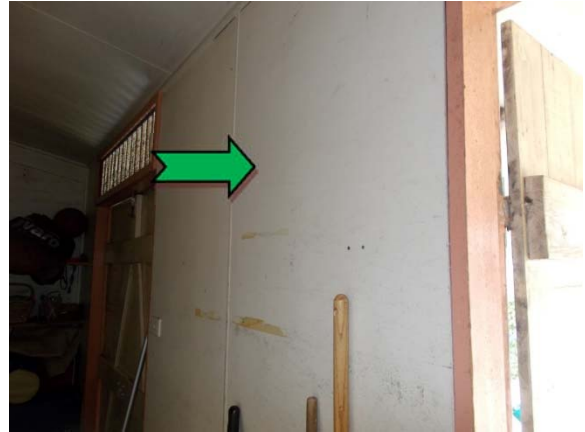
Photo 2. Interior, west elevation, wall – non asbestos-containing fibre cement sheeting.

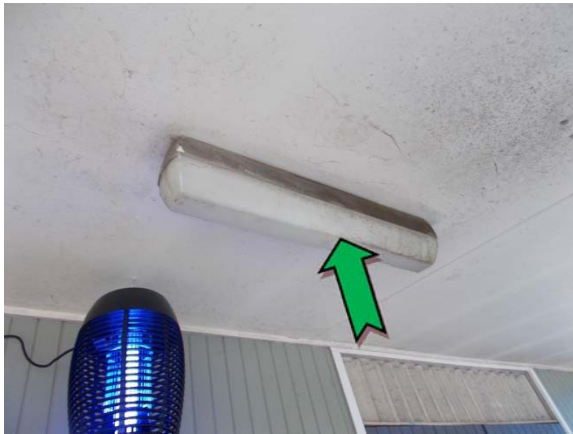
Area / Level	Room & Location	Feature	Item Description	Hazard Type	Sample No.	Sample Status	Friability	Disturb. Potential	Condition	Risk Status	Approx. Quantity	Recommendations & Comments	Control Priority	Reinspect Date	Photo No.
Exterior	West elevation	Awning	Fibre cement sheeting	Asbestos	Not sampled: Age & appearance	Suspected Negative	-	-	-	-	5 m ²	Suspected negative due to age and appearance.	-	-	1
Interior	West elevation, throughout	Wall	Fibre cement sheeting	Asbestos	57722-102-001	Negative	-	-	-	-	-	-	-	-	2
Interior	Throughout	Ceiling	Fibre cement sheeting	Asbestos	Not sampled: Age & appearance	Suspected Negative	-	-	-	-	6 m ²	Suspected negative due to age and appearance.	-	-	-
Throughout	-	-	-	SMF	-	-	-	-	-	-	-	No suspect SMF material identified at the time of the assessment.	-	-	-
Exterior	Throughout	Fluorescent light fitting - single tube	Capacitor	PCBs	Not sampled: Electrical hazard	Suspected Negative	-	-	-	-	-	PCB-containing capacitors are unlikely to be present due to age and appearance of light fittings. Confirm PCB status prior to refurbishment or demolition works.	-	-	3

Photo 3. Exterior, throughout, single tubed fluorescent light fitting – suspected non PCB-containing capacitors.

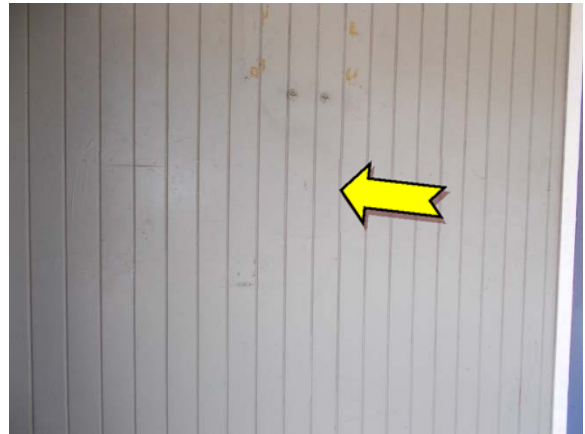
Exterior	Throughout	Walls	Green - upper coloured paint system	Lead Paint - Swab	-	Suspected Positive	-	Low	Good	Low	12 m ²	Confirm status by quantitative test method, maintain in current condition, over paint with a lead-free paint as part of ongoing maintenance. Remove under controlled conditions in accordance with AS 4361.2:2017 Guide to hazardous paint management prior to renovation or demolition works.	-	-	4
Exterior	Throughout	Door	Blue - upper coloured paint system	Lead Paint - Swab	-	Suspected Positive	-	Low	Good	Low	4 units	Confirm status by quantitative test method, maintain in current condition, over paint with a lead-free paint as part of ongoing maintenance. Remove under controlled conditions in accordance with AS 4361.2:2017 Guide to hazardous paint management prior to renovation or demolition works.	-	-	5
Exterior	Throughout	Door frame	White - upper coloured paint system	Lead Paint - Swab	-	Suspected Positive	-	Low	Good	Low	8 m	Confirm status by quantitative test method, maintain in current condition, over paint with a lead-free paint as part of ongoing maintenance. Remove under controlled conditions in accordance with AS 4361.2:2017 Guide to hazardous paint management prior to renovation or demolition works.	-	-	5

Photo 4. Exterior, throughout, walls – suspected lead-containing green upper paint systems.

- LCP was suspected in the form of green, blue and white upper coloured paint systems throughout the building during the Assessment.

- The *LeadCheck* paint swab method can detect lead in paint at concentrations of 0.5% and above, and may indicate lead in some paint films as low as 0.2%. As paint with a lead content greater than 0.1% by dry weight is now considered to be lead-containing, Prensa recommends confirming status of suspected LCP identified during the Assessment by quantitative test method.

- The safest method of dealing with LCP is to replace or remove the items in their entirety that have LCP on them and replace them with new items that do not contain lead. This allows the items to be disposed of as regular building or demolition unsegregated waste in accordance with the NSW Environment Protection Authority (EPA) *Waste Classification Guidelines 2014 Part 1 – Classifying Waste*. The advantage of this method is the reduction in labour requirements to remove the lead paint and also this reduces the risk to workers from exposure to lead dust or fumes. If the removal of the LCP or coatings is the preferred or required option this may generate significant amounts of potential hazardous waste. This waste must be removed, collected and disposed of by an appropriately licensed contractor under controlled conditions that minimises the release to air, water and soil. Disposal of lead waste must be disposed of as hazardous waste at an approved waste facility.

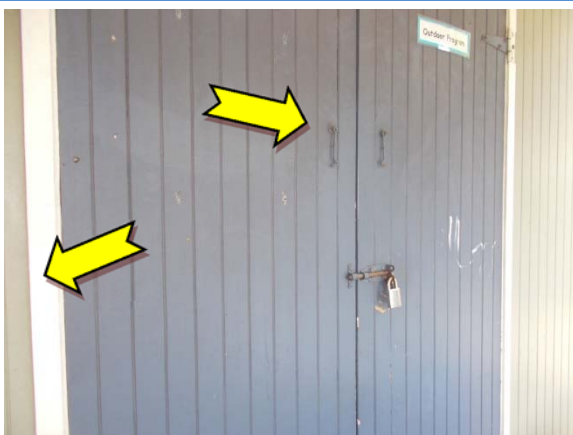
Photo 5. Exterior, throughout, doors – suspected lead-containing white and blue upper coloured paint systems.
