Hazardous Building Materials Assessment Leichhardt Service Centre - Demountable 3-7 Marion Street, Leichhardt NSW 2040

Inner West Council
April 2018

Job No.: 57722-091

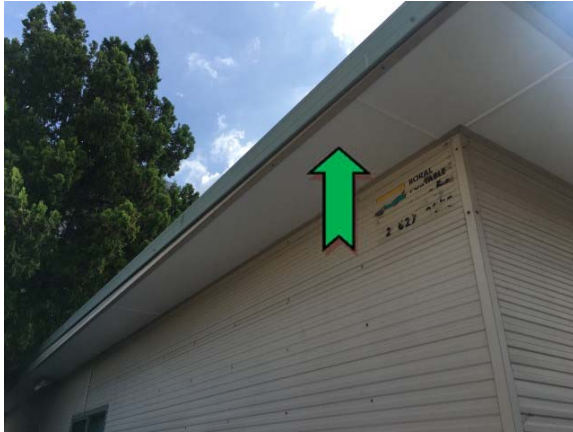
Photo 1. Exterior, throughout, eaves – non asbestos-containing fibre cement sheeting and suspected lead-containing white upper paint systems.

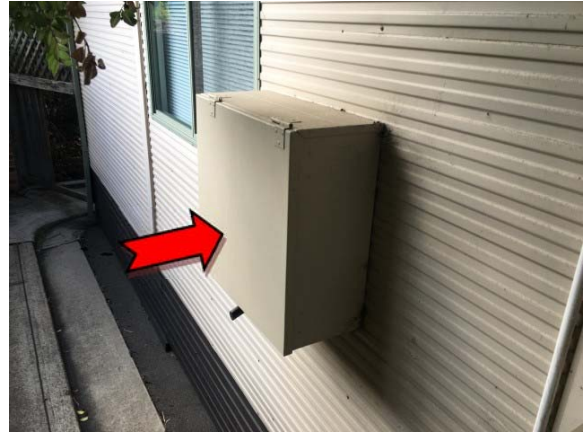
Photo 2. Exterior, north elevation – suspected asbestos-containing bituminous backing board.

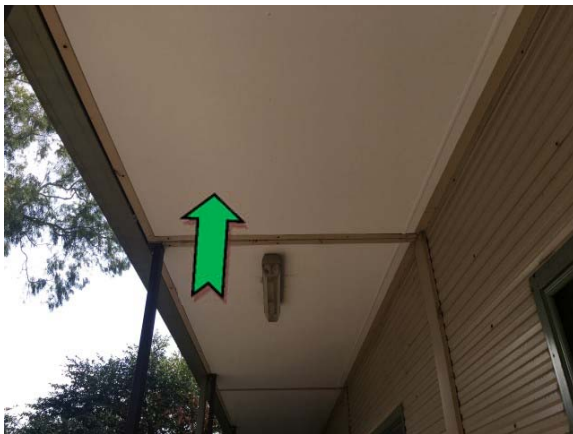
Photo 3. Exterior, north elevation, awning – assumed non asbestos-containing fibre cement sheeting and suspected lead-containing white upper paint systems.

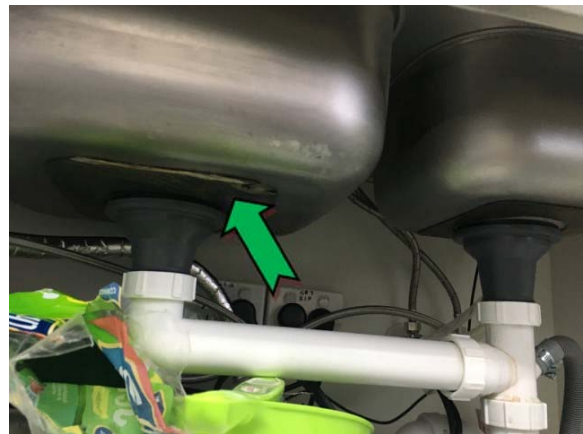
Photo 4. Interior, kitchen, sink pad – non asbestos-containing bituminous material.

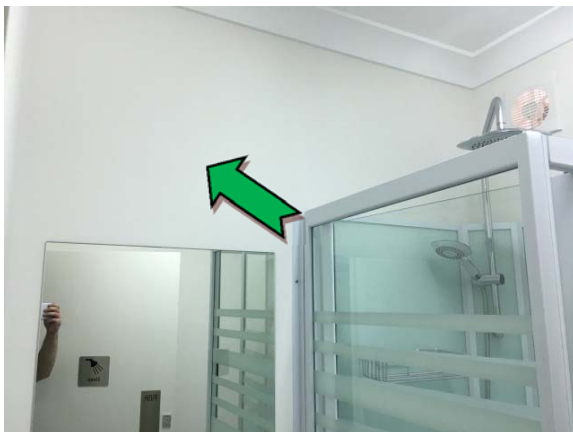
Photo 5. Interior, shower room, north elevation, wall – non asbestos-containing fibre cement sheeting.

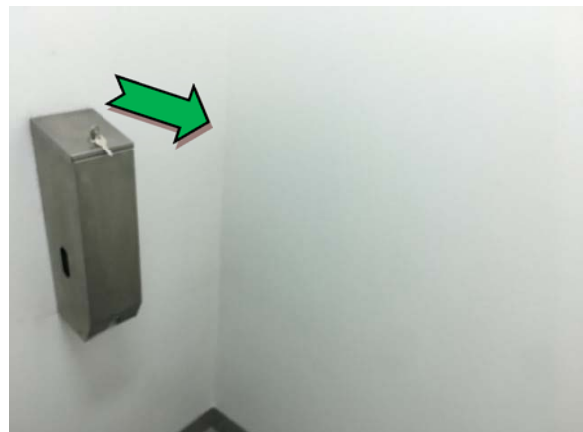
Photo 6. Interior, female toilets, south elevation, wall – assumed non asbestos-containing fibre cement sheeting.

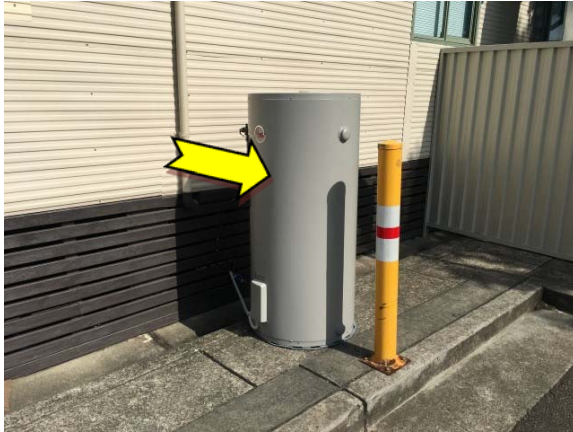
Photo 7. Exterior, north-east elevation, hot water heater – suspected SMF internal insulation material.

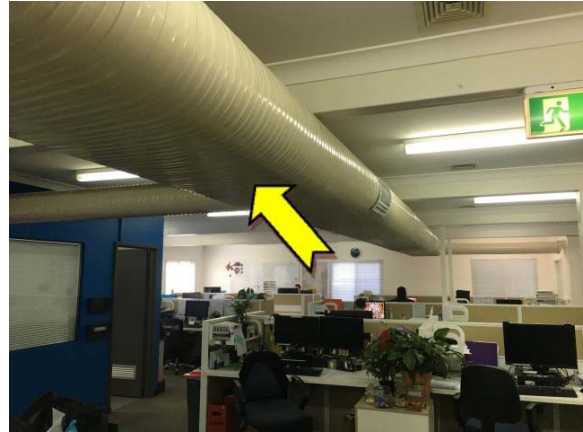
Photo 8. Interior, throughout, ductwork – suspected SMF internal insulation material.

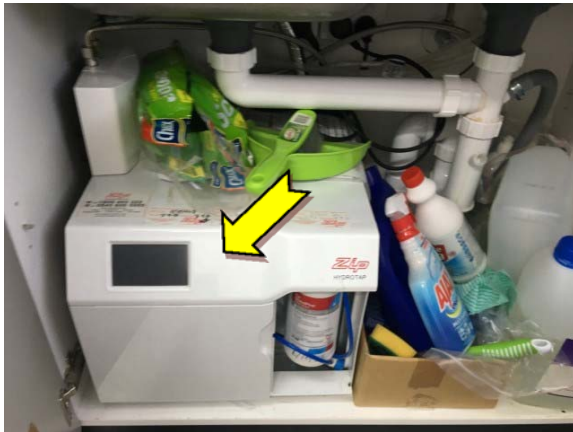
Photo 9. Interior, kitchen, under sink hot water heater – suspected SMF internal insulation material.

Interior	Kitchen, under sink	Hot Water Heater	Insulation material - internal	SMF	-	Suspected Positive	Bonded	Low	Good	Low	1 unit	Maintain in current condition if to remain in-situ. Remove under controlled SMF conditions as per the Code of Practice for the Safe Use of Synthetic Mineral Fibres [NOHSC: 2006 (1990)].	-	-	-	9
Interior	Subfloor, throughout	Air conditioning ductwork	Insulation material - internal	SMF	-	Suspected Positive	Bonded	Low	Good	Low	10m ²	Maintain in current condition if to remain in-situ. Remove under controlled SMF conditions as per the Code of Practice for the Safe Use of Synthetic Mineral Fibres [NOHSC: 2006 (1990)].	-	-	-	10
Exterior	Throughout	Fluorescent light fitting - single tube	Capacitor	PCBs	Not Sampled: Electrical hazard	Suspected Positive	-	Low	Good	Low	7 units	PCB-containing capacitors are suspected due to age & appearance of electrical fittings. Remove and dispose of in accordance with the Polychlorinated Biphenyls Management Plan, Revised Edition April 2003.	-	-	-	11

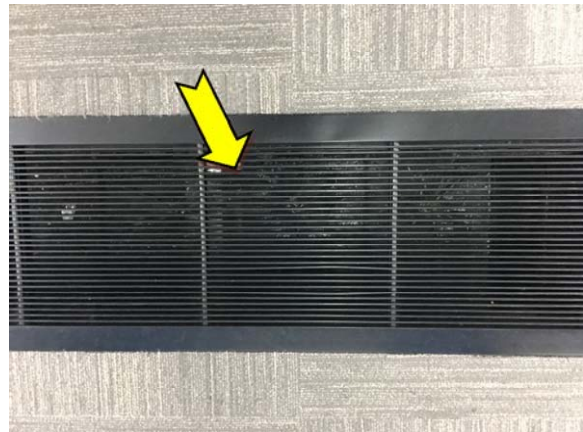
Photo 10. Interior, throughout, subfloor, air conditioning duct work – suspected SMF internal insulation material.

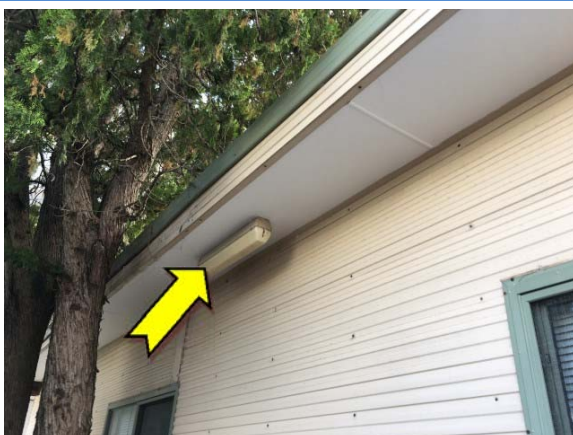
Photo 11. Exterior, throughout, single tubed fluorescent light fitting – suspected PCB-containing capacitor.

- Electrical fittings that contain or suspected to contain PCB oil-containing capacitors should be removed as hazardous/regulated waste under controlled working conditions prior to the demolition or refurbishment works in accordance with the *Polychlorinated Biphenyls Management Plan, Revised Edition April 2003*.

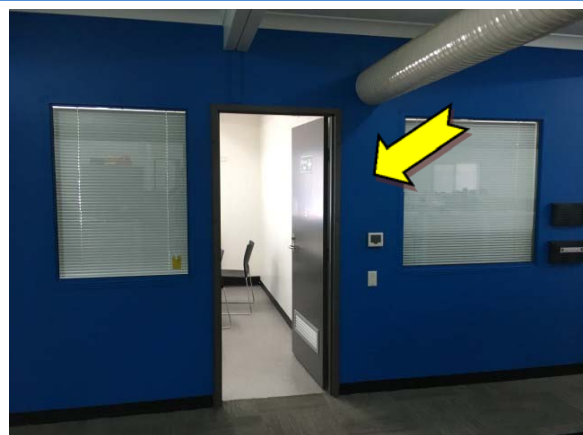
Photo 12. Interior, throughout, southern wall – suspected lead-containing dark blue upper paint systems.

Interior	South	Wall	Blue (dark) - upper coloured paint system	Lead Paint - Swab	-	Suspected Positive	-	Low	Good	Low	12m ²	Confirm status by quantitative test method, maintain in current condition, over paint with a lead-free paint as part of ongoing maintenance. Remove under controlled conditions in accordance with AS 4361.2:2017 Guide to hazardous paint management prior to renovation or demolition works.	-	-	12
Interior	North-east elevation	Wall	Blue (light) - upper coloured paint system	Lead Paint - Swab	-	Suspected Positive	-	Low	Good	Low	12m ²	Confirm status by quantitative test method, maintain in current condition, over paint with a lead-free paint as part of ongoing maintenance. Remove under controlled conditions in accordance with AS 4361.2:2017 Guide to hazardous paint management prior to renovation or demolition works.	-	-	-
Throughout	-	-	-	Ozone Depleting Substances	-	-	-	-	-	-	-	No suspect ODS's identified at the time of the assessment.	-	-	-
