Hazardous Building Materials Assessment

Lambert Park - Kiosk

Marion Street,
Leichhardt NSW 2040

Inner West Council
April 2018

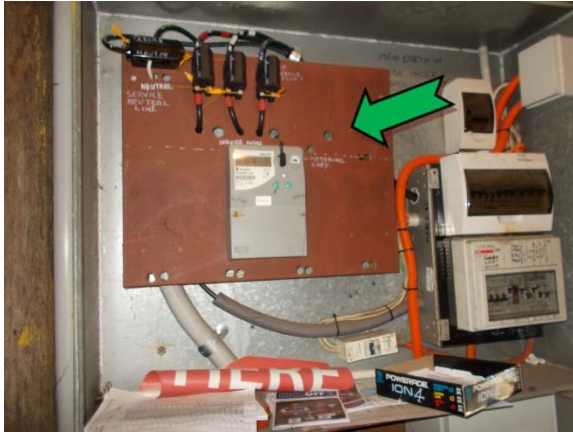
| Area / Level | Room & Location | Feature | Item Description | Hazard Type | Sample No. | Sample Status | Friability | Disturb. Potential | Condition | Risk Status | Approx. Quantity | Recommendations & Comments | Control Priority | Reinspect Date | Photo No. |
|---|---|---|--|---|---|---|---|---|---|---|---|--|---|---|---|
| Interior, ground level | Switch room | Electrical backing board | Bituminous backing board | Asbestos | Not sampled: electrical hazard | Suspected Negative | - | - | - | - | - | Suspected negative due to age and appearance. | - | - | 1 |

Photo 1. Interior, switch room, electrical board – suspected non-asbestos containing bituminous backing board.

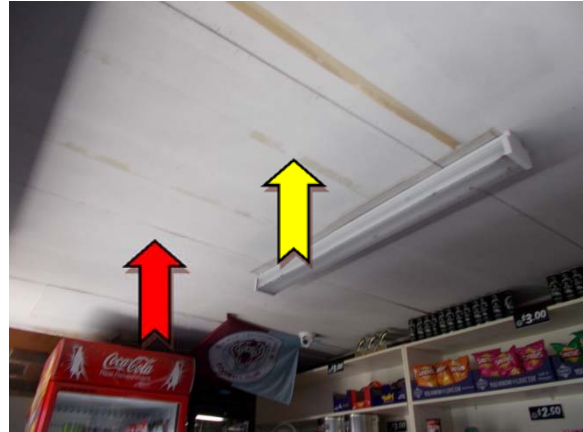
| Area / Level | Room & Location | Feature | Item Description | Hazard Type | Sample No. | Sample Status | Friability | Disturb. Potential | Condition | Risk Status | Approx. Quantity | Recommendations & Comments | Control Priority | Reinspect Date | Photo No. |
|---|---|---|--|---|---|---|---|---|---|---|---|--|---|---|---|
| Interior, ground level | Ceiling, throughout | Ceiling | Fibre cement sheeting | Asbestos | 57722-062-002 | Positive | Non-friable | Low | Good | Low | 6 m ² | Label as containing asbestos and maintain in current condition if to remain in-situ. Remove under controlled non-friable asbestos removal conditions prior to refurbishment or demolition works by a Class B (non-friable) licensed asbestos removal contractor. | P4 | Feb-23 | 2 |
| Interior, ground level | Throughout | Ceiling | White - upper coloured paint system | Lead Paint - Swab | - | Suspected Positive | - | Low | Good | Low | 60 m ² | Confirm status by quantitative test method, maintain in current condition, over paint with a lead-free paint as part of ongoing maintenance. Remove under controlled conditions in accordance with AS 4361.2:2017 Guide to hazardous paint management prior to renovation or demolition works. | - | - | 2 |

Photo 2. Interior, throughout, ceiling – asbestos-containing fibre cement sheeting and suspected lead-containing white upper paint system.

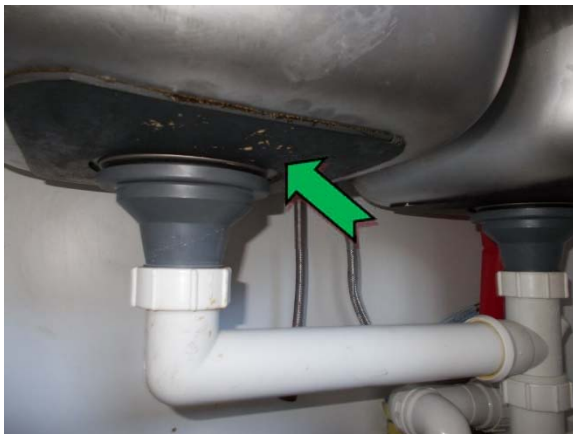
Photo 3. Interior, beneath sink, sink pad – non asbestos-containing bituminous material.

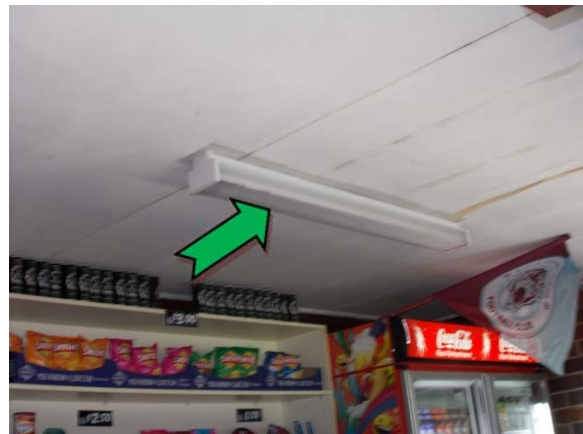
| Area / Level | Room & Location | Feature | Item Description | Hazard Type | Sample No. | Sample Status | Friability | Disturb. Potential | Condition | Risk Status | Approx. Quantity | Recommendations & Comments | Control Priority | Reinspect Date | Photo No. |
|---|---|---|--|---|---|---|---|---|---|---|---|--|---|---|---|
| Interior, ground level | Throughout | Fluorescent light fitting - double tube | Capacitor | PCBs | Not sampled: Electrical hazard | Suspected Negative | - | - | - | - | - | PCB-containing capacitors are unlikely to be present due to age and appearance of light fittings. Confirm PCB status prior to refurbishment or demolition works. | - | - | 4 |

Photo 4. Interior, throughout, double tubed fluorescent light fitting – suspected non PCB-containing capacitor.

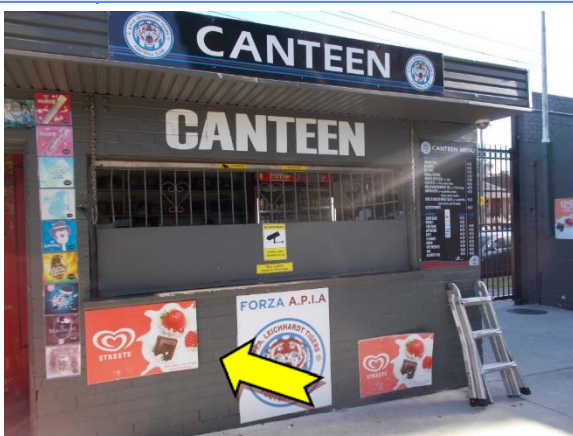
| Area / Level | Room & Location | Feature | Item Description | Hazard Type | Sample No. | Sample Status | Friability | Disturb. Potential | Condition | Risk Status | Approx. Quantity | Recommendations & Comments | Control Priority | Reinspect Date | Photo No. |
|---|---|---|--|---|---|---|---|---|---|---|---|--|---|---|---|
| Exterior, ground level | Throughout | Walls | Brown - upper coloured paint system | Lead Paint - Swab | - | Suspected Positive | - | Low | Good | Low | 80 m ² | Confirm status by quantitative test method, maintain in current condition, over paint with a lead-free paint as part of ongoing maintenance. Remove under controlled conditions in accordance with AS 4361.2:2017 Guide to hazardous paint management prior to renovation or demolition works. | - | - | 5 |

Photo 5. Exterior, throughout, walls – suspected lead-containing brown upper paint system.

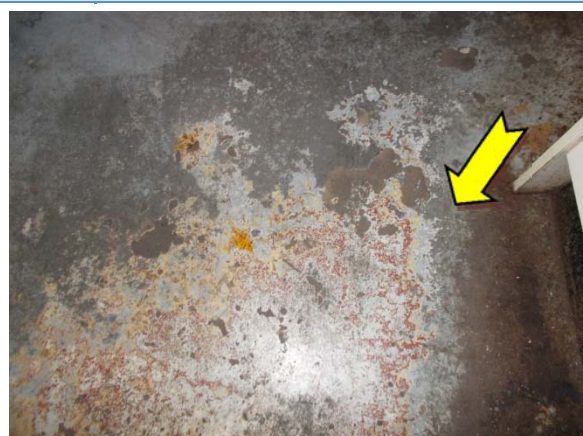
| Area / Level | Room & Location | Feature | Item Description | Hazard Type | Sample No. | Sample Status | Friability | Disturb. Potential | Condition | Risk Status | Approx. Quantity | Recommendations & Comments | Control Priority | Reinspect Date | Photo No. |
|---|---|---|--|---|---|---|---|---|---|---|---|--|---|---|---|
| Interior, ground level | Floor, throughout | Floor | Blue (light) - upper coloured paint system | Lead Paint - Swab | - | Suspected Positive | - | Low | Poor | Medium | 6 m ² | Confirm status by quantitative test method, maintain in current condition, over paint with a lead-free paint as part of ongoing maintenance. Remove under controlled conditions in accordance with AS 4361.2:2017 Guide to hazardous paint management prior to renovation or demolition works. | - | - | 6 |
| Interior, ground level | Floor, throughout | Floor | Cream - lower coloured paint system | Lead Paint - Swab | - | Suspected Positive | - | Low | Poor | Medium | 6 m ² | Confirm status by quantitative test method, maintain in current condition, over paint with a lead-free paint as part of ongoing maintenance. Remove under controlled conditions in accordance with AS 4361.2:2017 Guide to hazardous paint management prior to renovation or demolition works. | - | - | 6 |
| Interior, ground level | Floor, throughout | Floor | Red - lower coloured paint system | Lead Paint - Swab | - | Suspected Positive | - | Low | Poor | Medium | 6 m ² | Confirm status by quantitative test method, maintain in current condition, over paint with a lead-free paint as part of ongoing maintenance. Remove under controlled conditions in accordance with AS 4361.2:2017 Guide to hazardous paint management prior to renovation or demolition works. | - | - | 6 |

Photo 6. Interior, throughout, floor – suspected lead-containing cream and red lower coloured paint systems, and light blue upper paint system.

- Remove flaking lead containing paint to the floor throughout the property and stabilise by over painting in accordance with AS4361.2-2017 Guide to Hazardous Paint Management and relevant legislation.
