Hazardous Building Materials Assessment Lambert Park – Pavilion/Amenities Block Marion Street, Leichhardt NSW 2040

Inner West Council
April 2018

Job No.: 57722-063

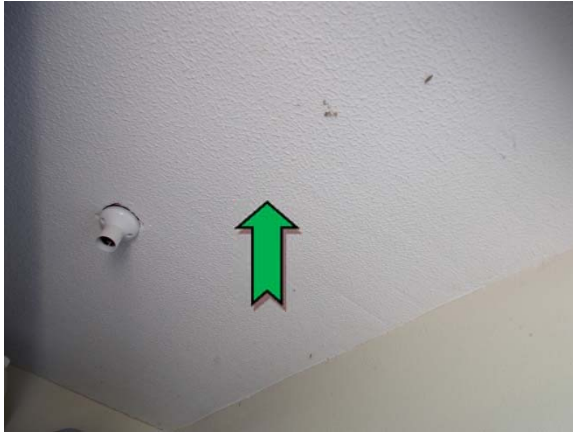
Photo 1. Exterior, ground level, ceiling – non asbestos-containing textured coating.

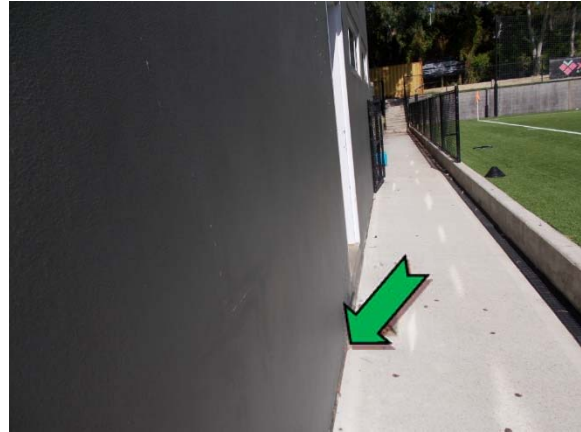
Photo 2. Exterior, ground level, ground, expansion joint – non asbestos-containing construction joint mastic.

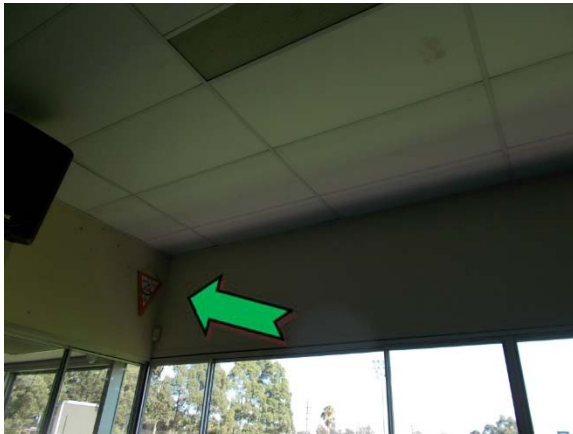
Photo 3. Interior, level one, north-west elevation, walls – non asbestos-containing compressed board.

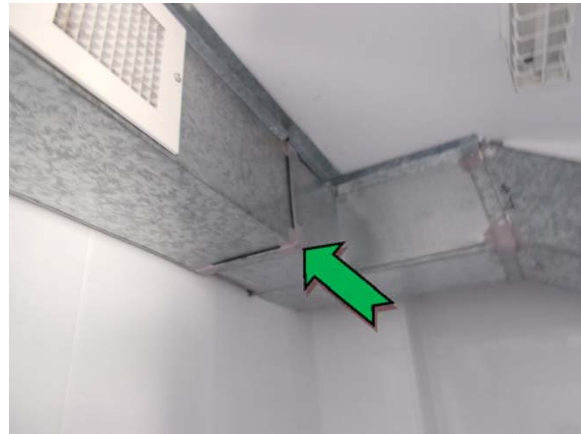
Photo 4. Interior, ground level, ceiling, duct work – non asbestos-containing mastic sealant.

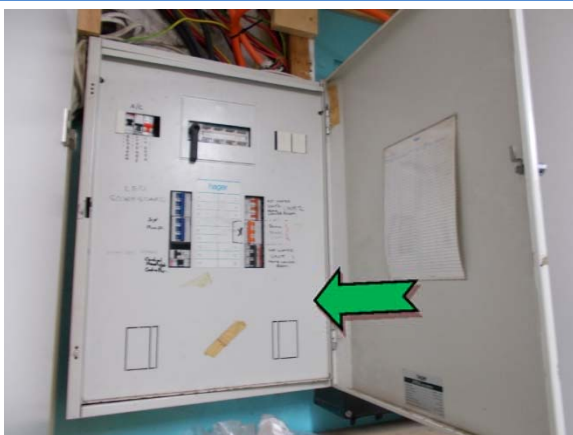
Photo 5. Interior, ground level, away shed, electrical board – suspected non-asbestos containing backing board.

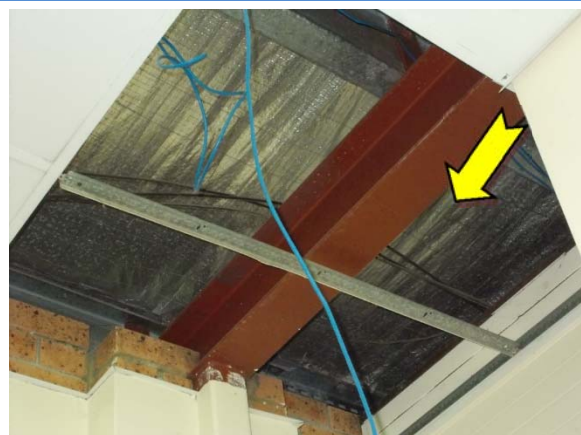
Photo 6. Interior, level one, throughout, roof space, insulation – suspected SMF sarking insulation material.

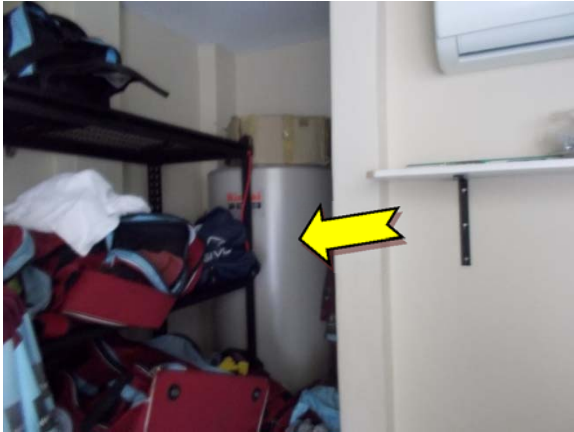
Photo 7. Interior, ground level, laundry room, hot water heater – suspected internal SMF insulation material.

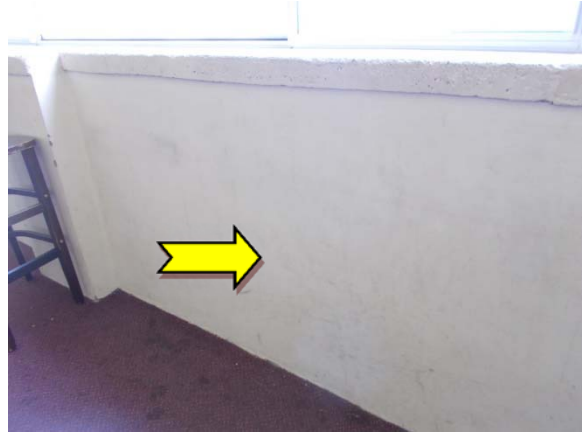
Photo 8. Interior, level one, throughout, walls – suspected lead-containing beige upper paint systems.

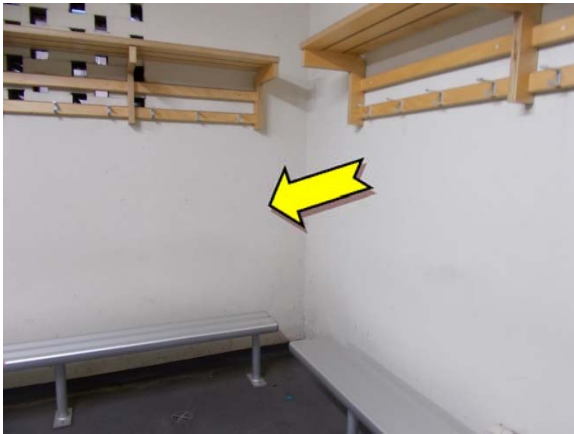
Interior, ground level	Home shed, walls, throughout	Walls	Cream - upper coloured paint system	Lead Paint - Swab	-	Suspected Positive	-	Low	Poor	Medium	200 m ²	Confirm status by quantitative test method, maintain in current condition, over paint with a lead-free paint as part of ongoing maintenance. Remove under controlled conditions in accordance with AS 4361.2:2017 Guide to hazardous paint management prior to renovation or demolition works.	-	-	9

Photo 9. Interior, ground level, dressing sheds, throughout, walls – suspected lead-containing cream upper paint systems.

- Remove flaking lead containing paint to walls throughout the property in accordance with AS4361.2-2017 Guide to Hazardous Paint Management and relevant legislation.

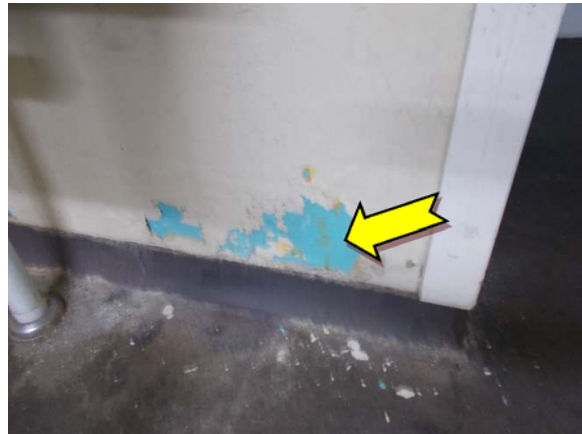
Area / Level	Room & Location	Feature	Item Description	Hazard Type	Sample No.	Sample Status	Friability	Disturb. Potential	Condition	Risk Status	Approx. Quantity	Recommendations & Comments	Control Priority	Reinspect Date	Photo No.
Interior, ground level	Home shed, walls, throughout	Walls	Blue (light) - lower coloured paint system	Lead Paint - Swab	-	Suspected Positive	-	Low	Fair	Low	200 m ²	Confirm status by quantitative test method, maintain in current condition, over paint with a lead-free paint as part of ongoing maintenance. Remove under controlled conditions in accordance with AS 4361.2:2017 Guide to hazardous paint management prior to renovation or demolition works.	-	-	10

Photo 10. Interior, ground level, home dressing shed, walls – suspected lead-containing light blue lower paint systems.
