Hazardous Building Materials Assessment Lambert Park – Spectator Shed Marion Street, Leichhardt NSW 2040

Inner West Council
April 2018

Project: Hazardous Building
Materials Assessment

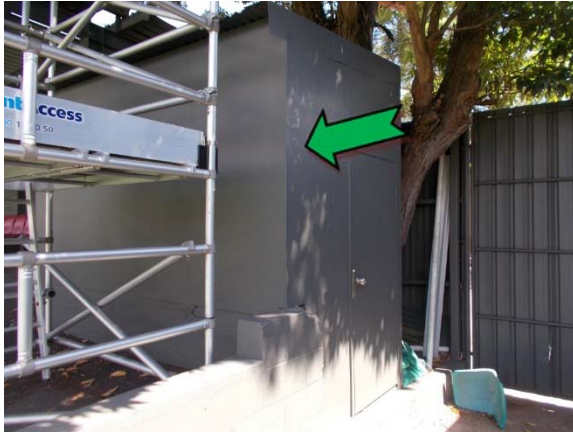
Photo 1. Exterior, shed, throughout, external walls – non asbestos-containing fibre cement sheeting.

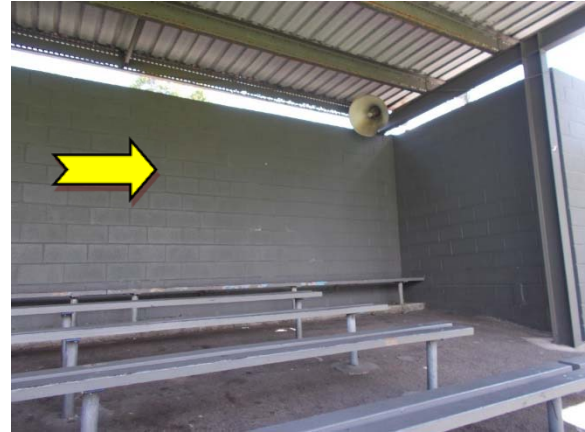
Photo 2. Exterior, throughout, walls – suspected lead-containing dark green upper paint system.

- LCP was suspected in the form of dark green upper paint systems to the walls at the time of Assessment.

- The *LeadCheck* paint swab method can detect lead in paint at concentrations of 0.5% and above, and may indicate lead in some paint films as low as 0.2%. As paint with a lead content greater than 0.1% by dry weight is now considered to be lead-containing, Prensa recommends confirming status of suspected LCP identified during the Assessment by quantitative test method.

- The safest method of dealing with LCP is to replace or remove the items in their entirety that have LCP on them and replace them with new items that do not contain lead. This allows the items to be disposed of as regular building or demolition unsegregated waste in accordance with the NSW Environment Protection Authority (EPA) *Waste Classification Guidelines 2014 Part 1 – Classifying Waste*. The advantage of this method is the reduction in labour requirements to remove the lead paint and also this reduces the risk to workers from exposure to lead dust or fumes. If the removal of the LCP or coatings is the preferred or required option this may generate significant amounts of potential hazardous waste. This waste must be removed, collected and disposed of by an appropriately licensed contractor under controlled conditions that minimises the release to air, water and soil. Disposal of lead waste must be disposed of as hazardous waste at an approved waste facility.
