# Hazardous Building Materials Assessment Lambert Park – Toilet Block Marion Street, Leichhardt NSW 2040

Inner West Council  
April 2018

Job No.: 57722-064

Count ID: CID: 191

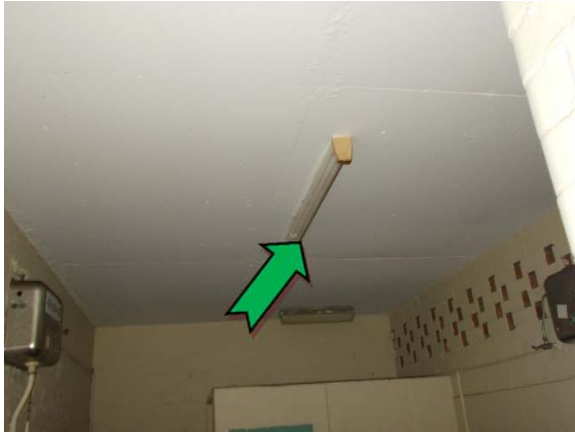
**Photo 1.** Interior, men's toilet, single tube fluorescent light fitting – suspected non PCB-containing capacitor.

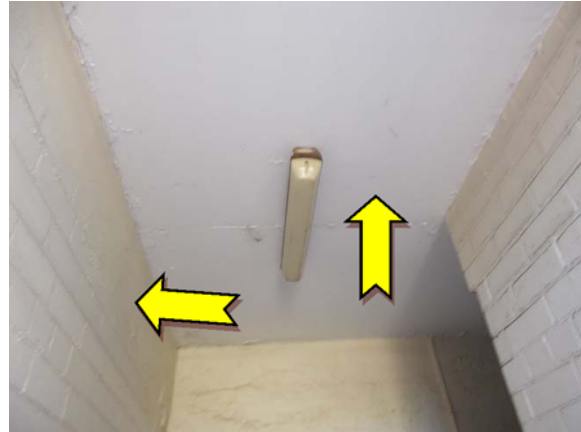
Interior, ground level	Men's toilet, throughout	Walls	Yellow - lower coloured paint system	Lead Paint - Swab	-	Suspected Positive	-	Low	Good	Low	10 m <sup>2</sup>	Confirm status by quantitative test method, maintain in current condition, over paint with a lead-free paint as part of ongoing maintenance. Remove under controlled conditions in accordance with AS 4361.2:2017 Guide to hazardous paint management prior to renovation or demolition works.	-	-	-
Interior, ground level	Men's toilet, throughout	Walls	Cream - upper coloured paint system	Lead Paint - Swab	-	Suspected Positive	-	Low	Good	Low	10 m <sup>2</sup>	Confirm status by quantitative test method, maintain in current condition, over paint with a lead-free paint as part of ongoing maintenance. Remove under controlled conditions in accordance with AS 4361.2:2017 Guide to hazardous paint management prior to renovation or demolition works.	-	-	2

**Photo 2.** Interior, men's toilet, ceiling and walls – suspected lead-containing upper white and cream coloured paint systems.

- LCP was suspected in the form of white upper paint systems to the ceiling in the men’s toilets at the time of Assessment.
- LCP was suspected in the form of cream upper paint systems and yellow lower paint systems to the internal walls in the men’s toilets at the time of Assessment.

- The *LeadCheck* paint swab method can detect lead in paint at concentrations of 0.5% and above, and may indicate lead in some paint films as low as 0.2%. As paint with a lead content greater than 0.1% by dry weight is now considered to be lead-containing, Prensa recommends confirming status of suspected LCP identified during the Assessment by quantitative test method.

- The safest method of dealing with LCP is to replace or remove the items in their entirety that have LCP on them and replace them with new items that do not contain lead. This allows the items to be disposed of as regular building or demolition unsegregated waste in accordance with the NSW Environment Protection Authority (EPA) *Waste Classification Guidelines 2014 Part 1 – Classifying Waste*. The advantage of this method is the reduction in labour requirements to remove the lead paint and also this reduces the risk to workers from exposure to lead dust or fumes. If the removal of the LCP or coatings is the preferred or required option this may generate significant amounts of potential hazardous waste. This waste must be removed, collected and disposed of by an appropriately licensed contractor under controlled conditions that minimises the release to air, water and soil. Disposal of lead waste must be disposed of as hazardous waste at an approved waste facility.

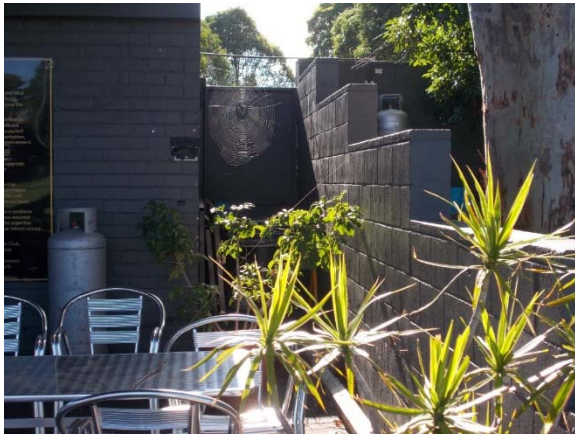
**Photo 3.** No access to ladies toilets due to blocked entrance.
