Hazardous Building Materials Assessment Pioneer Memorial Park – Amenities Block / Tool Shed Norton Street, Leichhardt NSW 2040

Inner West Council
April 2018

Job No.: 57722-092

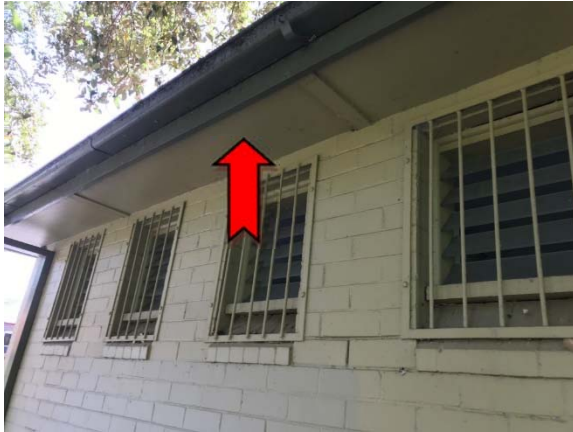
Photo 1. Exterior, throughout, eaves – asbestos-containing fibre cement sheeting.

- Friable asbestos was suspected in the form of millboard insulation within the fuse box within the Tool Shed at the time of the Assessment.
- Non-friable asbestos was identified in the form of fibre cement sheeting throughout the eaves to the exterior of the building at the time of the Assessment.

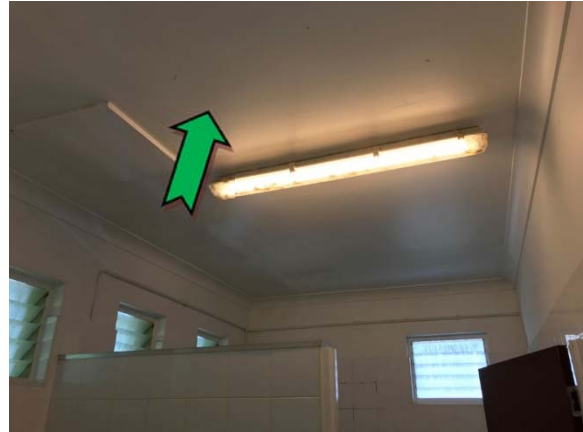
Photo 2. Interior, ladies toilet, ceiling – non asbestos-containing fibre cement sheeting.

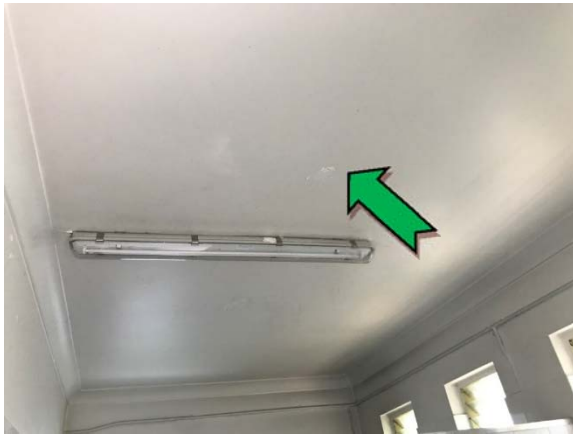
Photo 3. Interior, men's toilet, ceiling – assumed non asbestos-containing fibre cement sheeting.

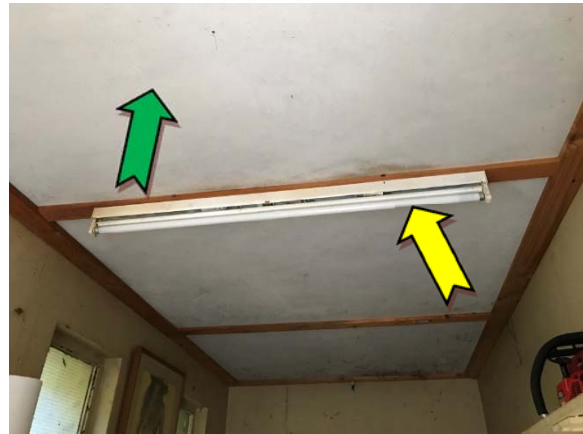
Photo 4. Interior, store, ceiling and single tubed fluorescent light fitting – non asbestos-containing fibre cement sheeting and suspected PCB-containing capacitor.

- Electrical fittings suspected of containing PCB oil capacitors should be treated as containing PCB oils until such time as evidence suggest otherwise e.g. further assessed.
- Electrical fittings that contain or suspected to contain PCB oil-containing capacitors should be removed as hazardous/regulated waste under controlled working conditions prior to the demolition or refurbishment works in accordance with the *Polychlorinated Biphenyls Management Plan, Revised Edition April 2003*.

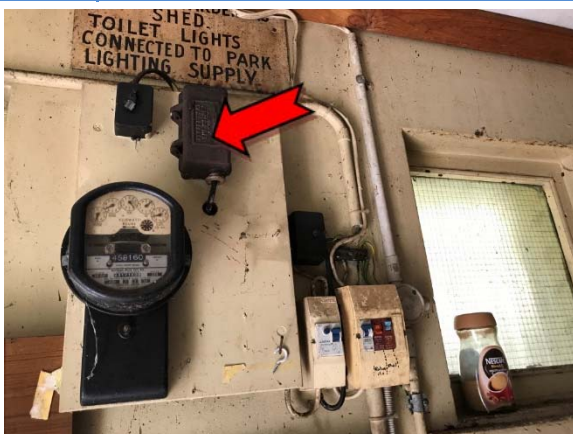
Interior, ground level	Store, south elevation, on electrical board	Fuse	Millboard insulation	Asbestos	Not sampled: Electrical hazard	Suspected Positive	Friable	Low	Good	Low	1 unit	Confirm status, label as containing asbestos and maintain in current condition if to remain in-situ. Remove under controlled friable asbestos removal conditions prior to refurbishment or demolition works by a Class A (friable) licensed asbestos removal contractor.	P4	Feb-23	5
Interior, ground level	Store	Electrical backing board	Bituminous backing board	Asbestos	Not sampled: Age and appearance	Suspected Negative	-	-	-	-	-	Suspected negative due to age and appearance.	-	-	-
Throughout	-	-	-	SMF	-	-	-	-	-	-	-	No suspect SMF material identified at the time of the assessment.	-	-	-
Interior, ground level	Store	Fluorescent light fitting - single tube	Capacitor	PCBs	Not sampled: Electrical hazard	Suspected Positive	-	Low	Good	Low	1 unit	PCB-containing capacitors are suspected due to age & appearance of electrical fittings. Remove and dispose of in accordance with the Polychlorinated Biphenyls Management Plan, Revised Edition April 2003.	-	-	4

Photo 5. Interior, store, fuse – suspected asbestos-containing millboard insulation.

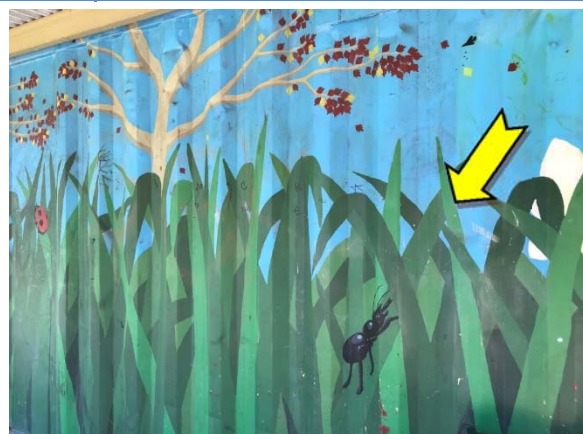
Exterior	Tool shed	Graffiti wall, throughout	Various colours - upper coloured paint system	Lead Paint - Swab	-	Suspected Positive	-	Low	Good	Low	50m ²	Confirm status by quantitative test method, maintain in current condition, over paint with a lead-free paint as part of ongoing maintenance. Remove under controlled conditions in accordance with AS 4361.2:2017 Guide to hazardous paint management prior to renovation or demolition works.	-	-	6
Exterior	Throughout	Walls & eaves	Green (light) - upper coloured paint system	Lead Paint - Swab	-	Suspected Positive	-	Low	Good	Low	80m ²	Confirm status by quantitative test method, maintain in current condition, over paint with a lead-free paint as part of ongoing maintenance. Remove under controlled conditions in accordance with AS 4361.2:2017 Guide to hazardous paint management prior to renovation or demolition works.	-	-	7
Exterior	Throughout	Features	Green (dark) - upper coloured paint system	Lead Paint - Swab	-	Suspected Positive	-	Low	Good	Low	100m	Confirm status by quantitative test method, maintain in current condition, over paint with a lead-free paint as part of ongoing maintenance. Remove under controlled conditions in accordance with AS 4361.2:2017 Guide to hazardous paint management prior to renovation or demolition works.	-	-	7

Photo 6. Exterior, graffiti wall – suspected lead-containing various upper coloured paint systems.

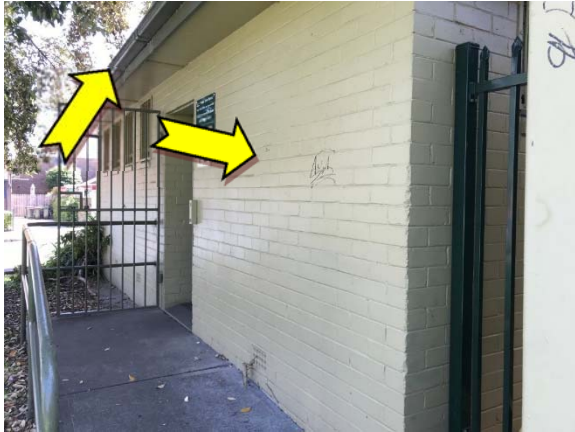
Photo 7. Exterior, throughout, walls and features – suspected lead-containing light and dark green upper coloured paint systems.

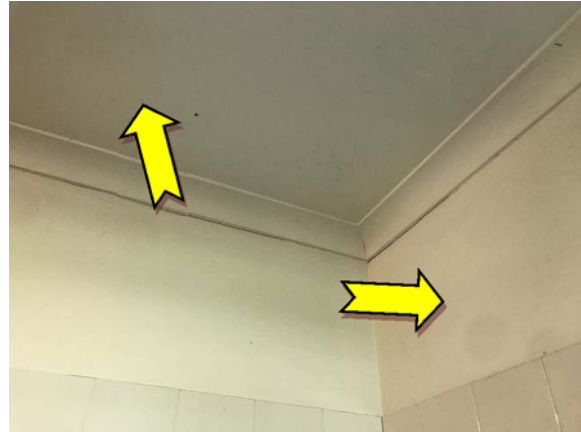
Interior, ground level	Throughout	Walls & ceiling	White - upper coloured paint system	Lead Paint - Swab	-	Suspected Positive	-	Low	Good	Low	60m ²	Confirm status by quantitative test method, maintain in current condition, over paint with a lead-free paint as part of ongoing maintenance. Remove under controlled conditions in accordance with AS 4361.2:2017 Guide to hazardous paint management prior to renovation or demolition works.	-	-	8
Throughout	-	-	-	Ozone Depleting Substances	-	-	-	-	-	-	-	No suspect ODS's identified at the time of the assessment.	-	-	-

Photo 8. Interior, throughout walls and ceiling – suspected lead-containing white upper paint systems.
