Hazardous Building Materials Assessment Prospect St Kindergarten / Kiosk / Store 8 Prospect Street, Leichhardt NSW 2040

Inner West Council
April 2018

Job No.: 57722-095

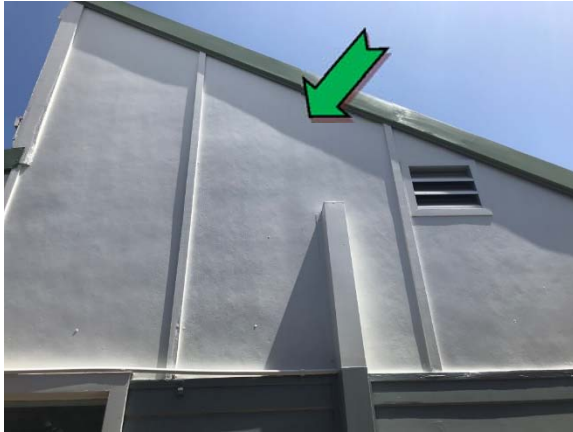
Photo 1. Exterior, north elevation, high level infill panels – non asbestos-containing fibre cement sheeting.

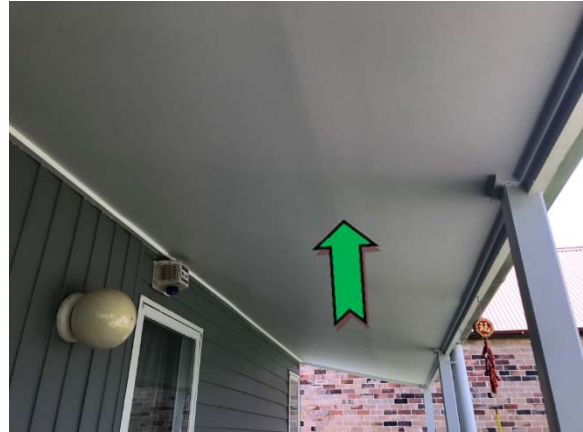
Photo 2. Exterior, east elevation, awning – non asbestos-containing fibre cement sheeting.

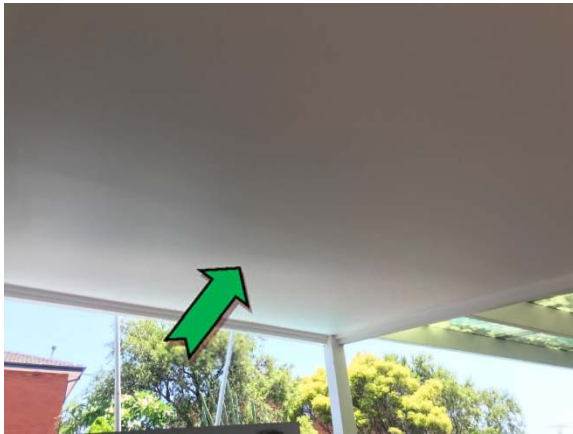
Photo 3. Exterior, shed, awning – non asbestos-containing fibre cement sheeting.

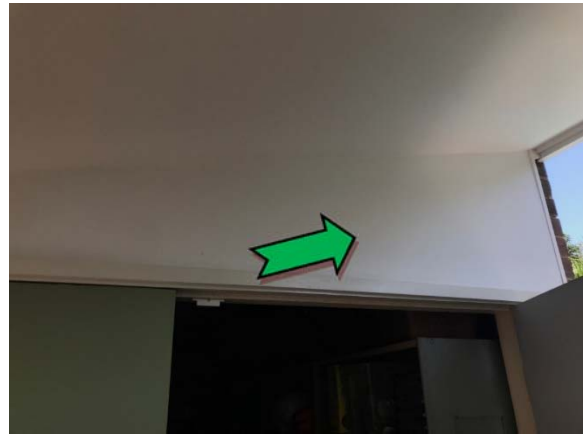
Photo 4. Exterior, shed, high level infill panel – non asbestos-containing fibre cement sheeting.

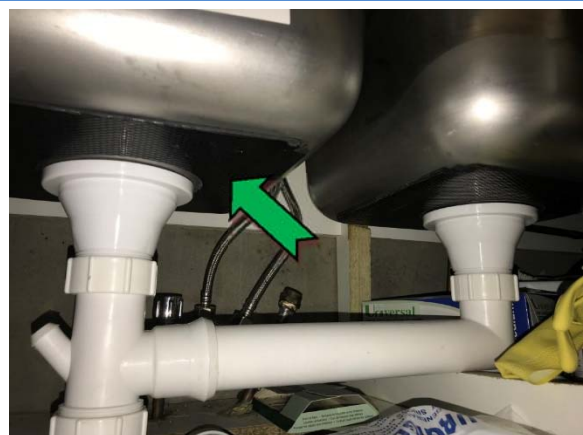
Photo 6. Interior, kitchen, under sink, sink pad – non asbestos-containing bituminous material.

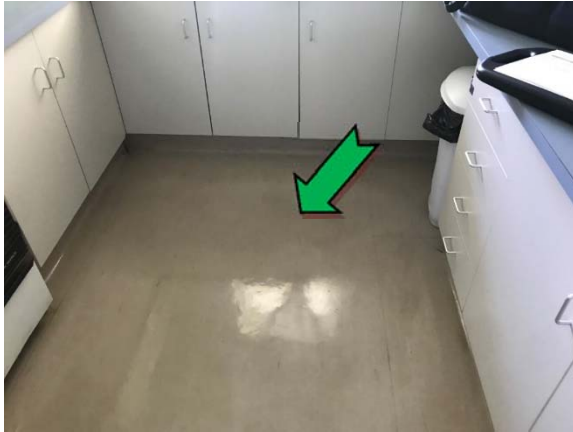
Photo 7. Interior, kitchen, floor coverings – non asbestos-containing sheet vinyl.

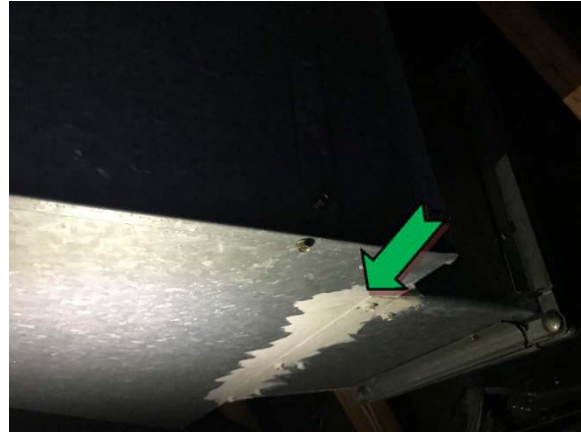
Photo 8. Interior, roof space, air conditioning ductwork – non asbestos-containing mastic sealant.

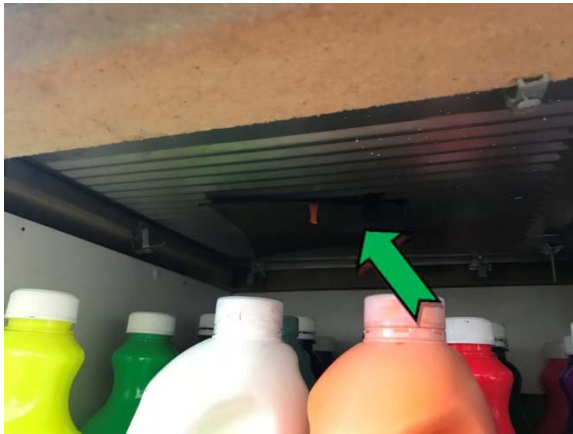
Photo 9. Interior, craft room, under sink, sink pad – assumed non asbestos-containing bituminous material.

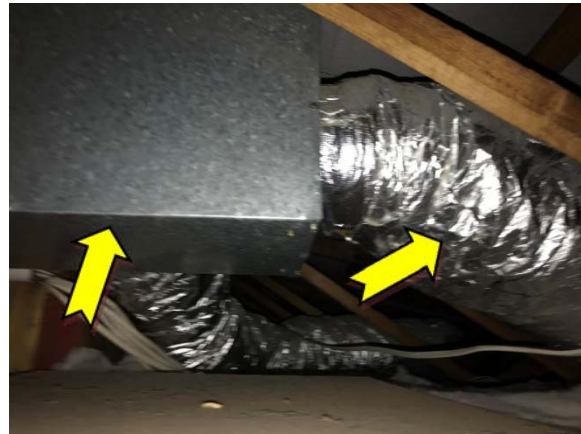
Interior	Kitchen, under sink	Sink pad	Bituminous material	Asbestos	57722-095-001	Negative	-	-	-	-	-	-	-	-	6
Interior	Kitchen	Floor coverings - cream	Sheet vinyl	Asbestos	57722-095-002	Negative	-	-	-	-	-	-	-	-	7
Interior	Roof space	Air conditioning ductwork	Mastic sealant	Asbestos	57722-095-003	Negative	-	-	-	-	-	-	-	-	8
Interior	Craft room, under sink	Sink pad	Bituminous material	Asbestos	Same as 57722-095-001	Assumed Negative	-	-	-	-	-	-	-	-	9
Interior	Ceiling space, throughout	Flexible ductwork	Insulation material - internal	SMF	-	Suspected Positive	Bonded	Low	Good	Low	20 m	Maintain in current condition if to remain in-situ. Remove under controlled SMF conditions as per the Code of Practice for the Safe Use of Synthetic Mineral Fibres [NOHSC: 2006 (1990)].	-	-	10
Interior	Ceiling space, throughout	Air conditioning ductwork	Insulation material - internal	SMF	-	Suspected Positive	Bonded	Low	Good	Low	10 m	Maintain in current condition if to remain in-situ. Remove under controlled SMF conditions as per the Code of Practice for the Safe Use of Synthetic Mineral Fibres [NOHSC: 2006 (1990)].	-	-	10

Photo 10. Interior, ceiling space, air conditioning ductwork – suspected SMF internal insulation.

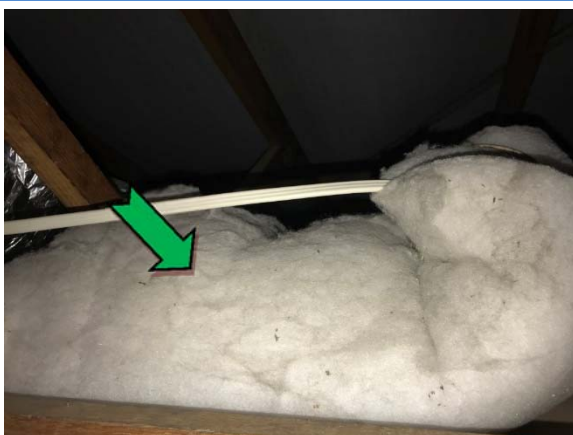
Photo 11. Interior, ceiling space, throughout – suspected non SMF insulation batts.

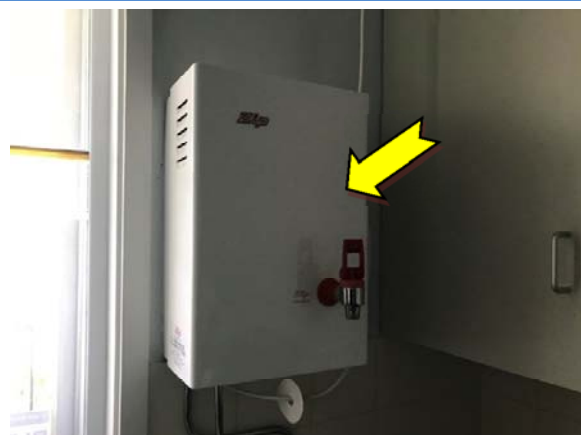
Interior	Ceiling space, throughout	Insulation	Insulation batts	SMF	-	Suspected Negative	-	-	-	-	-	-	-	-	11
Interior	Kitchen	Hot Water Boiler	Insulation material - internal	SMF	-	Suspected Positive	Bonded	Low	Good	Low	1 unit	Maintain in current condition if to remain in-situ. Remove under controlled SMF conditions as per the Code of Practice for the Safe Use of Synthetic Mineral Fibres [NOHSC: 2006 (1990)].	-	-	12

Photo 12. Interior, kitchen, hot water boiler – suspected SMF internal insulation material.

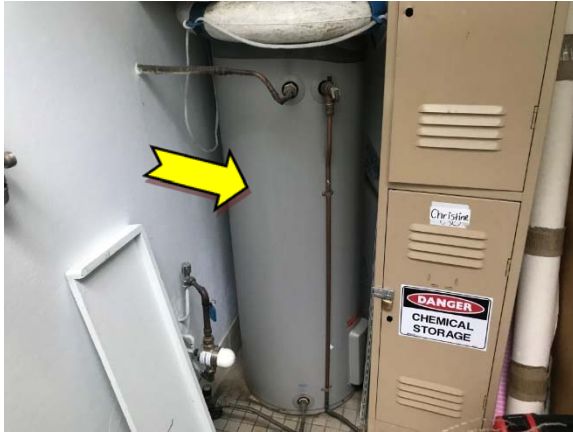
Photo 13. Interior, staff toilet, hot water heater – suspected SMF internal insulation material.

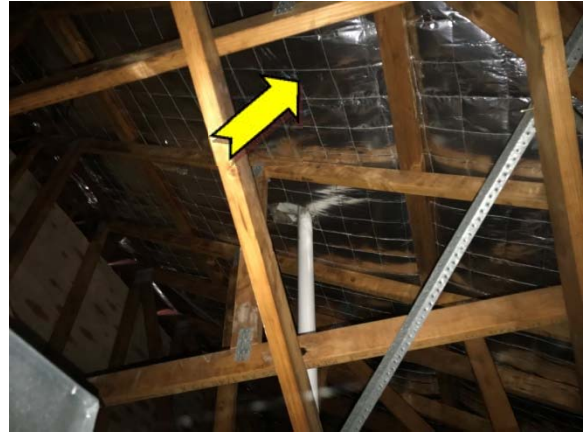
Photo 14. Interior, roof space, throughout – suspected SMF sarking insulation material.

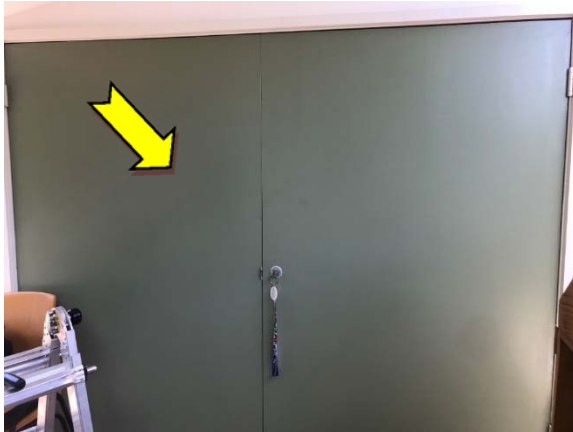
Photo 15. Exterior, doors and frames – suspected lead-containing green upper paint systems.

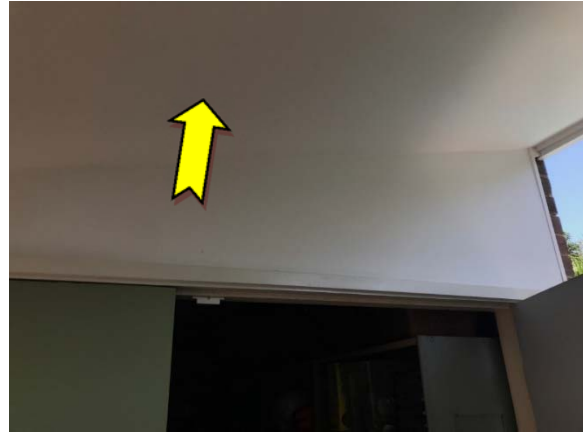
Exterior	Throughout	Doors & Features	Green - upper coloured paint system	Lead Paint - Swab	-	Suspected Positive	-	Low	Good	Low	10 m ²	Confirm status by quantitative test method, maintain in current condition, over paint with a lead-free paint as part of ongoing maintenance. Remove under controlled conditions in accordance with AS 4361.2:2017 Guide to hazardous paint management prior to renovation or demolition works.	-	-	15
Exterior	Throughout	Fencing	Green (light) - upper coloured paint system	Lead Paint - Swab	-	Suspected Positive	-	Low	Good	Low	40 m ²	Confirm status by quantitative test method, maintain in current condition, over paint with a lead-free paint as part of ongoing maintenance. Remove under controlled conditions in accordance with AS 4361.2:2017 Guide to hazardous paint management prior to renovation or demolition works.	-	-	-
Exterior	Throughout	Features & Infill panels	White - upper coloured paint system	Lead Paint - Swab	-	Suspected Positive	-	Low	Good	Low	120 m ²	Confirm status by quantitative test method, maintain in current condition, over paint with a lead-free paint as part of ongoing maintenance. Remove under controlled conditions in accordance with AS 4361.2:2017 Guide to hazardous paint management prior to renovation or demolition works.	-	-	16

Photo 16. Exterior, awnings and high level infill panels – suspected lead-containing white upper paint systems.

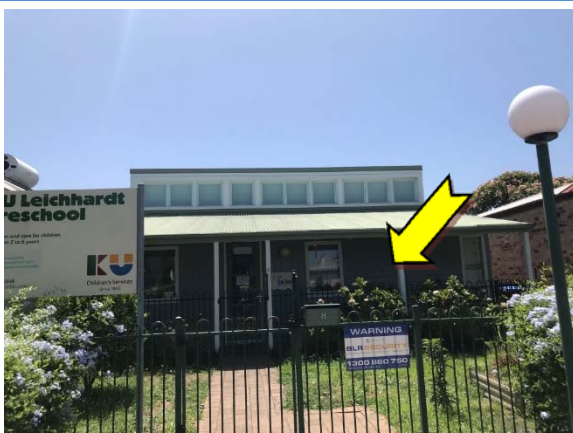
Photo 17. Exterior, walls, throughout – suspected lead-containing grey upper paint systems.

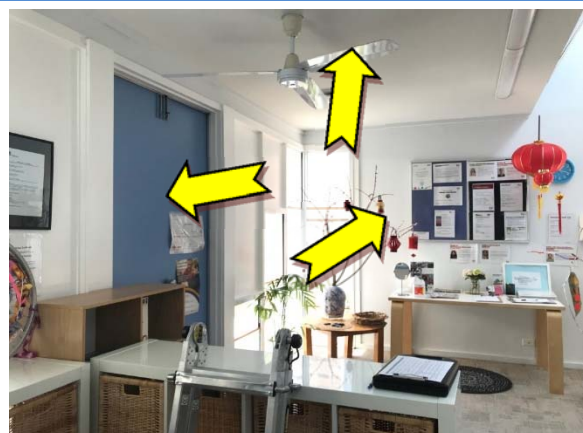
Exterior	East elevation	Wall	Grey - upper coloured paint system	Lead Paint - Swab	-	Suspected Positive	-	Low	Good	Low	20 m ²	Confirm status by quantitative test method, maintain in current condition, over paint with a lead-free paint as part of ongoing maintenance. Remove under controlled conditions in accordance with AS 4361.2:2017 Guide to hazardous paint management prior to renovation or demolition works.	-	-	17
Interior	Throughout	Walls & Ceiling	White - upper coloured paint system	Lead Paint - Swab	-	Suspected Positive	-	Low	Good	Low	200 m ²	Confirm status by quantitative test method, maintain in current condition, over paint with a lead-free paint as part of ongoing maintenance. Remove under controlled conditions in accordance with AS 4361.2:2017 Guide to hazardous paint management prior to renovation or demolition works.	-	-	18
Interior	Throughout	Door	Blue (light) - upper coloured paint system	Lead Paint - Swab	-	Suspected Positive	-	Low	Good	Low	10 m ²	Confirm status by quantitative test method, maintain in current condition, over paint with a lead-free paint as part of ongoing maintenance. Remove under controlled conditions in accordance with AS 4361.2:2017 Guide to hazardous paint management prior to renovation or demolition works.	-	-	18

Photo 18. Interior, walls, ceiling and doors – suspected lead-containing white and light blued upper coloured paint systems.

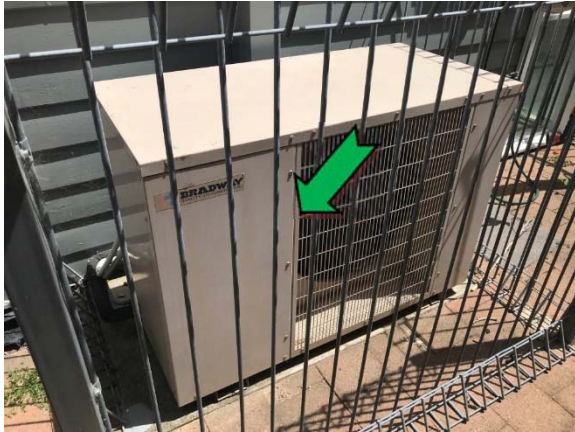
Exterior	North elevation	Air conditioning unit	Unknown refrigerant	Ozone Depleting Substances	Not sampled: No access	Suspected Positive	-	-	-	-	1 unit	No data was visible at the time of the assessment. Confirm status of suspected ozone depleting substances identified in the assessment.	-	-	19
Exterior	North-west elevation	Air conditioning unit	Unknown refrigerant	Ozone Depleting Substances	Not sampled: No access	Suspected Positive	-	-	-	-	1 unit	No data was visible at the time of the assessment. Confirm status of suspected ozone depleting substances identified in the assessment.	-	-	19

Photo 19. Exterior, north elevation, air conditioning unit – suspected ODS-containing unknown refrigerant gas.

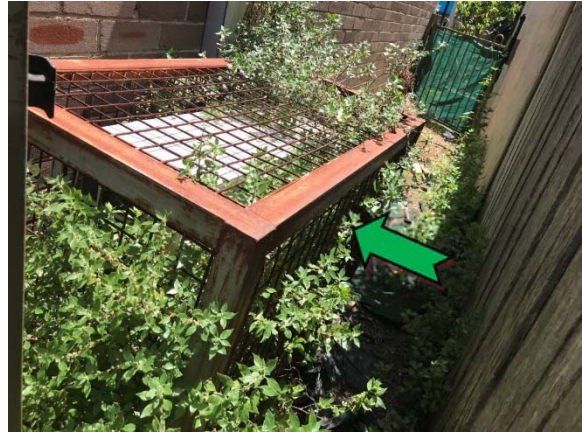
Photo 20. Exterior, north-west elevation, air conditioning unit – suspected ODS-containing unknown refrigerant gas.
