# Hazardous Building Materials Assessment Leichhardt Service Centre 7-15 Wetherill Street, Leichhardt NSW 2040

Inner West Council  
April 2018

Client: Inner West Council

Job No.: 57722-094

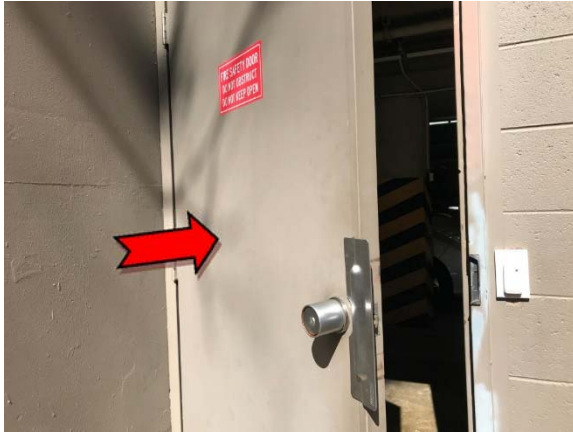
**Photo 1.** Exterior, north-east elevation, adjacent garage roller door, fire door – suspected asbestos-containing fire door core.

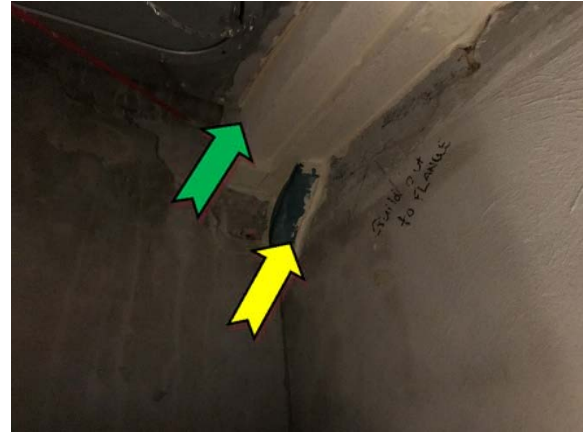
**Photo 2.** Interior, level 3, training room, ceiling space, to support beams – non asbestos-containing sprayed vermiculite and suspected SMF pillow insulation.

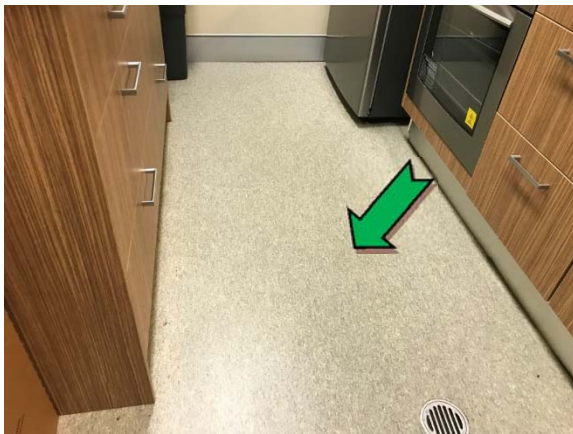
**Photo 3.** Interior, level 3, kitchen, floor coverings – suspected non asbestos-containing sheet vinyl.

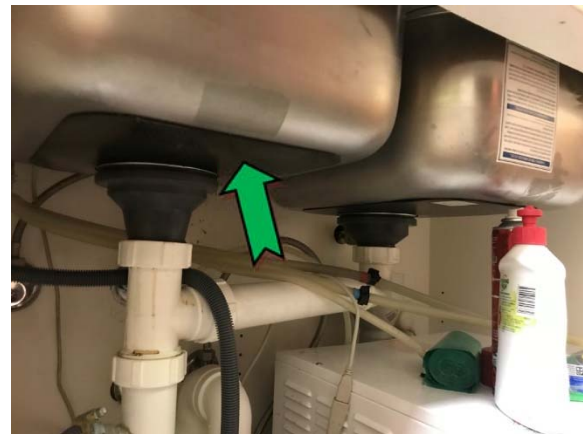
**Photo 4.** Interior, level 3, kitchen, under sink, sink pad – non asbestos-containing bituminous material.

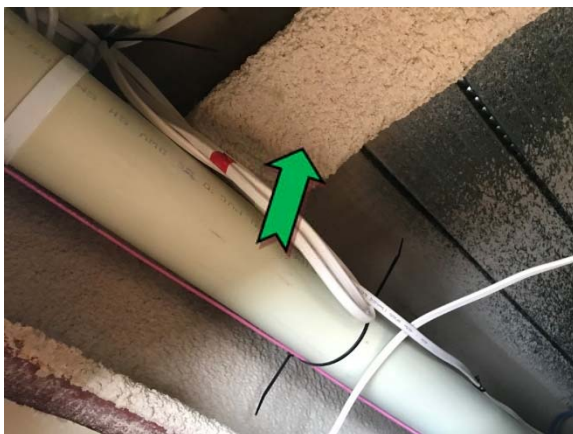
**Photo 5.** Interior, level 3, meeting room 2, ceiling space, to support beams – non asbestos-containing insulation.

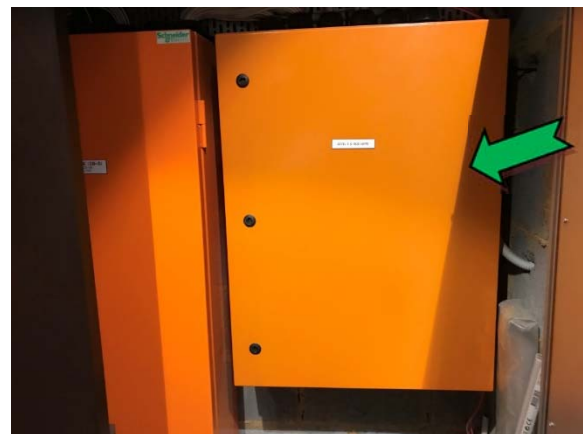
**Photo 6.** Interior, level 3, switch room, electrical backing board – suspected non asbestos-containing bituminous backing board.

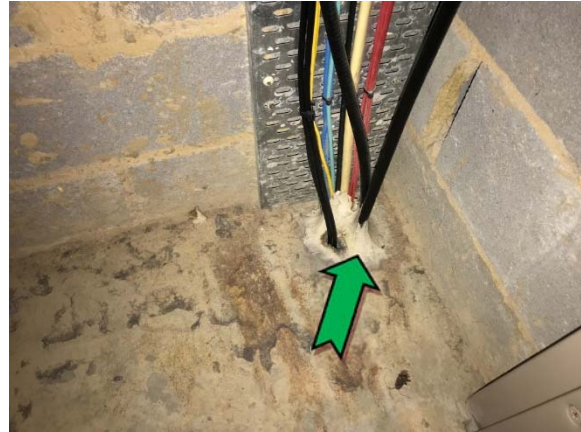
**Photo 8.** Interior, level 3, comms room, floor, to penetration point – assumed non asbestos-containing mastic sealant.

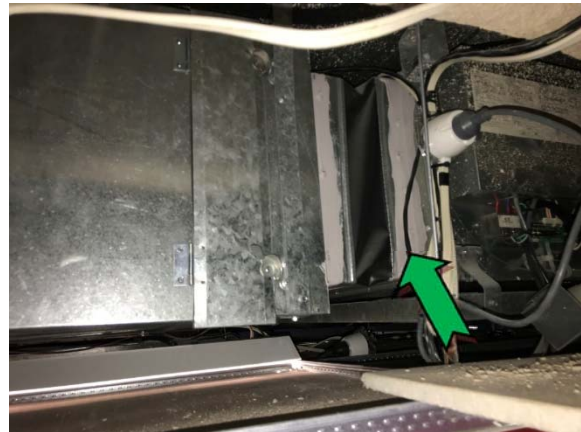
**Photo 10.** Interior, level 3, throughout, ceiling space, air conditioning ductwork – suspected non asbestos-containing mastic sealant and suspected SMF internal insulation.

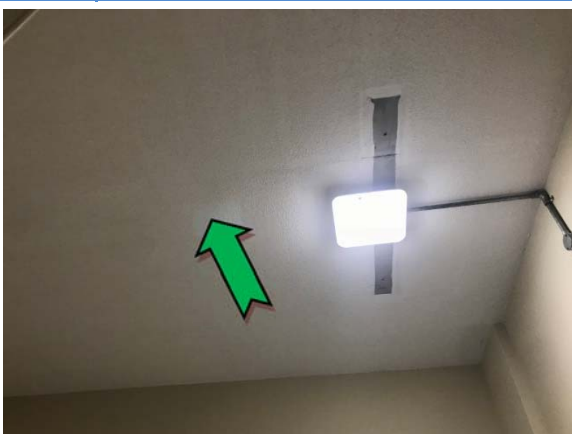
**Photo 11.** Interior, level 3, west elevation, staircase, ceiling – suspected non asbestos-containing textured coatings.

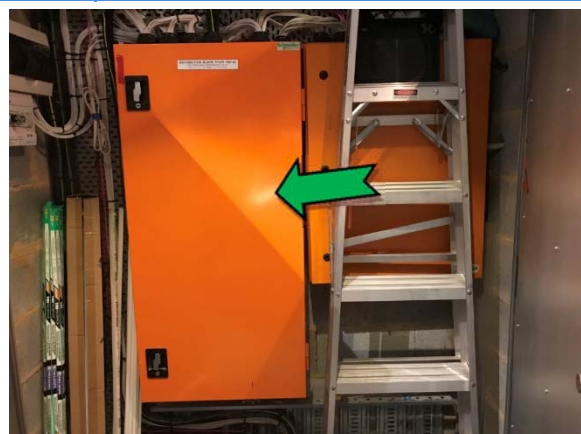
**Photo 12.** Interior, level 2, switch room, electrical backing board – suspected non asbestos-containing bituminous backing board.

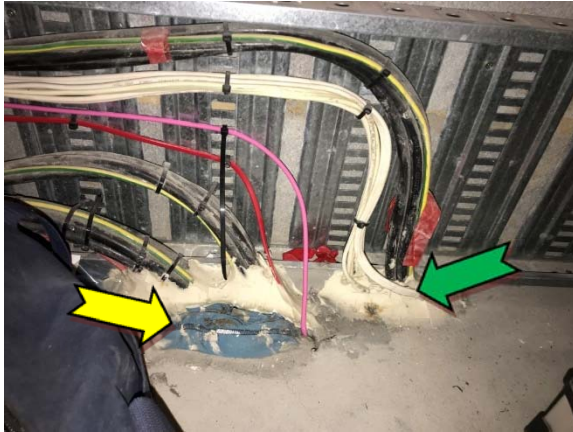
**Photo 13.** Interior, level 2, switch room, floor, to penetration point – non asbestos-containing mastic sealant and suspected SMF pillow insulation.

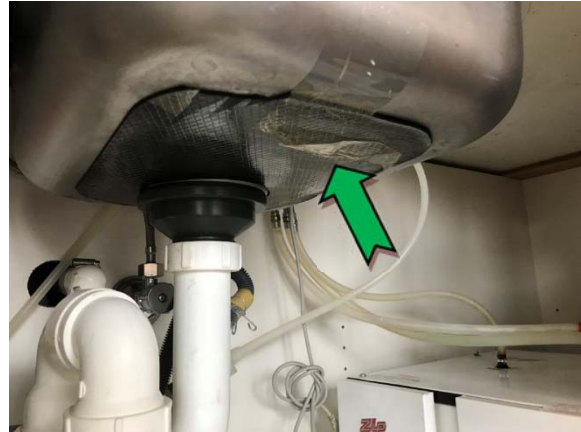
**Photo 14.** Interior, level 2, staff room, under sink, sink pad – non asbestos-containing bituminous material.

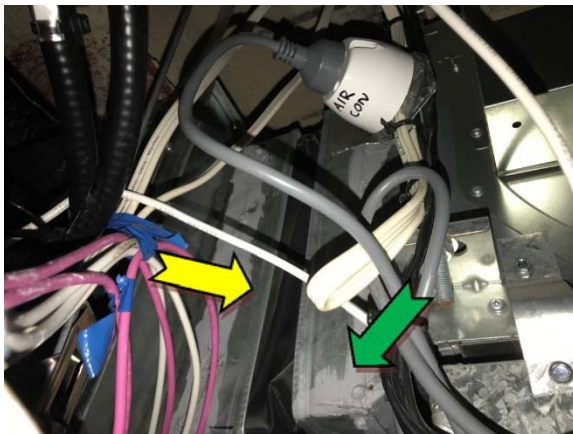
**Photo 15.** Interior, level 2, ceiling space, air conditioning ductwork – non asbestos-containing mastic sealant and suspected SMF internal insulation.

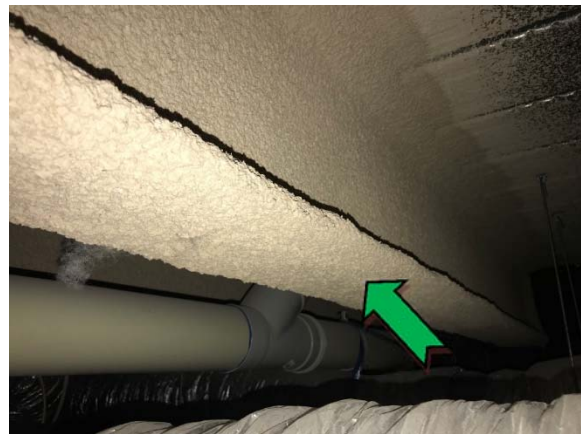
**Photo 16.** Interior, level 2, ceiling space, to support beams – non asbestos-containing insulation.

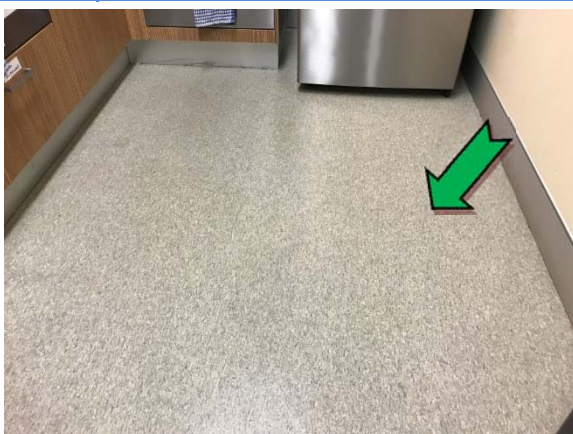
**Photo 17.** Interior, level 2, main office, kitchen, floor coverings – suspected non asbestos-containing sheet vinyl.

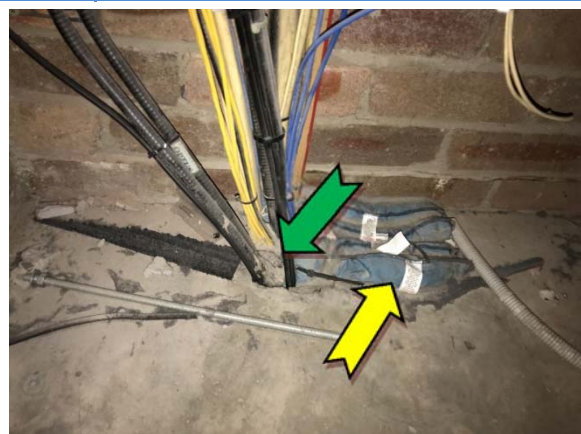
**Photo 18.** Interior, level 1, comms room, floor, to penetration point – non asbestos-containing mastic sealant and suspected SMF pillow insulation.

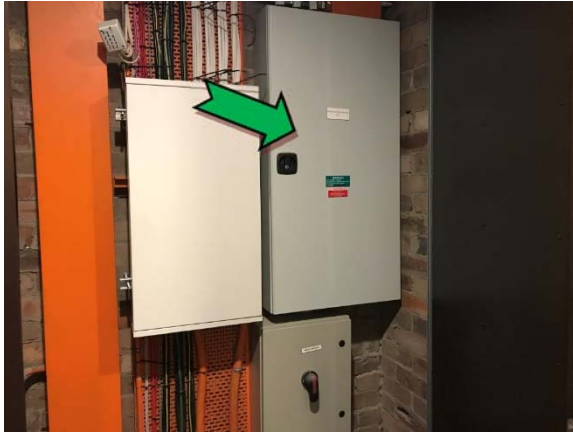
**Photo 19.** Interior, level 1, switch room, electrical backing board – suspected non asbestos-containing bituminous backing board.

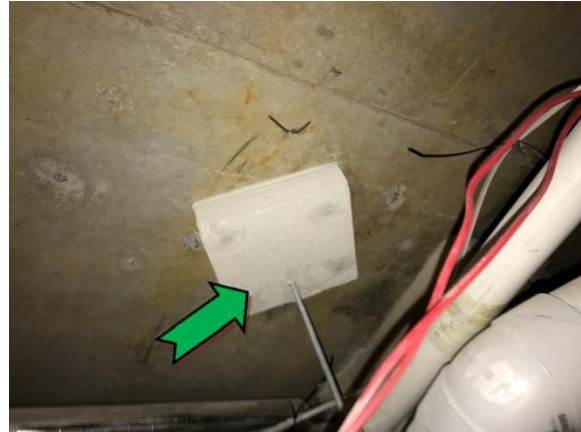
**Photo 20.** Interior, level 1, ceiling space – non asbestos-containing insulating board.

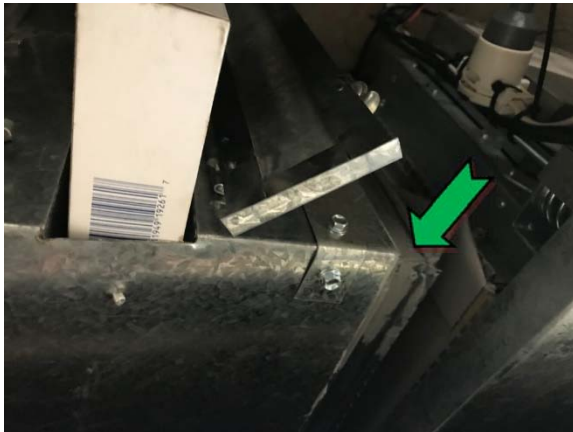
**Photo 21.** Interior, level 1, ceiling space, air conditioning ductwork – non asbestos-containing mastic sealant.

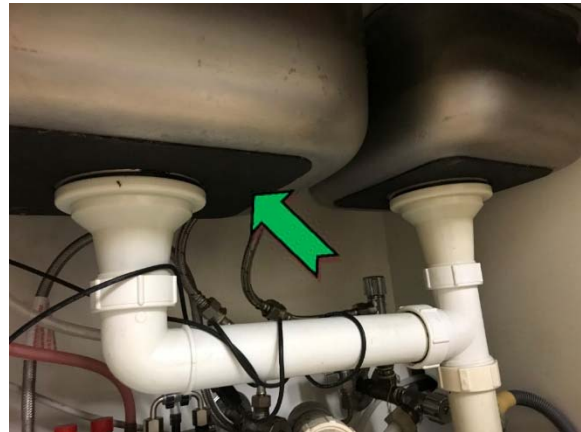
**Photo 22.** Interior, level 1, kitchen, under sink, sink pad – non asbestos-containing bituminous material.

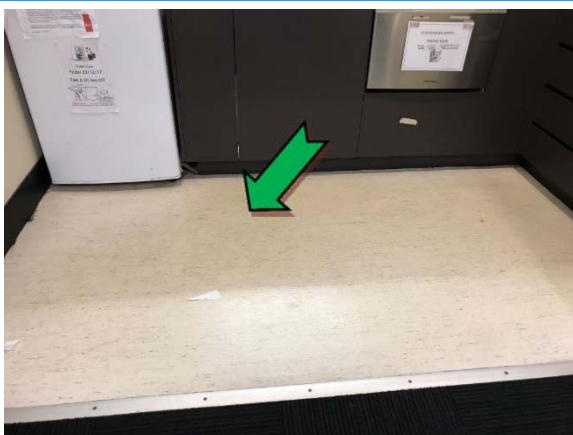
**Photo 23.** Interior, level 1, kitchen, floor coverings – non asbestos-containing sheet vinyl.

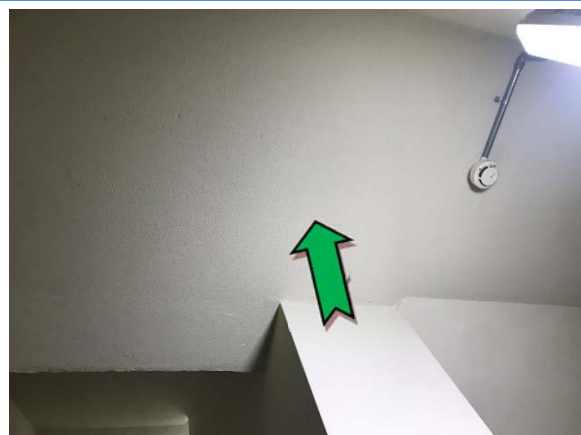
**Photo 24.** Interior, level 1, west elevation, staircase – suspected non asbestos-containing textured coatings.

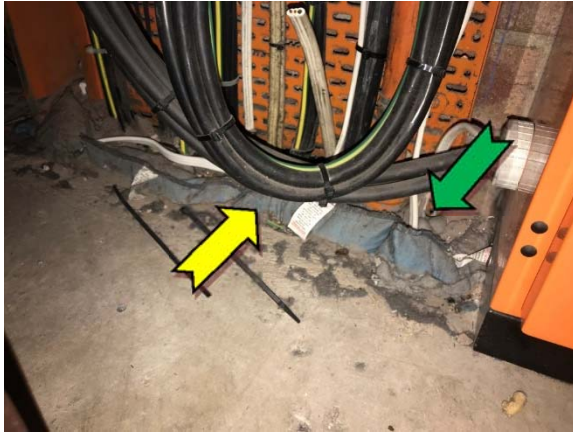
**Photo 25.** Interior, ground level, switch room, floor, to penetration point – non asbestos-containing mastic sealant and suspected SMF pillow insulation.

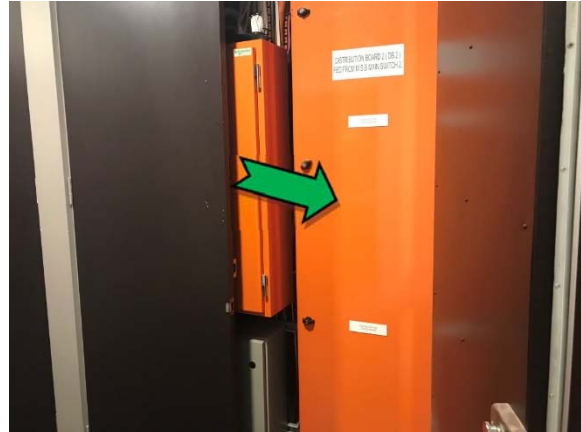
**Photo 26.** Interior, ground level, switch room, electrical backing board – suspected non asbestos-containing bituminous backing board.

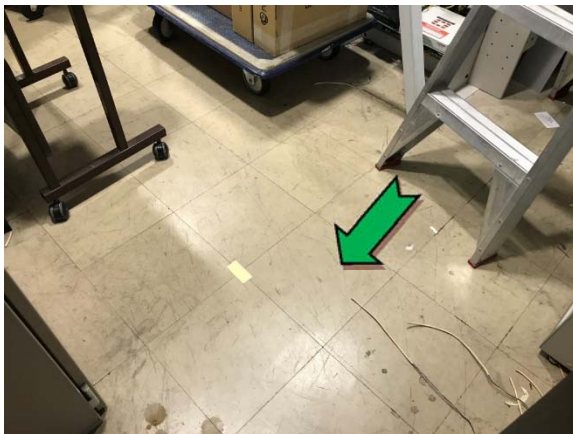
**Photo 27.** Interior, ground level, IT room, floor coverings – non asbestos-containing vinyl floor tiles.

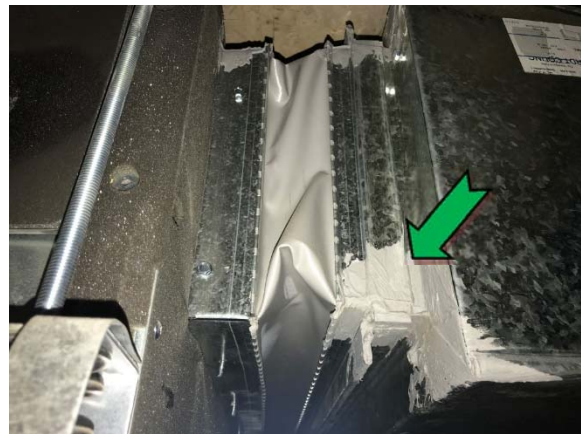
**Photo 28.** Interior, ground level, ceiling space, air conditioning ductwork – non asbestos-containing mastic sealant.

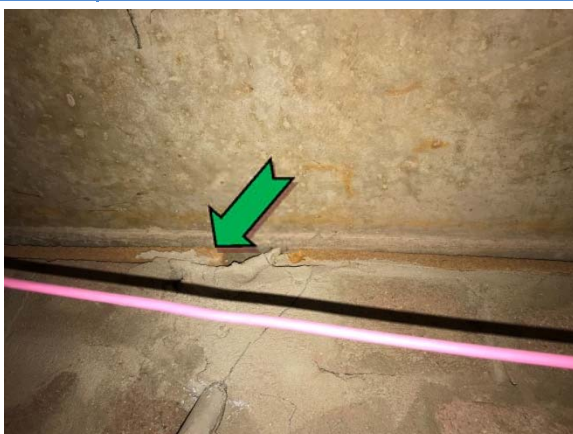
**Photo 29.** Interior, ground level, corridor to strong room, packing between wall and ceiling – non asbestos-containing fibre cement sheeting.

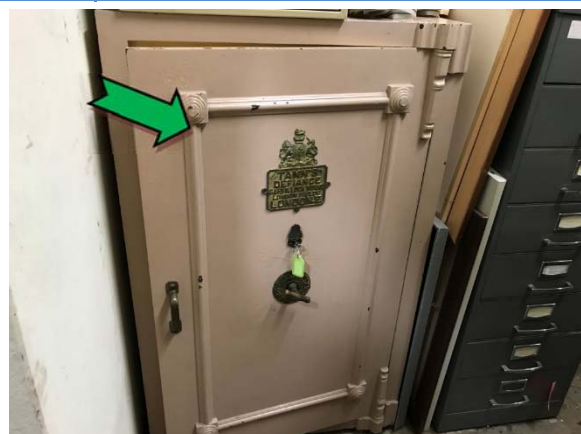
**Photo 30.** Interior, ground level, strong room, safe – suspected asbestos-containing internal insulation material.

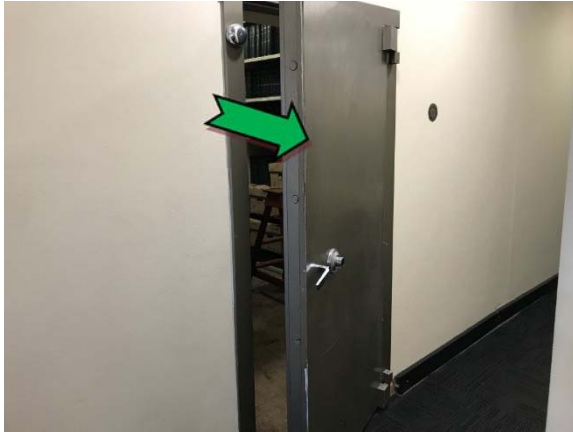
**Photo 31.** Interior, ground level, strong room, door – suspected asbestos-containing internal insulation material.

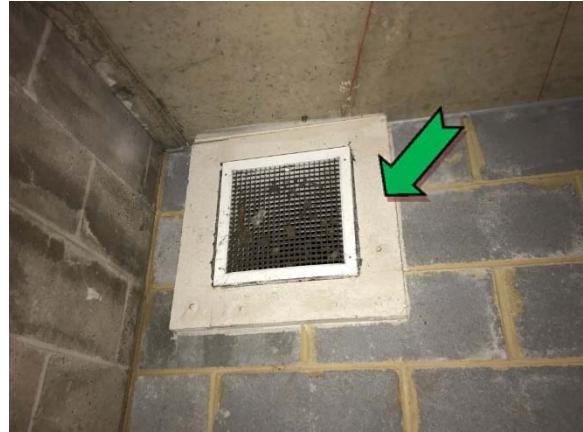
**Photo 32.** Interior, basement level, north-east corner – non asbestos-containing insulation board.

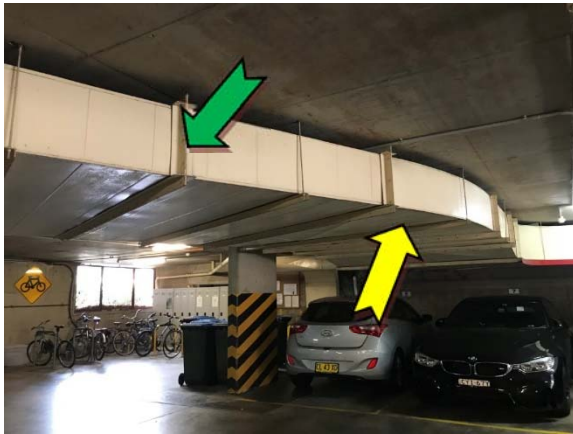
**Photo 33.** Interior, basement level, air conditioning ductwork – non asbestos-containing mastic sealant and suspected SMF internal insulation.

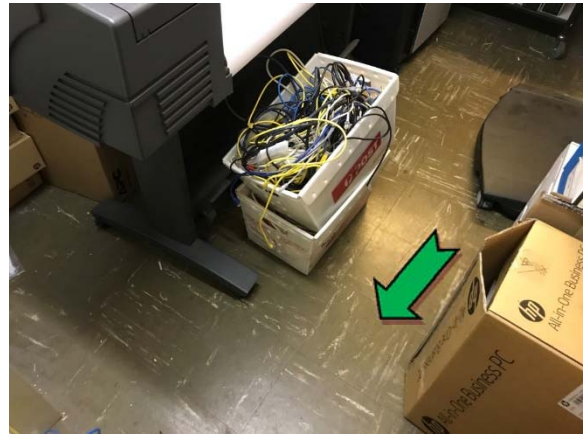
**Photo 34.** Interior, basement level, MDF room, floor coverings – non asbestos-containing vinyl floor tiles.

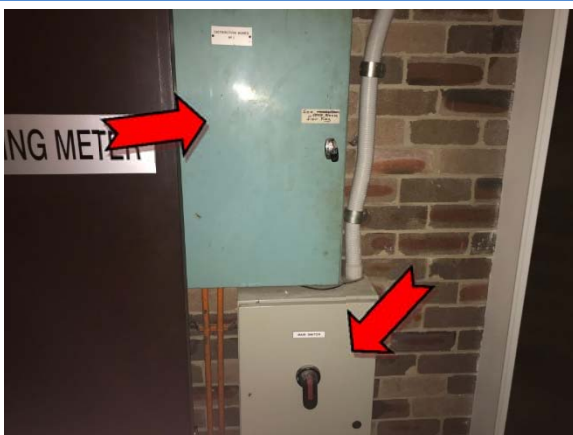
**Photo 35.** Interior, basement level, opposite lift, electrical backing board – suspected asbestos-containing bituminous backing boards.

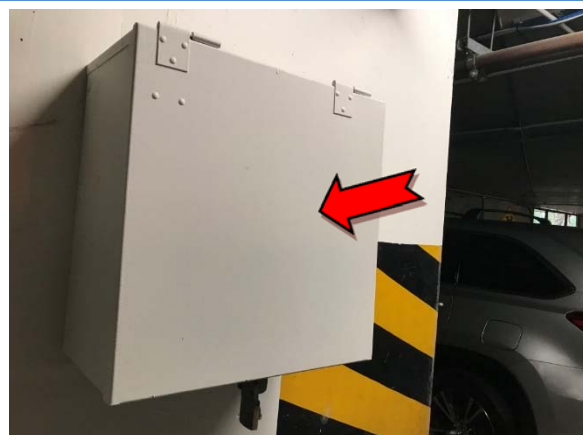
**Photo 36.** Interior, basement level, west elevation, electrical backing board – suspected asbestos-containing bituminous backing boards.

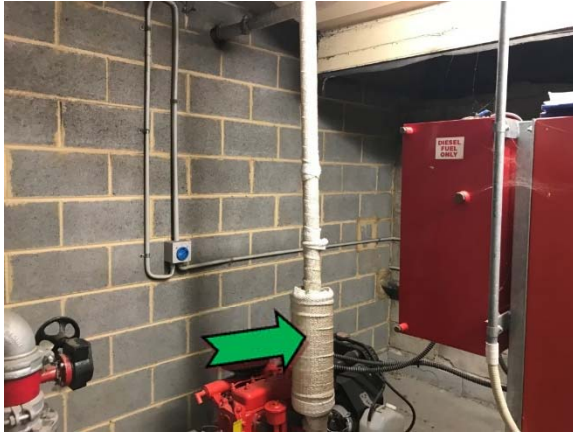
**Photo 37.** Interior, basement level, pump room, pipe work, to fire pressure pump system – non asbestos-containing woven material.

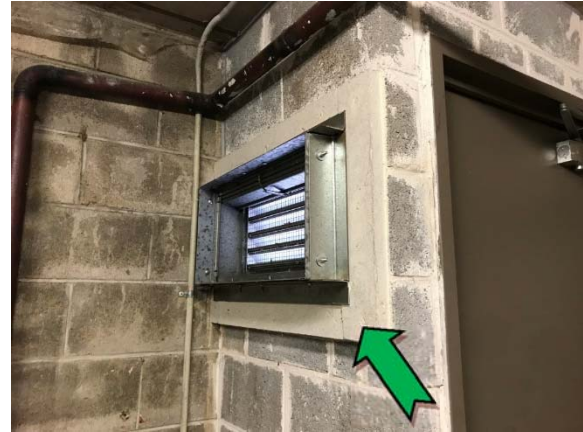
**Photo 38.** Interior, basement level, pump room, south elevation, infill panels – assumed non asbestos-containing insulating board.

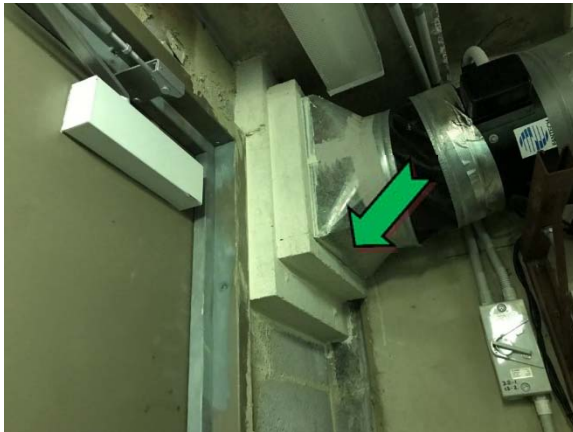
**Photo 39.** Interior, basement level, pump room, ductwork to wall, infill panel – assumed non asbestos-containing insulating board.

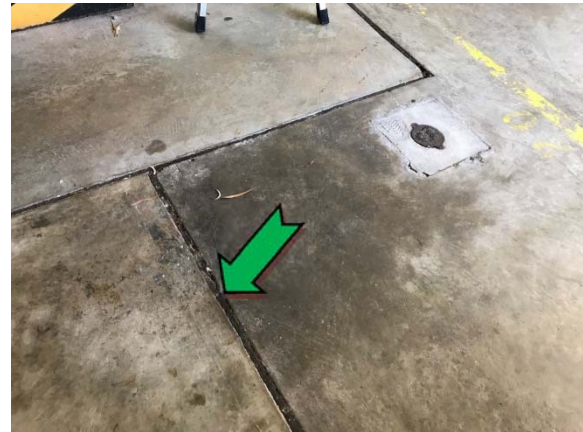
**Photo 40.** Interior, north-east corner, floor, expansion joint – non asbestos-containing construction joint mastic.

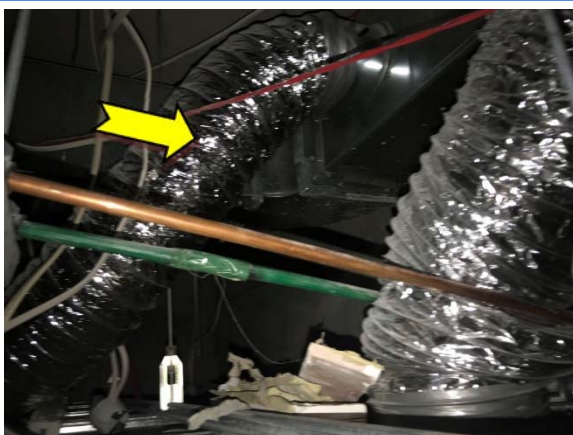
**Photo 41.** Interior, level 3, ceiling space flexible ductwork – suspected SMF internal insulation material.

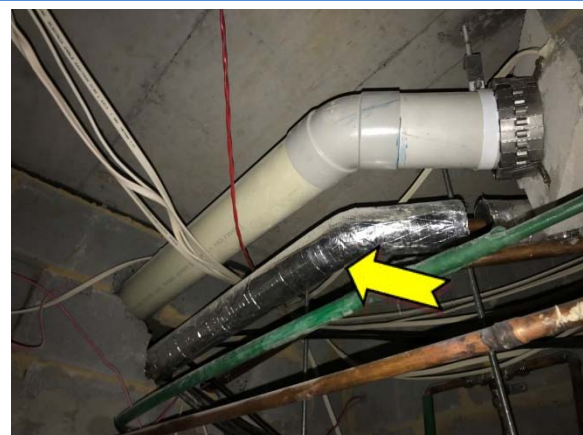
**Photo 42.** Interior, level 3, west elevation, west elevation, female toilets, ceiling space, to pipework – suspected SMF external insulation material.

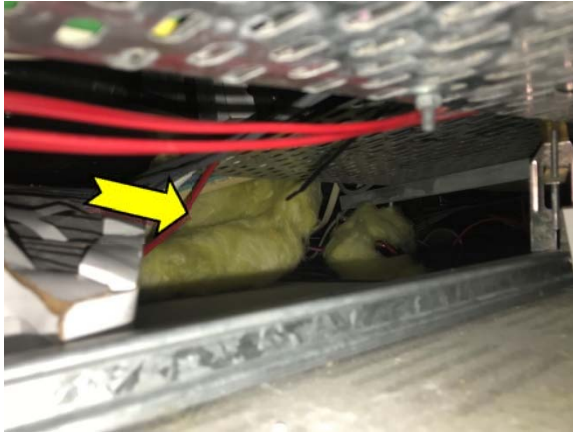
**Photo 43.** Interior, level 3, ceiling space, throughout – suspected SMF insulating batts.

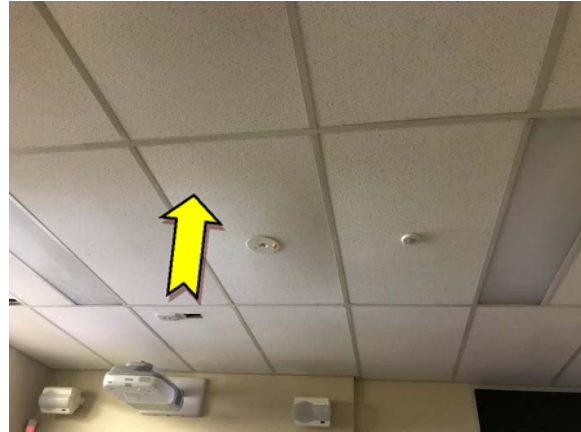
**Photo 44.** Interior, level 3, throughout, ceiling – suspected SMF compressed ceiling tiles.

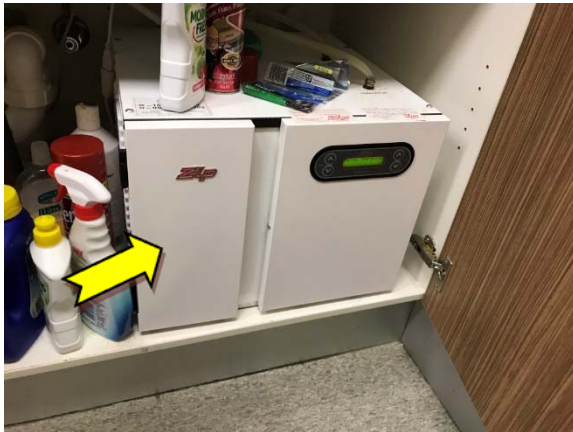
**Photo 45.** Interior, level 3, kitchen, under sink, hot water heater – suspected SMF internal insulation material.

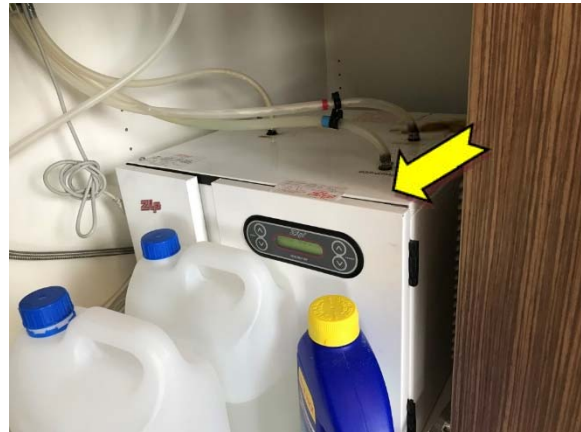
**Photo 46.** Interior, level 2, staffroom, hot water heater – suspected SMF internal insulation material.

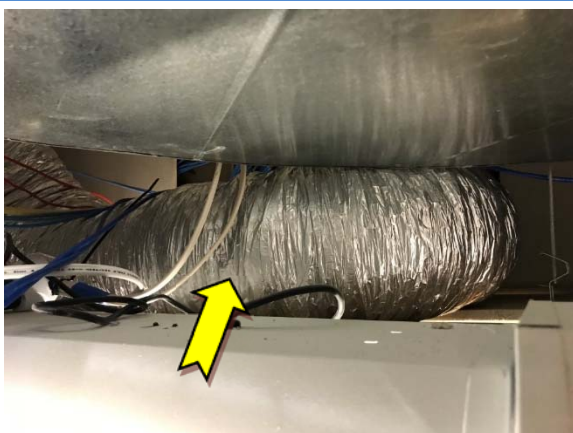
**Photo 47.** Interior, level 2, ceiling space, flexible ductwork – suspected SMF internal insulation material.

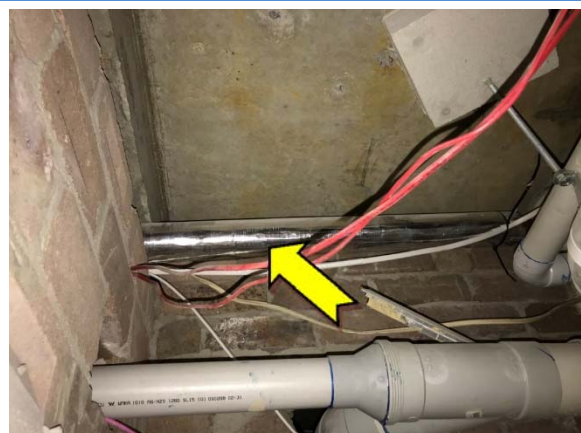
**Photo 48.** Interior, level 1, ceiling space, to pipework – suspected SMF external insulation.

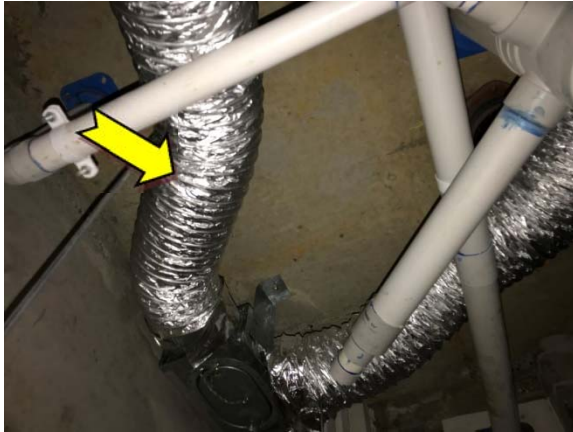
**Photo 49.** Interior, level 1, ceiling space, flexible ductwork – suspected SMF internal insulation.

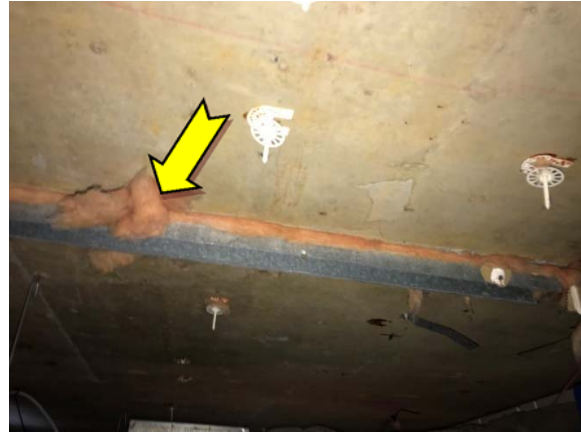
**Photo 50.** Interior, level 1, ceiling space, to redundant partition supports – suspected SMF insulation material.

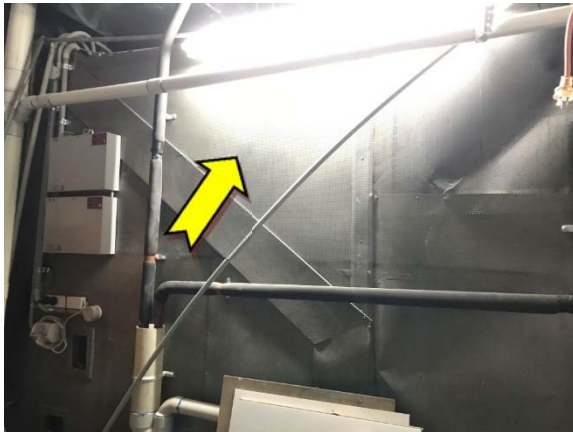
**Photo 51.** Interior, level 1, plant room, walls – suspected SMF wall insulation material.

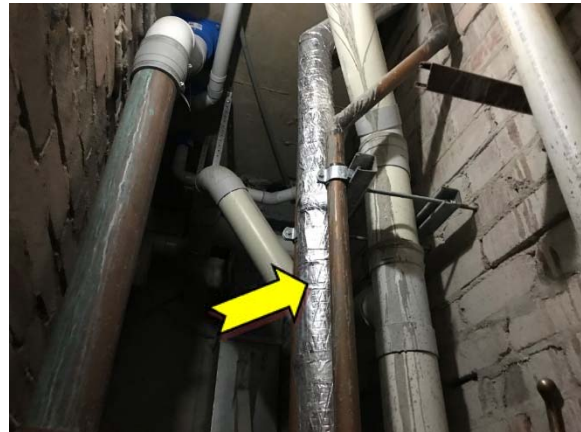
**Photo 52.** Interior, level 1, men’s toilet, riser cupboard, to pipework – suspected SMF external insulation material.

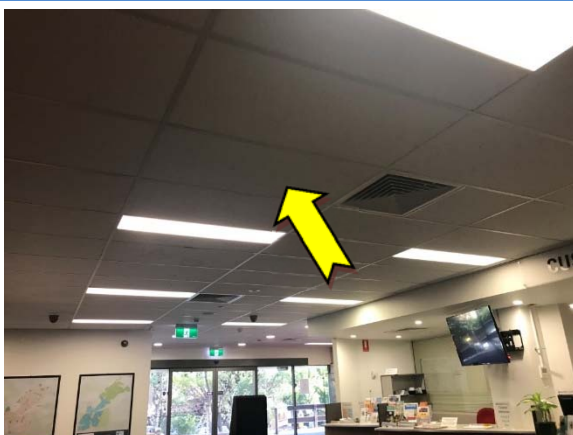
**Photo 53.** Interior, ground level, throughout, ceiling – suspected SMF compressed ceiling tiles.

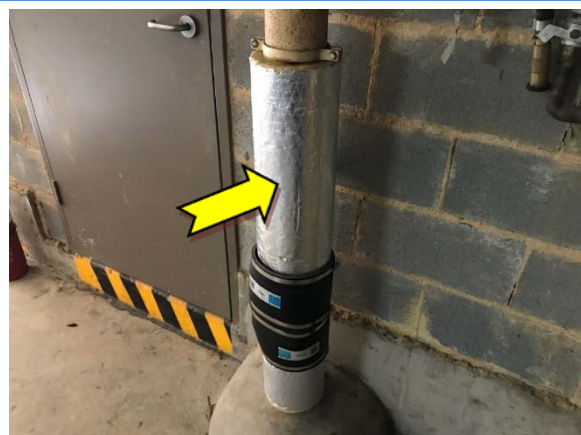
**Photo 54.** Interior, basement level, to pipework – suspected SMF insulation material.

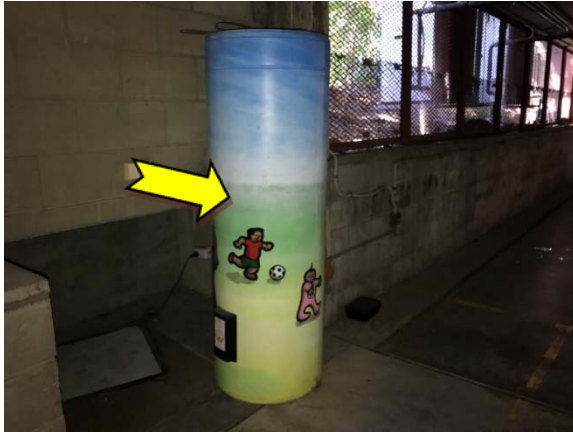
**Photo 55.** Interior, basement level, west elevation, hot water heater – suspected SMF internal insulation material.

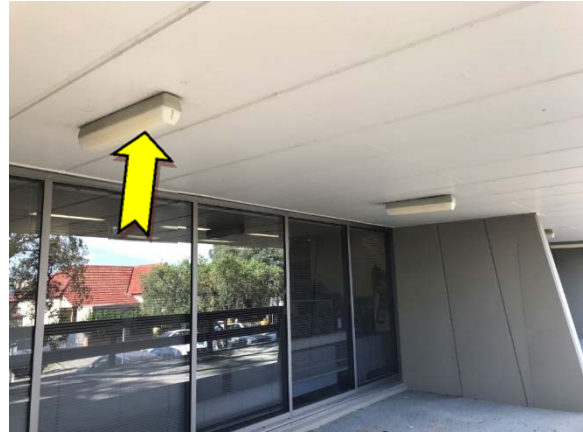
**Photo 56.** Exterior, throughout, single tubed fluorescent light fittings – suspected PCB-containing capacitors.

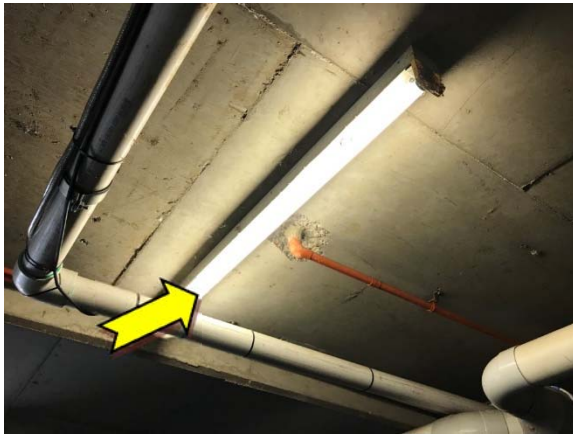
**Photo 57.** Interior, basement, throughout, single tubed fluorescent light fittings – suspected PCB-containing capacitors.

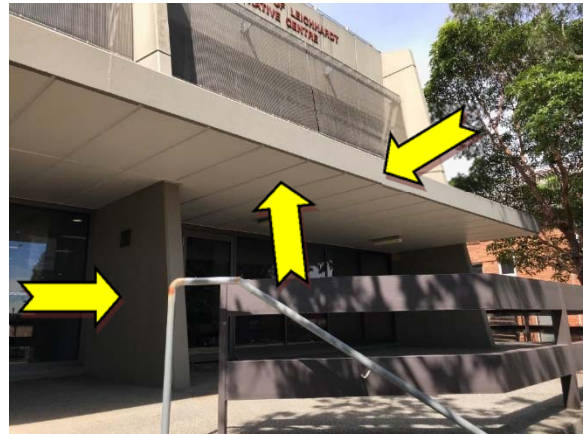
**Photo 58.** Exterior, throughout – suspected lead-containing white, light and dark brown upper coloured paint systems.

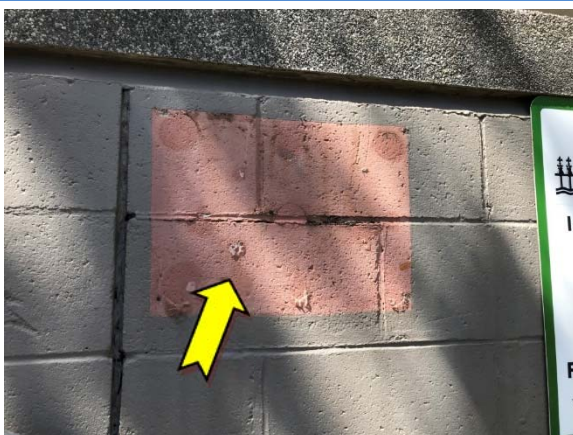
**Photo 59.** Exterior, throughout, street level, brick wall – suspected lead-containing red lower paint system.

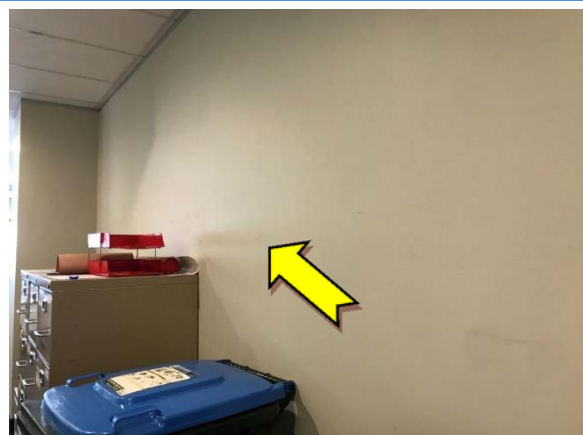
**Photo 60.** Interior, level 1, walls – suspected lead-containing cream upper paint systems.

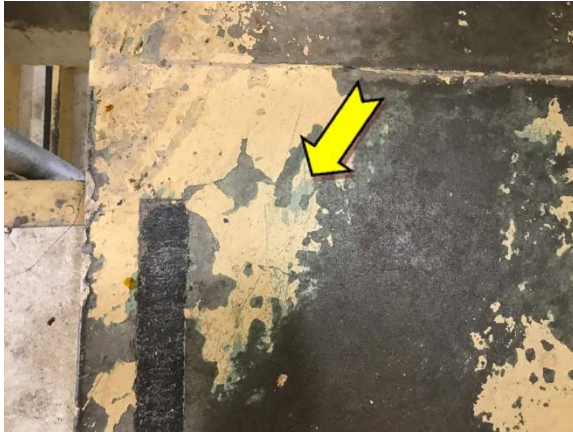
**Photo 61.** Interior, level 1, floor – suspected lead-containing yellow upper and green lower coloured paint systems.

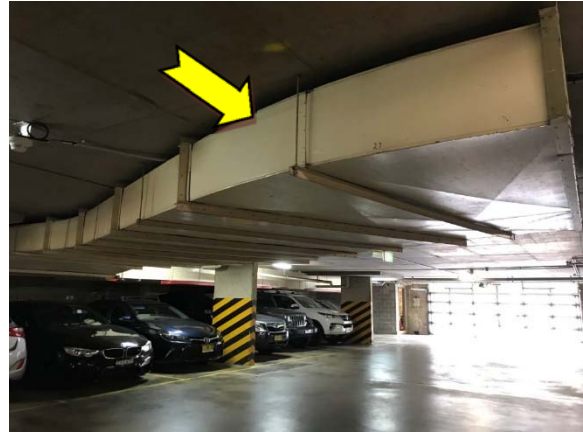
**Photo 62.** Interior, basement level, air condition ductwork – lead-containing cream upper paint system.

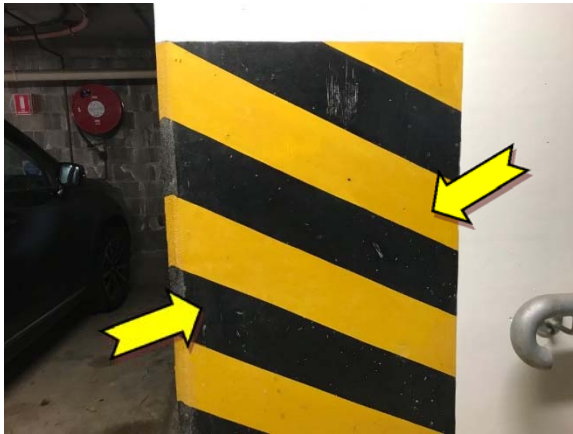
**Photo 63.** Interior, basement level, column – lead-containing yellow upper paint system and suspected lead-containing black upper paint systems.

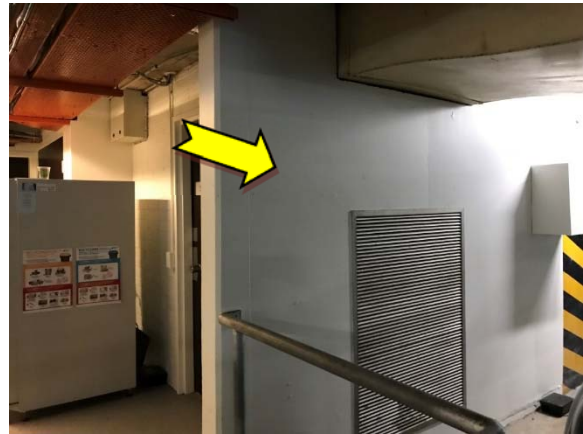
**Photo 64.** Interior, basement level, wall – lead-containing upper white paint systems.

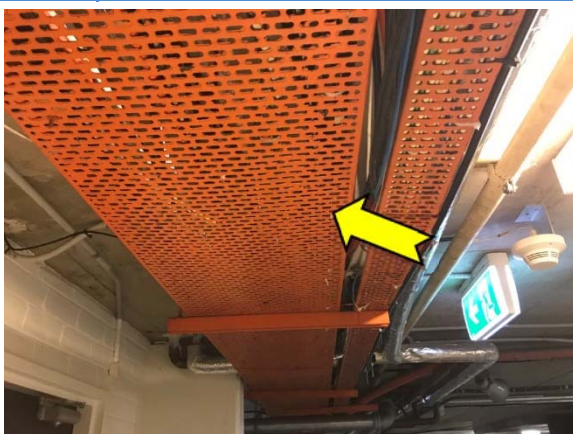
**Photo 65.** Interior, basement level, to conduit trays – lead-containing orange upper paint systems.

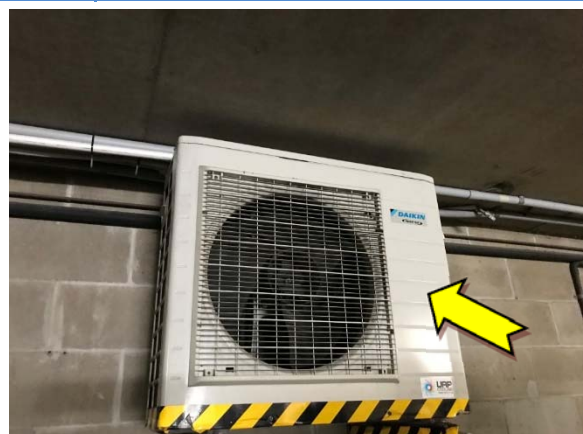
**Photo 66.** Interior, basement level, air conditioning unit – suspected ODS-containing unknown refrigerant
