Hazardous Building Materials Assessment Callan Park – Recreational Hall Balmain Road, Lilyfield NSW 2040

Inner West Council
April 2018

Job No.: 57722-180

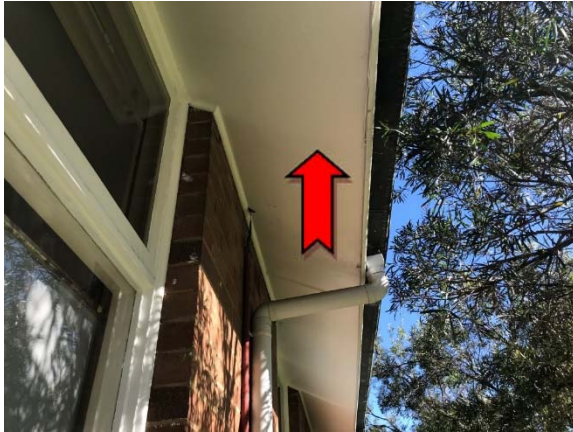
Photo 1. Exterior, throughout, eaves – asbestos-containing fibre cement sheeting.

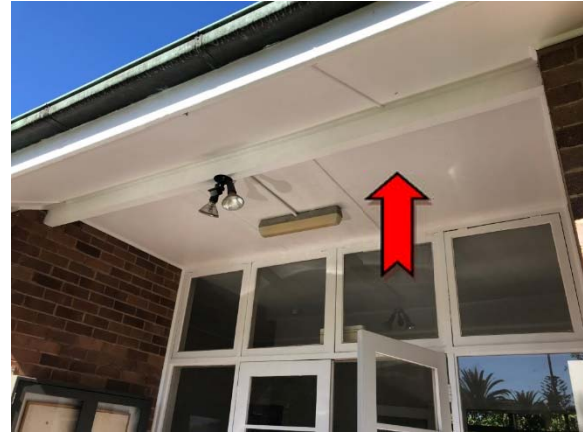
Photo 2. Exterior, eastern elevation, awning – assumed asbestos-containing fibre cement sheeting.

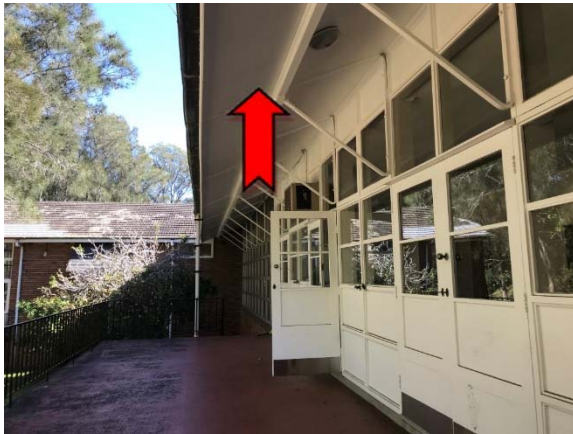
Photo 3. Exterior, western elevation, awning – assumed asbestos-containing fibre cement sheeting.

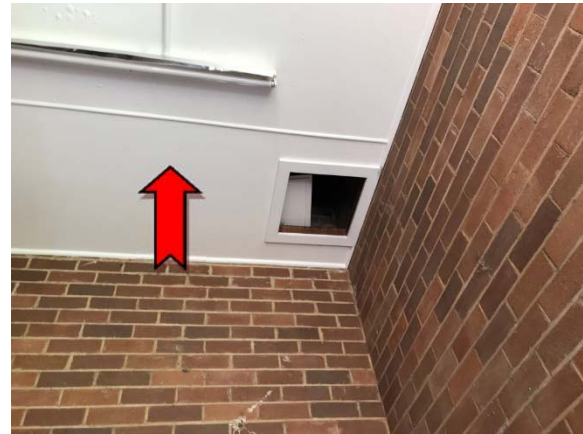
Photo 4. Exterior, north elevation, awning – assumed asbestos-containing fibre cement sheeting.

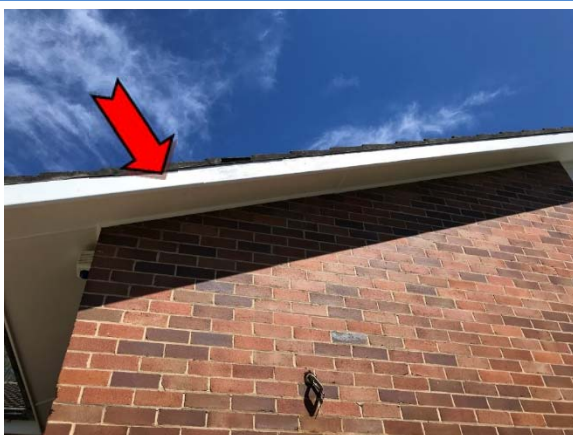
Photo 5. Exterior, throughout, gable verge lining – assumed asbestos-containing fibre cement sheeting.

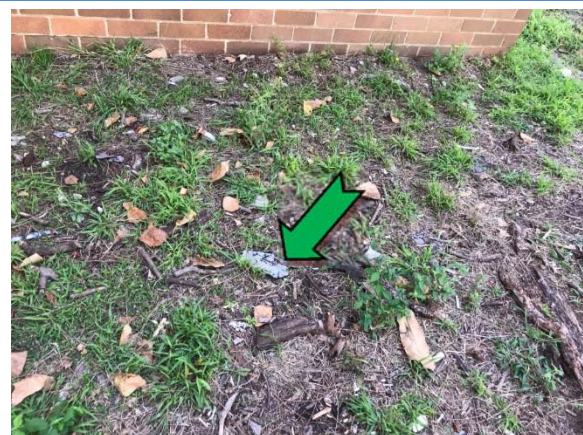
Photo 6. Exterior, west elevation, ground, debris – non asbestos-containing bituminous material.

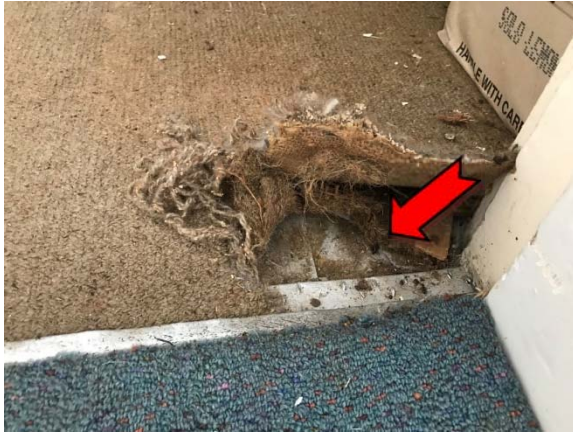
Photo 7. Interior, occupational therapy room, beneath carpet, throughout – asbestos-containing vinyl floor tiles.

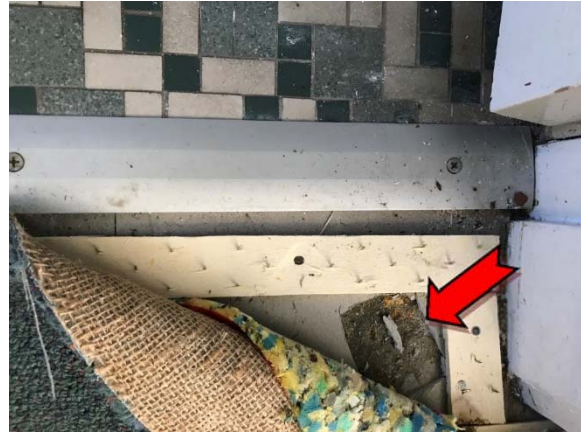
Photo 8. Interior, foyer, beneath carpet, throughout – asbestos-containing vinyl floor tiles.

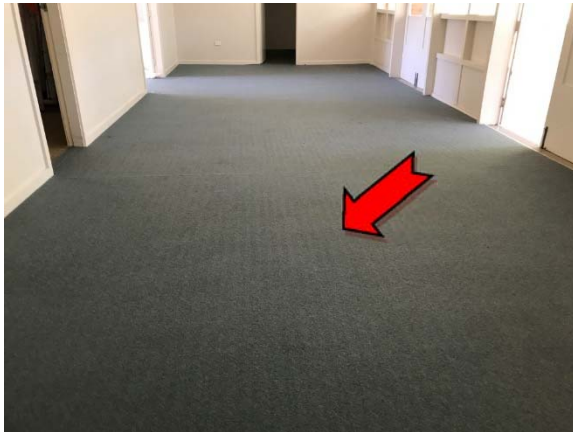
Photo 9. Interior, open room, beneath carpet, throughout – asbestos-containing vinyl floor tiles.

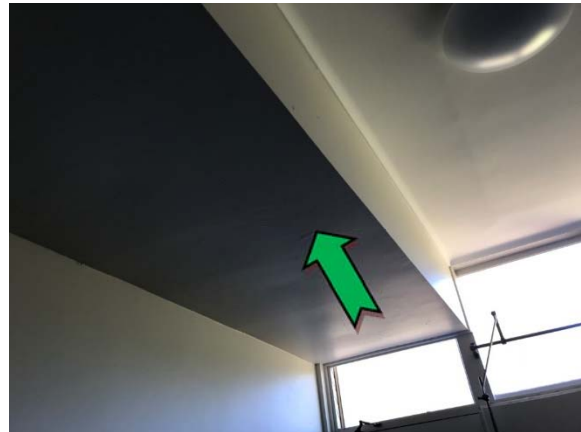
Photo 10. Interior, male toilets, high level boxing – non asbestos-containing fibre cement sheeting.

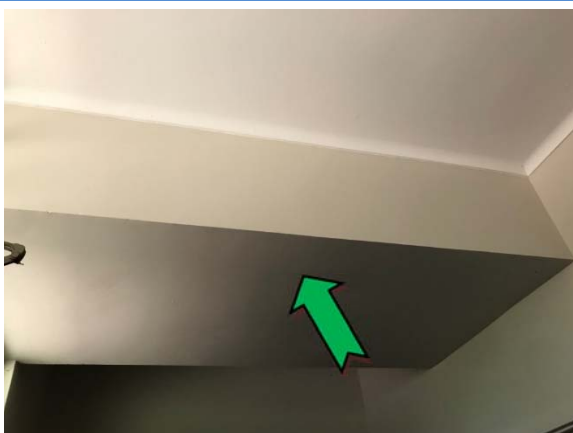
Photo 11. Interior, female toilets, high level boxing – non asbestos-containing fibre cement sheeting.

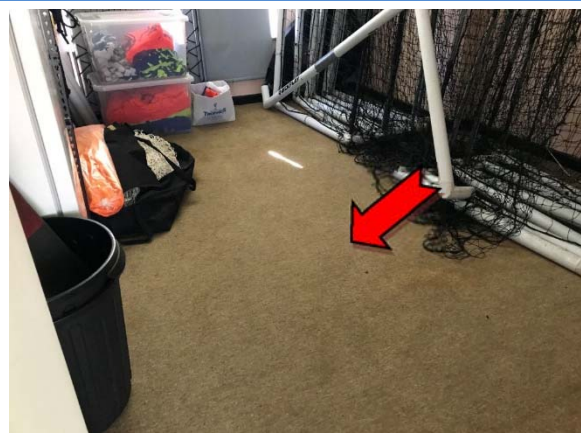
Photo 12. Interior, room 3, beneath carpet, throughout – asbestos-containing vinyl floor tiles.

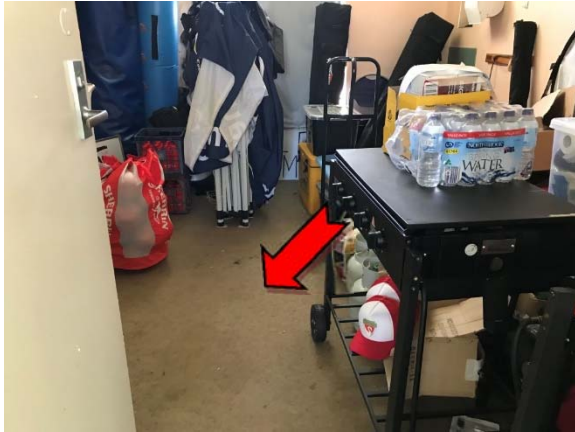
Photo 13. Interior, room 2, beneath carpet, throughout – assumed asbestos-containing vinyl floor tiles.

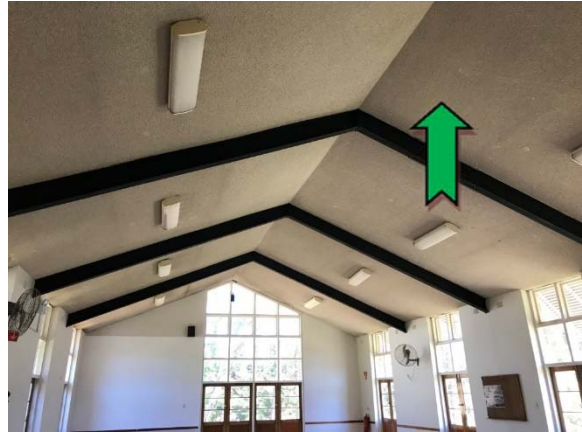
Photo 14. Interior, hall, ceiling, throughout – non asbestos-containing vermiculite.

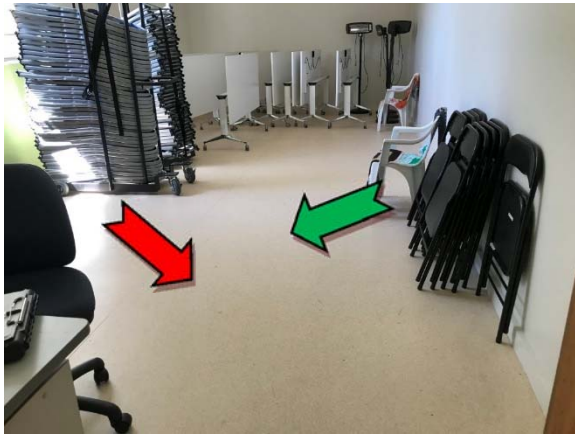
Photo 15. Interior, room 1, floor, throughout – non asbestos-containing sheet vinyl and asbestos-containing vinyl floor tiles (beneath sheet vinyl).

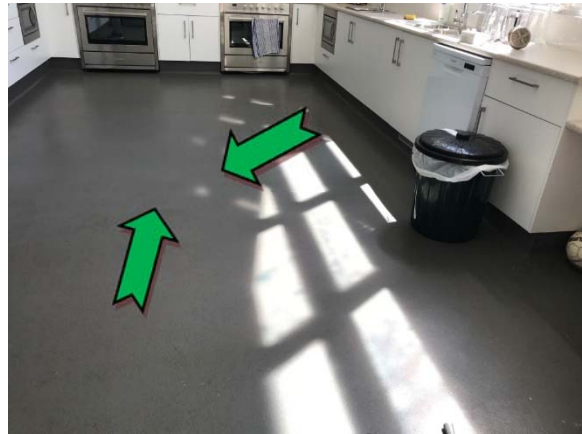
Photo 16. Interior, kitchen, floor – suspected non asbestos-containing sheet vinyl; non asbestos-containing vinyl floor tiles and screed (beneath sheet vinyl).

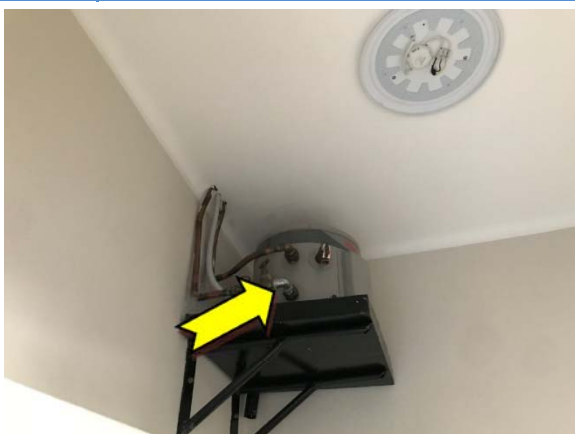
Interior	Female toilets	Hot water heater	Insulation material - internal	SMF	-	Suspected Positive	Bonded	Low	Good	Low	1 unit	Maintain in current condition if to remain in-situ. Remove under controlled SMF conditions as per the Code of Practice for the Safe Use of Synthetic Mineral Fibres [NOHSC: 2006 (1990)].	-	-	17

Photo 17. Interior, female toilets, hot water heater – suspected SMF internal insulation material.

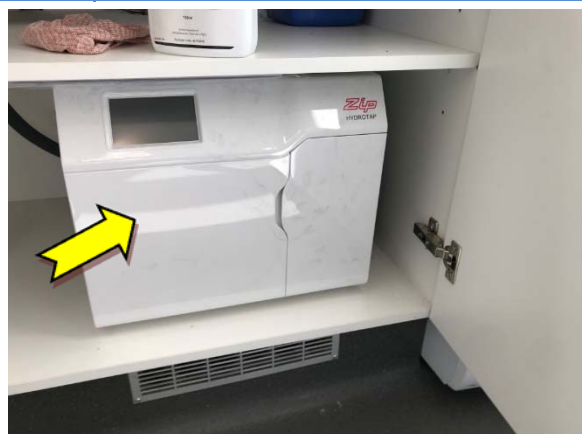
Photo 18. Interior, kitchen, under sink, hot water heater – suspected SMF internal insulation material.

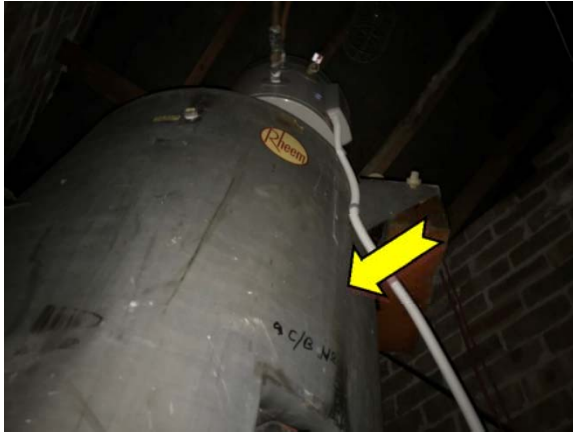
Photo 19. Interior, kitchen, ceiling space, hot water heater – suspected SMF internal insulation material.

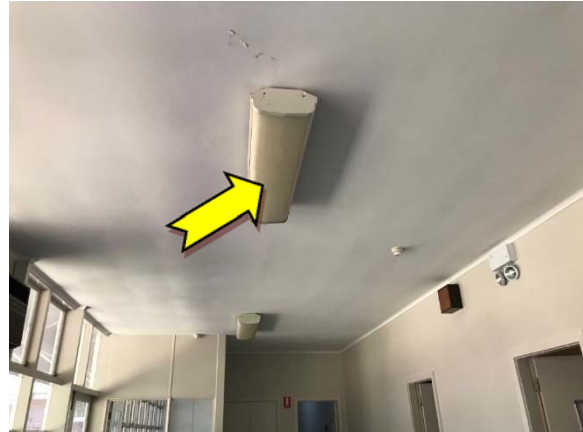
Photo 20. Interior, throughout, quadruple tubed fluorescent light fitting – suspected PCB-containing capacitors.

- Electrical fittings that contain or suspected to contain PCB oil-containing capacitors should be removed as hazardous/regulated waste under controlled working conditions prior to the demolition or refurbishment works in accordance with the *Polychlorinated Biphenyls Management Plan, Revised Edition April 2003*.

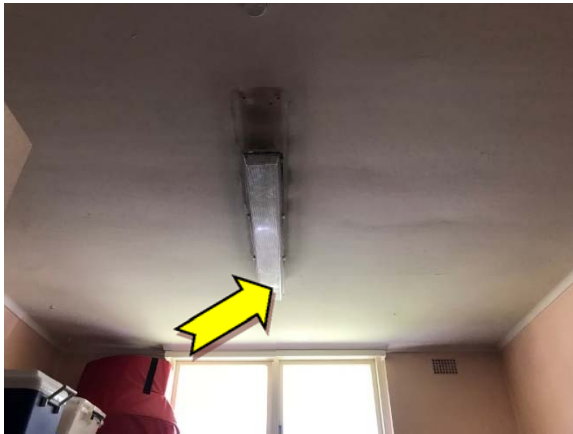
Photo 21. Interior, throughout, double tubed fluorescent light fitting – suspected PCB-containing capacitors.

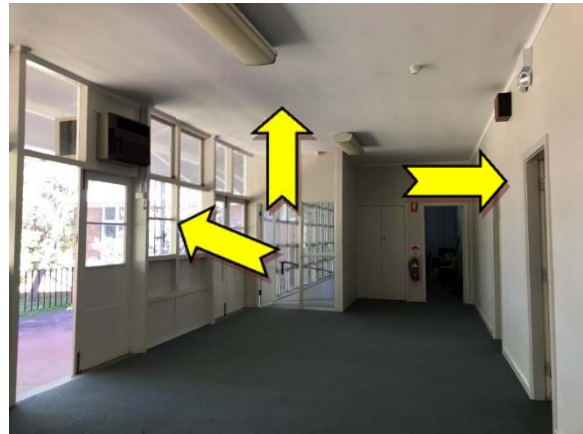
Photo 22. Interior, throughout, walls, window frames and ceiling – suspected lead-containing white upper paint systems.

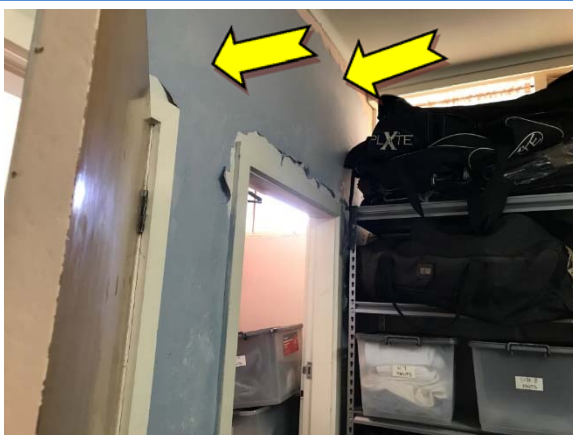
Interior	Occupational therapy room, throughout	Walls	Blue (light) - upper coloured paint system	Lead Paint - Swab	-	Suspected Positive	-	Low	Fair	Low	40 m ²	Confirm status by quantitative test method, remove flaking sections and over paint with a lead-free paint. Remove under controlled conditions in accordance with AS 4361.2:2017 Guide to hazardous paint management prior to renovation or demolition works.	-	-	23
Interior	Occupational therapy room, throughout	Walls	Orange - lower coloured paint system	Lead Paint - Swab	-	Suspected Positive	-	Low	Fair	Low	40 m ²	Confirm status by quantitative test method, remove flaking sections and over paint with a lead-free paint. Remove under controlled conditions in accordance with AS 4361.2:2017 Guide to hazardous paint management prior to renovation or demolition works.	-	-	23
Interior	Occupational therapy room, throughout	Walls	White - lower coloured paint system	Lead Paint - Swab	-	Suspected Positive	-	Low	Fair	Low	40 m ²	Confirm status by quantitative test method, remove flaking sections and over paint with a lead-free paint. Remove under controlled conditions in accordance with AS 4361.2:2017 Guide to hazardous paint management prior to renovation or demolition works.	-	-	-

Photo 23. Interior, occupational therapy room, walls – suspected lead-containing blue upper and orange lower coloured paint systems.

- Remove flaking lead containing paint to walls throughout the property in accordance with AS4361.2-2017 Guide to Hazardous Paint Management and relevant legislation.

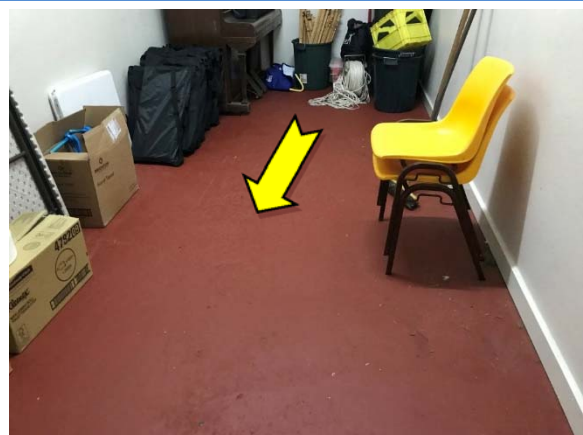
Photo 24. Interior, store, floor – suspected lead-containing red upper paint systems.

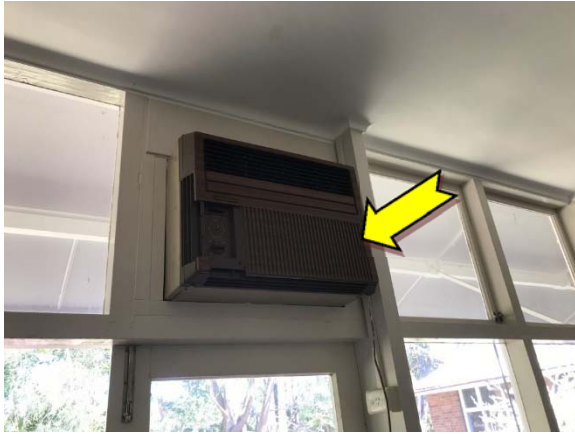
Photo 25. Interior, western elevation, air conditioning unit, unknown refrigerant – suspected ozone depleting substances.

- One air conditioning unit was suspected to containing ODS refrigerant gas at the time of the Assessment.

- If the ozone depleting substances identified on-site unit require removal they should be appropriately decanted and disposed of by a licensed contractor in accordance with the *Ozone Protection and Synthetic Greenhouse Gas Management Amendment Regulation 2017* as amended from time to time.
- In accordance with the Commonwealth Ozone Protection Legislation, Prensa recommends, in line with Australia's commitment to phase out ODS-containing substances that units which are required to be replaced due to their age, damage or functionality, have their ODS-containing refrigerants replaced with a non-ODS alternative such as R410A.
- It is important to note that, if a system which utilises ODS-refrigerants is in good working order, there is no need to transition to an alternative refrigerant/system (until 2029).
