# Hazardous Building Materials Assessment

## Callan Park - Storage

Balmain Road,  
Lilyfield NSW 2040

Inner West Council  
April 2018

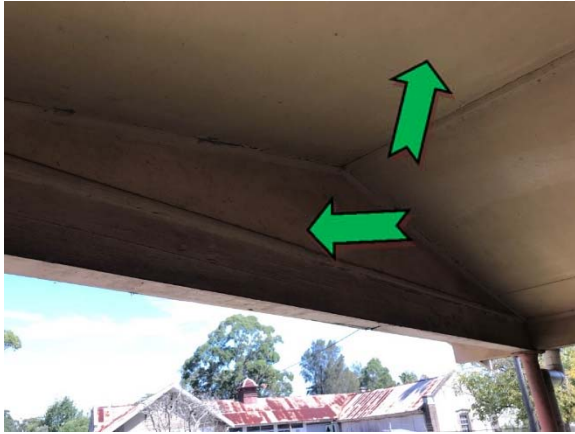
**Photo 1.** Exterior, south elevation, main entrance, awning and fascia – non asbestos-containing fibre cement sheeting.

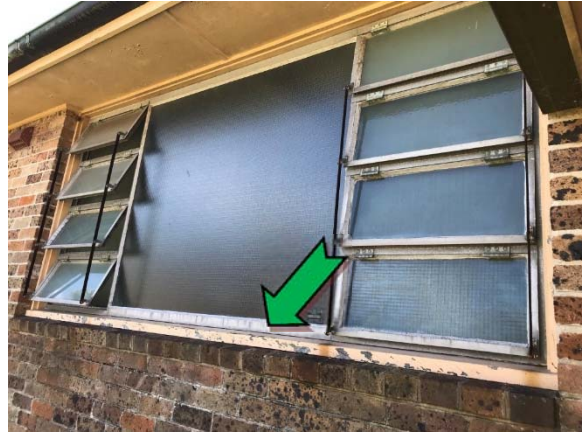
**Photo 2.** Exterior, metal window frames – non asbestos-containing window caulking.

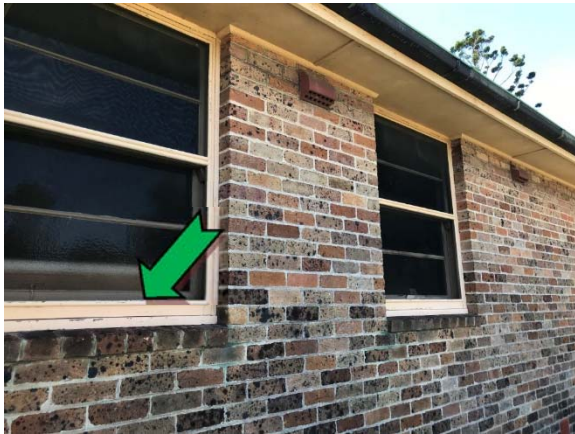
**Photo 3.** Exterior, timber window frames – non asbestos-containing window caulking.

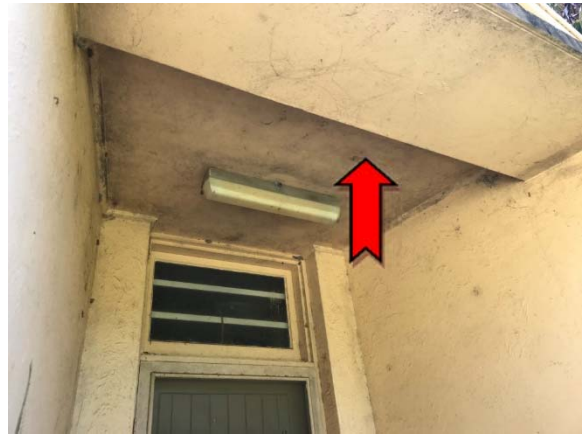
**Photo 4.** Exterior, north elevation, awning – suspected asbestos-containing fibre cement sheeting.

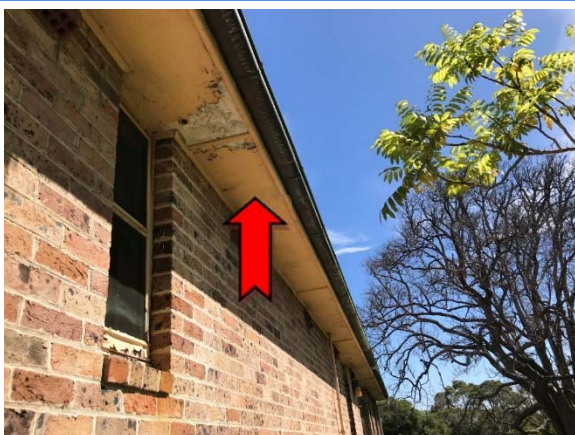
**Photo 5.** Exterior, throughout, eaves – suspected asbestos-containing fibre cement sheeting and suspected lead-containing cream upper paint systems.

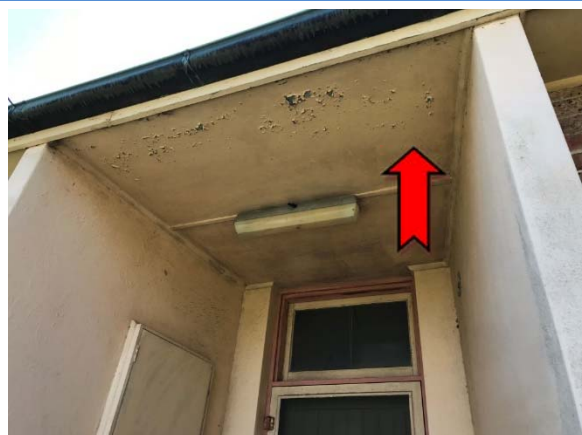
Exterior	Throughout	Eaves	Fibre cement sheeting	Asbestos	Refer to EBG report EBG.HMA-02352.rpt sample 02352/2	Assumed Positive	Non-friable	Low	Good	Low	30 m <sup>2</sup>	Sample noted to be positive for asbestos content by EBG report EBG.HMA-02352.rpt. Label as containing asbestos and maintain in current condition if to remain in-situ. Remove under controlled non-friable asbestos removal conditions prior to refurbishment or demolition works by a Class B (non-friable) licensed asbestos removal contractor.	P4	Feb-23	5
Exterior	South-west elevation	Awning	Fibre cement sheeting	Asbestos	Not sampled: Height restrictions	Suspected Positive	Non-friable	Low	Good	Low	4 m <sup>2</sup>	Confirm status, label as containing asbestos and maintain in current condition if to remain in-situ. Remove under controlled non-friable asbestos removal conditions prior to refurbishment or demolition works by a Class B (non-friable) licensed asbestos removal contractor.	P4	Feb-23	6

**Photo 6.** Exterior, south-west elevation, awning – suspected asbestos-containing fibre cement sheeting.

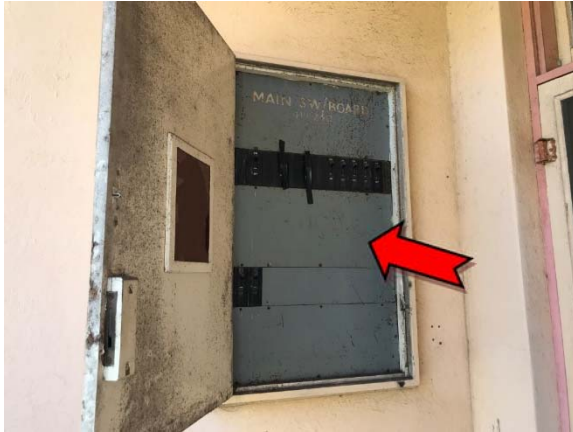
Exterior	South-west elevation	Electrical backing board	Bituminous backing board	Asbestos	Not sampled: Electrical hazard	Suspected Positive	Non-friable	Low	Good	Low	1 unit	Confirm status, label as containing asbestos and maintain in current condition if to remain in-situ. Remove under controlled non-friable asbestos removal conditions prior to refurbishment or demolition works by a Class B (non-friable) licensed asbestos removal contractor.	P4	Feb-23	7
Exterior	South-east elevation	On ground	Debris	Asbestos	57722-158-005	Negative	-	-	-	-	-	-	-	-	8
Interior	West entrance room	Flue	Moulded fibre cement	Asbestos	Refer to EBG report EBG.HMA-02352.rpt	Suspected Positive	Non-friable	Low	Good	Low	1 m	Item not found during PRENSA Assessment. Item noted to be suspected positive for asbestos content by EBG report EBG.HMA-02352.rpt. Confirm status, label as containing asbestos and maintain in current condition if to remain in-situ. Remove under controlled non-friable asbestos removal conditions prior to refurbishment or demolition works by a Class B (non-friable) licensed asbestos removal contractor.	P4	Feb-23	-

**Photo 7.** Exterior, south-west elevation, electrical backing board – suspected asbestos-containing bituminous backing board.

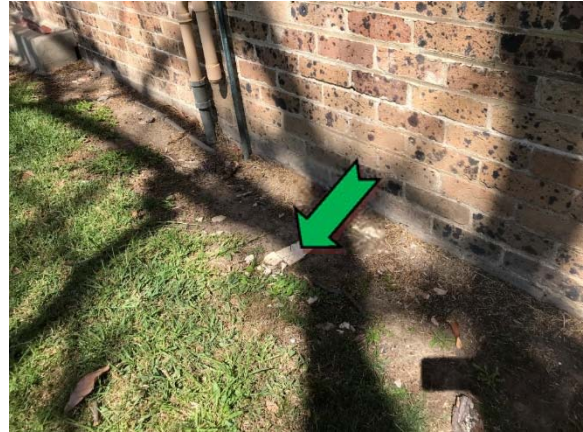
**Photo 8.** Exterior, south-west elevation, ground – non asbestos-containing debris.

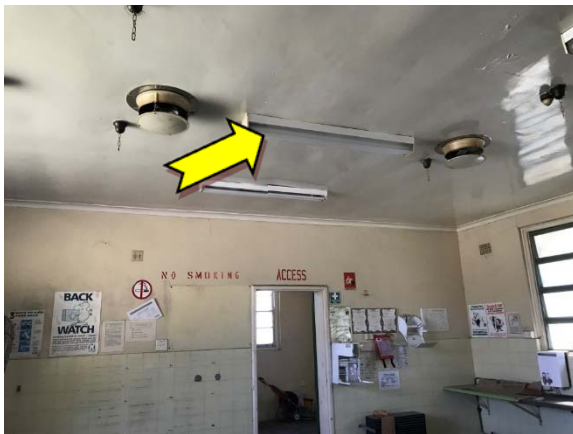
Throughout	-	-	-	SMF	-	-	-	-	-	-	-	No suspect SMF material identified at the time of the assessment.	-	-	-
Exterior	Throughout	Fluorescent light fitting - single tube	Capacitor	PCBs	Not sampled: Electrical hazard	Suspected Positive	-	-	-	-	2 units	PCB-containing capacitors are suspected due to age & appearance of electrical fittings. Remove and dispose of in accordance with the Polychlorinated Biphenyls Management Plan, Revised Edition April 2003.	-	-	-
Interior	Throughout	Fluorescent light fitting - double tube	Capacitor	PCBs	Not sampled: Electrical hazard	Suspected Positive	-	-	-	-	6 units	PCB-containing capacitors are suspected due to age & appearance of electrical fittings. Remove and dispose of in accordance with the Polychlorinated Biphenyls Management Plan, Revised Edition April 2003.	-	-	9

**Photo 9.** Interior, throughout, double tubed fluorescent light fitting – suspected PCB-containing capacitor.

- Electrical fittings suspected of containing PCB oil capacitors should be treated as containing PCB oils until such time as evidence suggest otherwise e.g. further assessed.
- Electrical fittings that contain or suspected to contain PCB oil-containing capacitors should be removed as hazardous/regulated waste under controlled working conditions prior to the demolition or refurbishment works in accordance with the *Polychlorinated Biphenyls Management Plan, Revised Edition April 2003*.

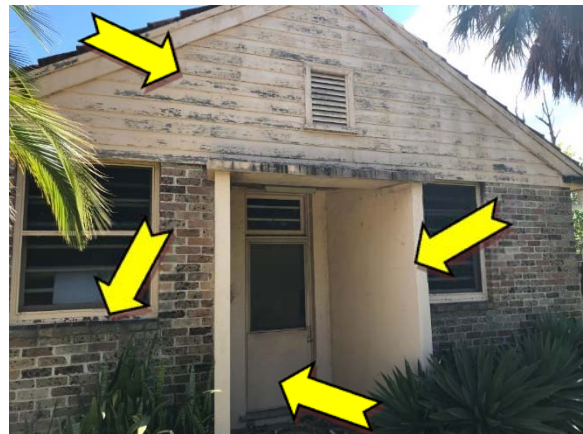
Area / Level	Room & Location	Feature	Item Description	Hazard Type	Sample No.	Sample Status	Friability	Disturb. Potential	Condition	Risk Status	Approx. Quantity	Recommendations & Comments	Control Priority	Reinspect Date	Photo No.
Exterior	Throughout	Eaves	Cream - upper coloured paint system	Lead Paint - Swab	-	Suspected Positive	-	Low	Poor	Medium	30 m <sup>2</sup>	Confirm status by quantitative test method, remove flaking sections and over paint with a lead-free paint. Remove under controlled conditions in accordance with AS 4361.2:2017 Guide to hazardous paint management prior to renovation or demolition works.	-	-	5
Exterior	Throughout	Features	Cream - upper coloured paint system	Lead Paint - Swab	-	Suspected Positive	-	Low	Poor	Medium	60 m <sup>2</sup>	Confirm status by quantitative test method, remove flaking sections and over paint with a lead-free paint. Remove under controlled conditions in accordance with AS 4361.2:2017 Guide to hazardous paint management prior to renovation or demolition works.	-	-	10

**Photo 10.** Exterior, throughout, window frames, doors, gable and features – suspected lead-containing cream upper coloured paint systems.

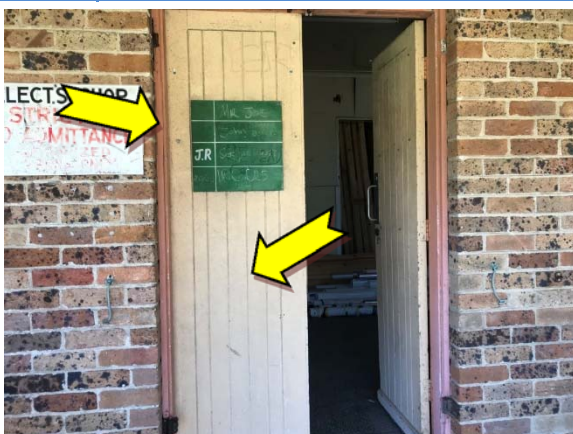
Exterior	Throughout	Windows & doors	Cream - upper coloured paint system	Lead Paint - Swab	-	Suspected Positive	-	Low	Poor	Medium	40 m <sup>2</sup>	Confirm status by quantitative test method, remove flaking sections and over paint with a lead-free paint. Remove under controlled conditions in accordance with AS 4361.2:2017 Guide to hazardous paint management prior to renovation or demolition works.	-	-	10
Exterior	Throughout	Gable	Cream - upper coloured paint system	Lead Paint - Swab	-	Suspected Positive	-	Low	Poor	Medium	8 m <sup>2</sup>	Confirm status by quantitative test method, remove flaking sections and over paint with a lead-free paint. Remove under controlled conditions in accordance with AS 4361.2:2017 Guide to hazardous paint management prior to renovation or demolition works.	-	-	10
Exterior	Throughout	Door frame	Orange - upper coloured paint system	Lead Paint - Swab	-	Suspected Positive	-	Low	Fair	Low	20 m <sup>2</sup>	Confirm status by quantitative test method, remove flaking sections and over paint with a lead-free paint. Remove under controlled conditions in accordance with AS 4361.2:2017 Guide to hazardous paint management prior to renovation or demolition works.	-	-	11

**Photo 11.** Exterior, throughout door and door frames – suspected lead-containing orange and cream upper coloured paint systems.

- Remove flaking lead containing paint to window surrounds throughout the property in accordance with AS4361.2-2017 Guide to Hazardous Paint Management and relevant legislation.

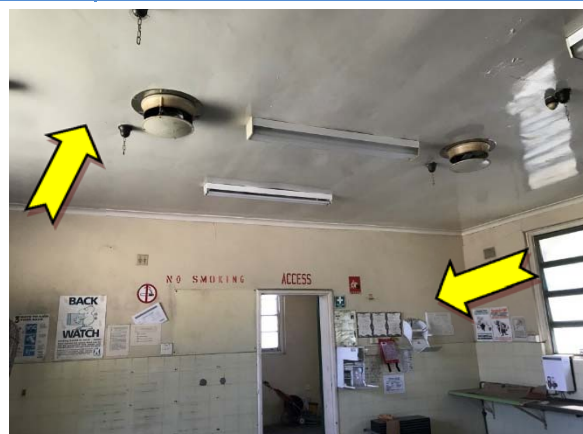
Exterior	Throughout	Door	Cream - upper coloured paint system	Lead Paint - Swab	-	Suspected Positive	-	Low	Fair	Low	4 m <sup>2</sup>	Confirm status by quantitative test method, remove flaking sections and over paint with a lead-free paint. Remove under controlled conditions in accordance with AS 4361.2:2017 Guide to hazardous paint management prior to renovation or demolition works.	-	-	11
Interior	Throughout	Walls	Yellow - upper coloured paint system	Lead Paint - Swab	-	Suspected Positive	-	Low	Fair	Low	300 m <sup>2</sup>	Confirm status by quantitative test method, remove flaking sections and over paint with a lead-free paint. Remove under controlled conditions in accordance with AS 4361.2:2017 Guide to hazardous paint management prior to renovation or demolition works.	-	-	12
Interior	Throughout	Ceiling	White - upper coloured paint system	Lead Paint - Swab	-	Suspected Positive	-	Low	Fair	Low	150 m <sup>2</sup>	Confirm status by quantitative test method, remove flaking sections and over paint with a lead-free paint. Remove under controlled conditions in accordance with AS 4361.2:2017 Guide to hazardous paint management prior to renovation or demolition works.	-	-	12

**Photo 12.** Interior, throughout, walls and ceiling – suspected lead-containing yellow and white upper coloured paint systems.
