# Hazardous Building Materials Assessment

## Callan Park - Toilets

### Balmain Road

Inner West Council  
April 2018

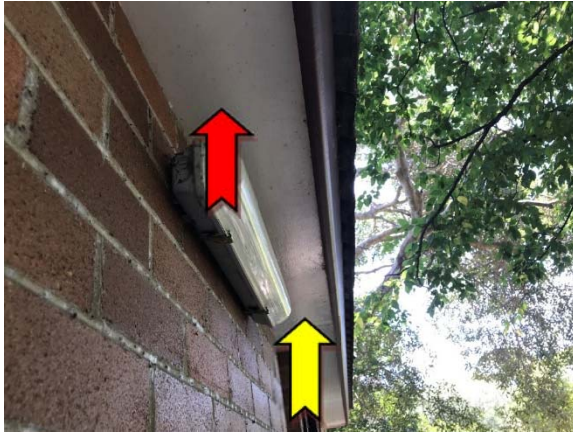
**Photo 1.** Exterior, throughout, eaves – asbestos-containing fibre cement sheeting and suspected lead-containing white upper paint systems.

- Non-friable asbestos was identified in the form of fibre cement sheeting to the eaves of the building at the time of the Assessment.

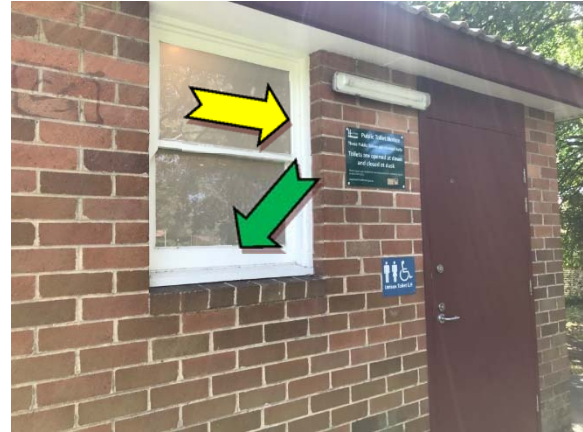
**Photo 2.** Exterior, throughout, window frames – non asbestos-containing window caulking and suspected lead-containing white upper paint systems.

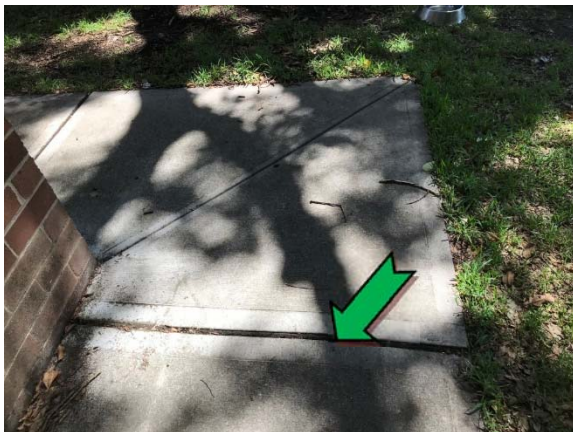
**Photo 3.** Exterior, throughout, ground, expansion joint – non asbestos-containing construction joint mastic.

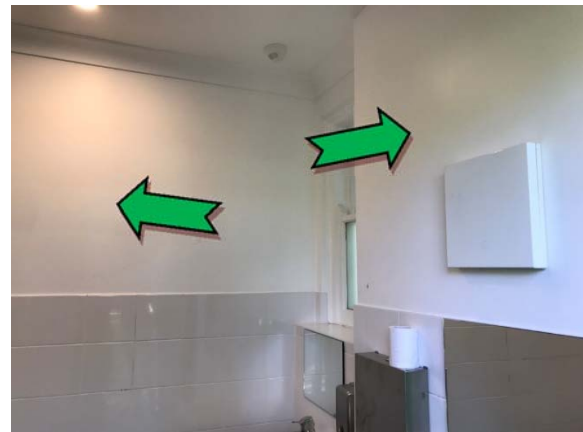
**Photo 4.** Interior, disabled toilets, north and west wall – non asbestos-containing fibre cement sheeting.

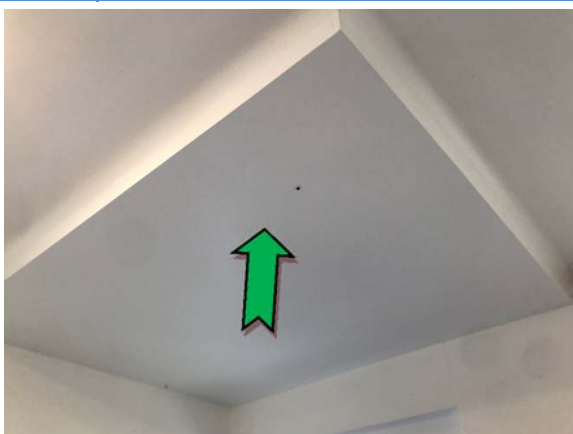
**Photo 5.** Interior, disabled toilets, boxing – non asbestos-containing fibre cement sheeting.

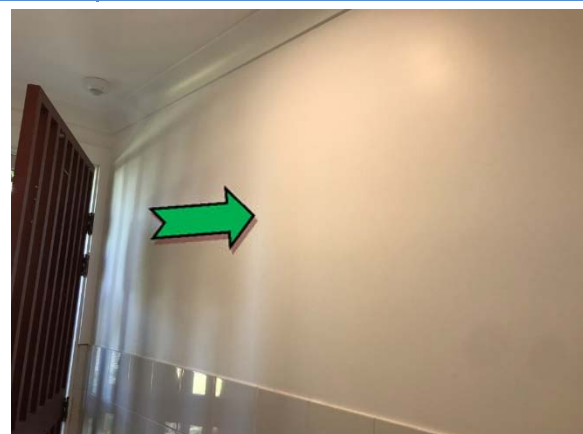
**Photo 6.** Interior, ladies toilet, east wall – non asbestos-containing fibre cement sheeting.

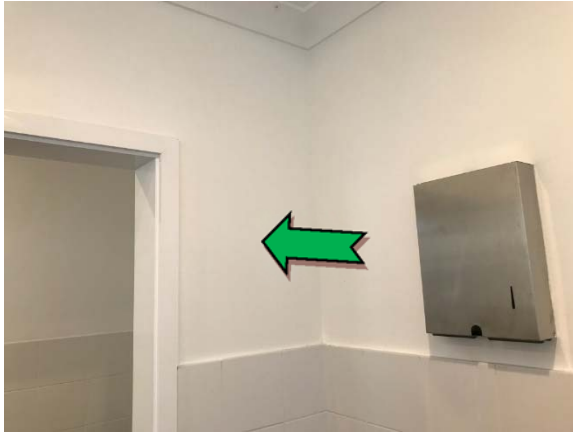
**Photo 7.** Ladies toilet lobby, south end, west elevation, wall – non asbestos-containing fibre cement sheeting.

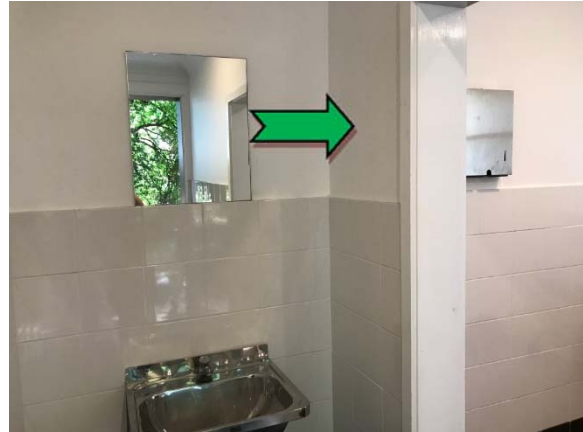
**Photo 8.** Ladies toilet lobby, south end, east elevation, wall – non asbestos-containing fibre cement sheeting.

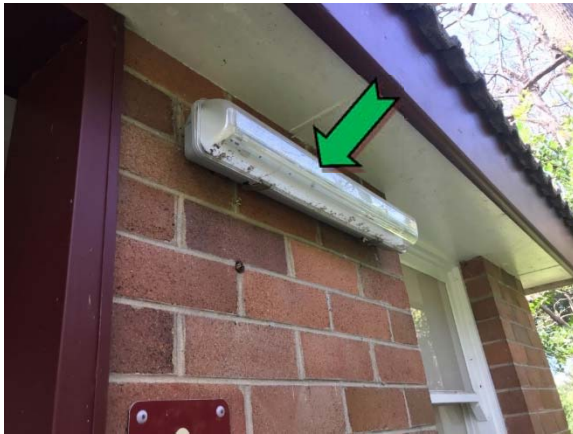
**Photo 9.** Exterior, throughout, single tubed fluorescent light fittings – suspected non PCB-containing capacitors.

- Electrical fittings suspected of containing PCB oil capacitors should be treated as containing PCB oils until such time as evidence suggest otherwise e.g. further assessed.
- Electrical fittings that contain or suspected to contain PCB oil-containing capacitors should be removed as hazardous/regulated waste under controlled working conditions prior to the demolition or refurbishment works in accordance with the *Polychlorinated Biphenyls Management Plan, Revised Edition April 2003*.

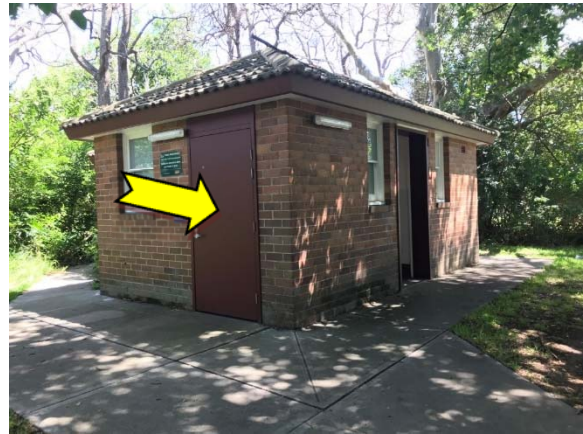
**Photo 10.** Exterior, throughout, door – suspected lead-containing red upper paint systems.

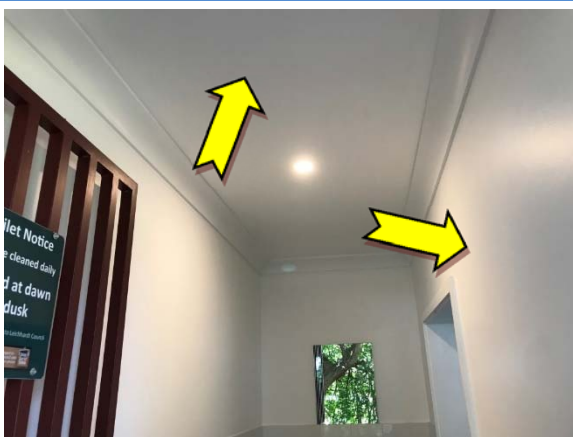
**Photo 11.** Interior, throughout, walls and ceilings – suspected lead-containing white upper coloured paint systems.
