Hazardous Building Materials Assessment Cecily Street Community Centre 19 Cecily Street, Lilyfield NSW 2040

Inner West Council
April 2018

Job No.: 57722-027

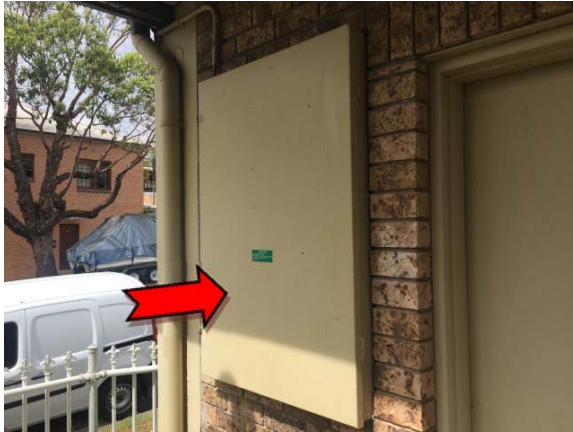
Photo 1. Exterior, north-east elevation, electrical backing board – suspected asbestos-containing bituminous backing board.

- Non-friable asbestos in the form of bituminous backing board was suspected in the electrical backing board located to the north-east exterior of the building.
- No clearance paperwork is known to exist for the removal of ACMs noted in the EBG report. As such, an assumption must be made that the asbestos-containing roof, gutters and flashing remain *in-situ* until such a time as a clearance certificate can be produced to show material has been removed as per current standards.

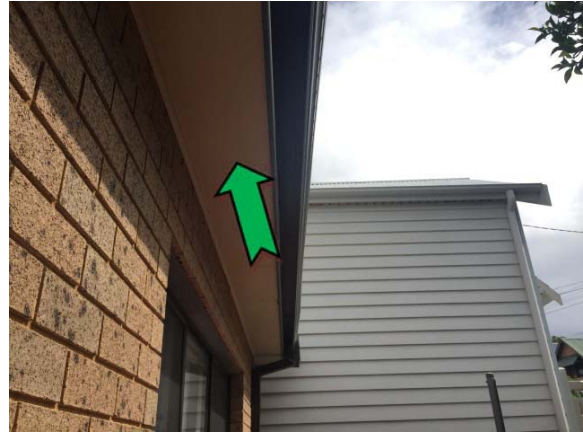
Photo 2. Exterior, north corner, eaves – non asbestos-containing fibre cement sheeting and suspected lead-containing cream upper paint systems.

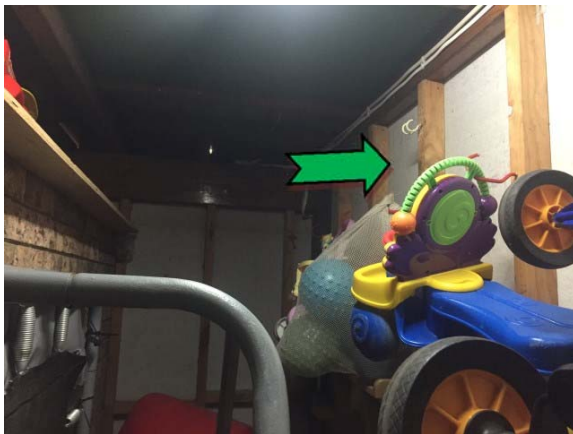
Photo 3. Interior, north store room, throughout, internal walls – non asbestos-containing fibre cement sheeting.

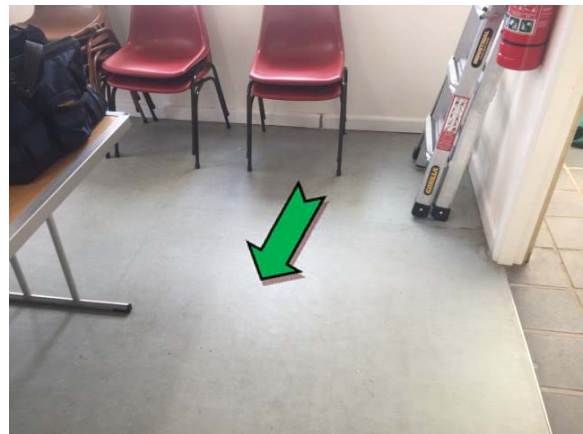
Photo 4. Interior, meeting room, light blue floor coverings – non asbestos-containing sheet vinyl.

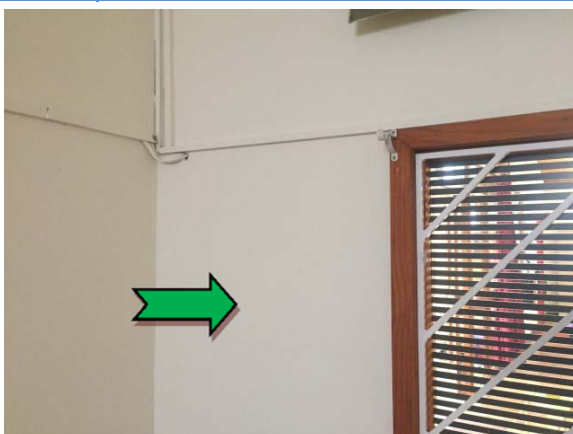
Photo 5. Interior, quiet room, southern wall – non asbestos-containing fibre cement sheeting.

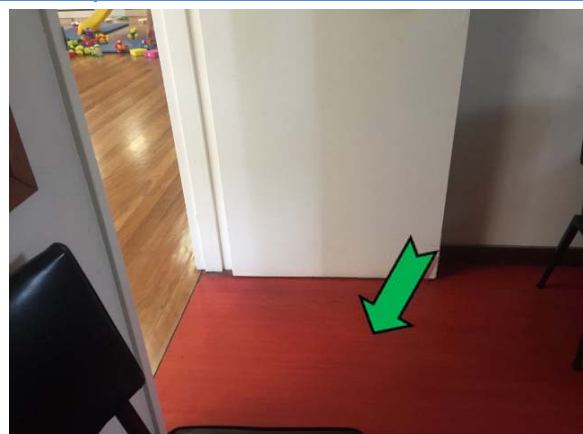
Photo 6. Interior, quiet room, throughout, red floor coverings – non asbestos-containing sheet vinyl.

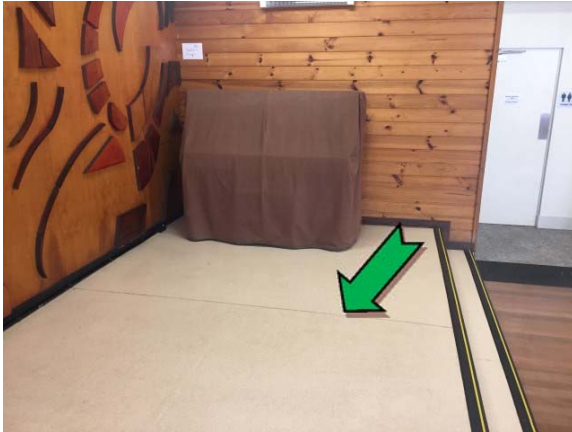
Photo 7. Interior, hall stage, cream floor coverings – non asbestos-containing sheet vinyl.

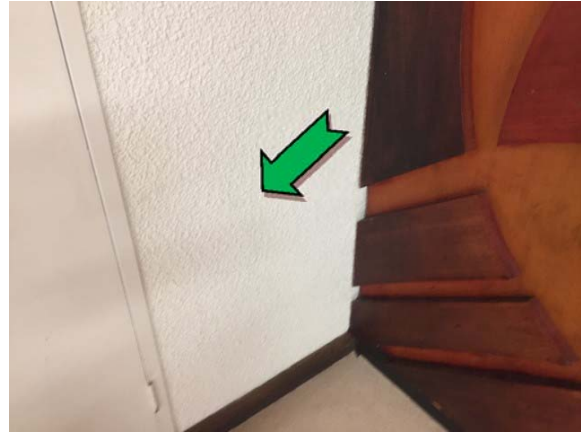
Photo 8. Interior, hall, eastern and northern elevation, walls – non asbestos-containing textured coatings.

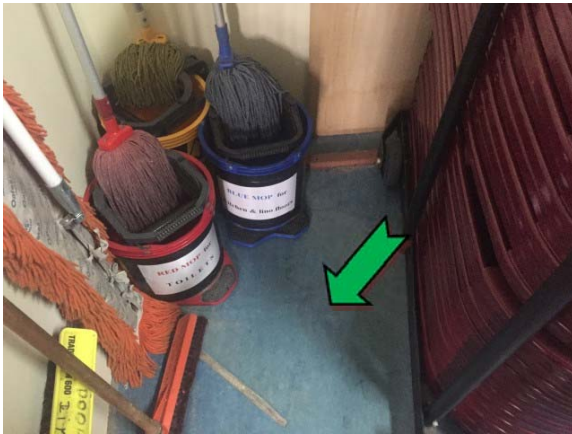
Photo 9. Interior, western store room, blue floor coverings – non asbestos-containing sheet vinyl.

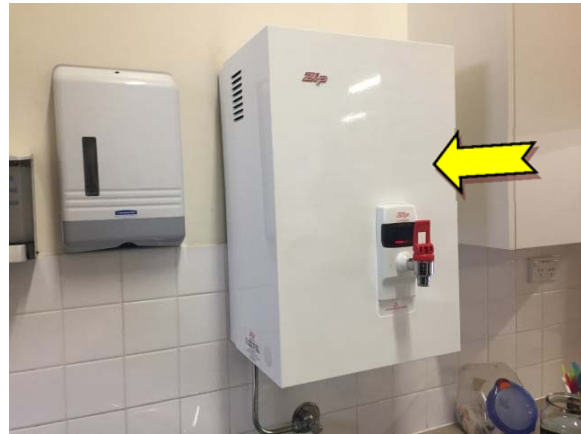
Photo 10. Interior, kitchen, east wall, above sink, hot water boiler – suspected SMF internal insulation material.

- SMF materials that are likely to be disturbed during any proposed demolition/refurbishment works should be handled in accordance with the *Code of Practice for the Safe Use of Synthetic Mineral Fibres* [NOHSC:2006(1990)]. If these materials are impacted upon by accident or by pre-planned works, the Inner West Council must be informed via the contact detailed within Section 7: *Accidental Disturbance of Known or Suspected Hazardous Building Materials*. Following disturbance, inspection by a competent person should be undertaken.

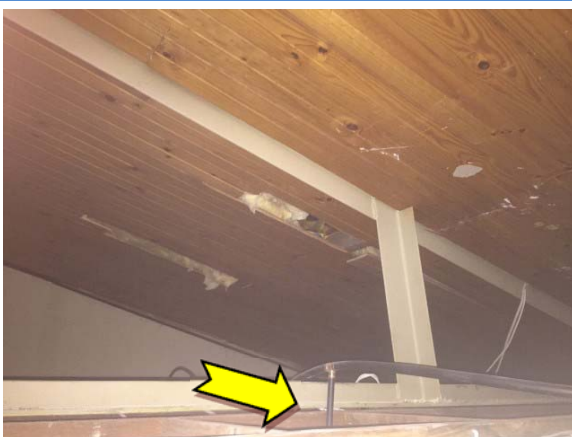
Photo 11. Interior, roof space, throughout, insulation – suspected SMF insulation batts.

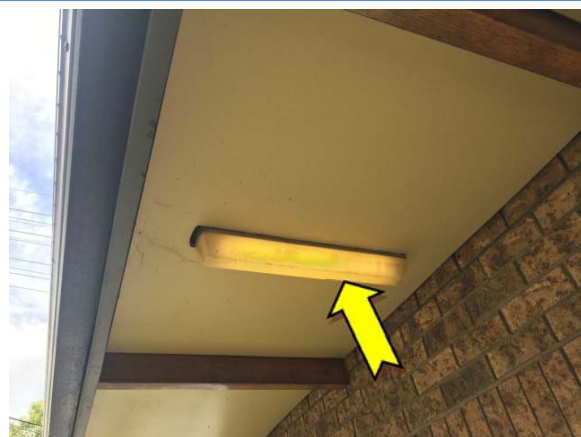
Photo 12. Exterior, north-east elevation, to covered play area, single tubed fluorescent light fittings – suspected PCB-containing capacitors.

- Electrical fittings suspected of containing PCB oil capacitors should be treated as containing PCB oils until such time as evidence suggest otherwise e.g. further assessed.
- Electrical fittings that contain or suspected to contain PCB oil-containing capacitors should be removed as hazardous/regulated waste under controlled working conditions prior to the demolition or refurbishment works in accordance with the *Polychlorinated Biphenyls Management Plan, Revised Edition April 2003*.

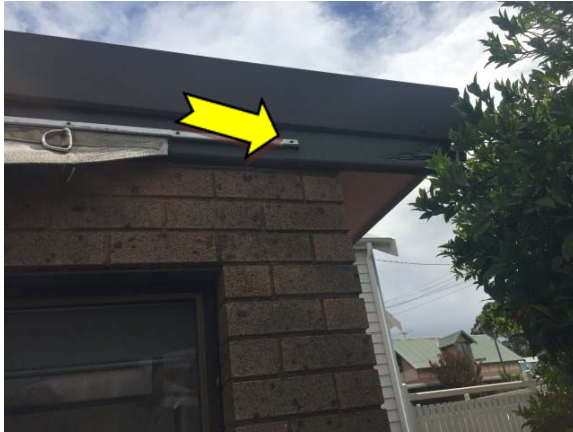
Photo 13. Exterior, throughout, decorative skirting to eaves – suspected lead-containing dark green upper paint systems.

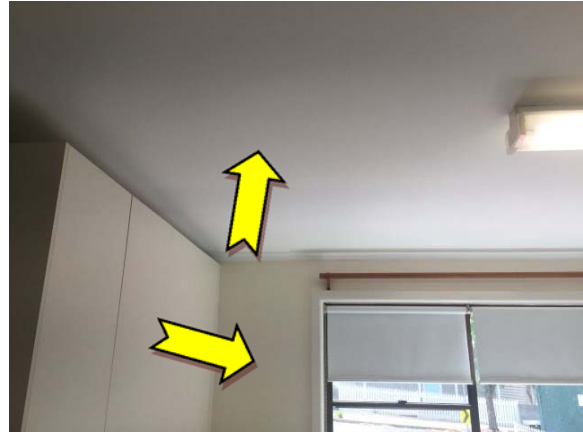
Photo 14. Interior, meeting room, ceiling and walls – suspected lead-containing white and cream upper coloured paint systems.

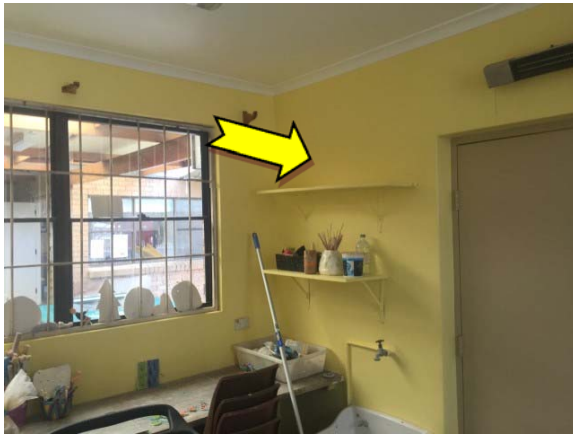
Photo 15. Interior, ceramics room, walls – suspected lead-containing light yellow upper paint systems.
