Hazardous Building Materials Assessment Leichhardt Park - Caretakers Cottage 66 Mary Street, Lilyfield NSW 2040

Inner West Council
April 2018

Job No.: 57722-153

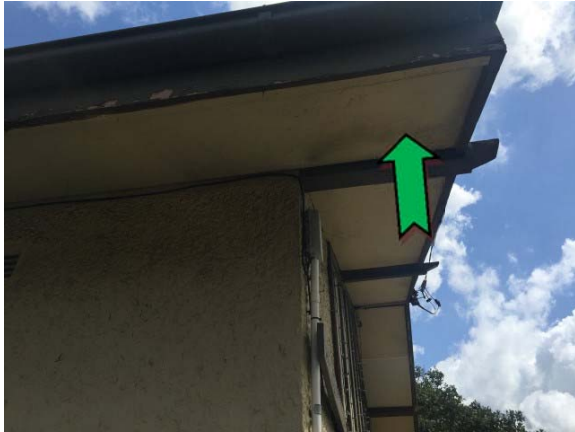
Photo 1. Exterior, throughout, eaves – non asbestos-containing fibre cement sheeting.

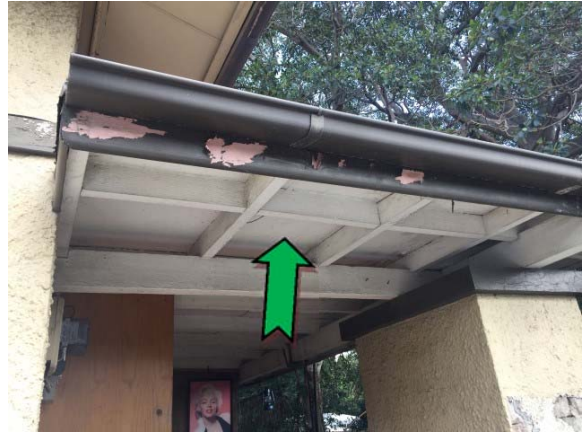
Photo 2. Exterior, north-east corner, awning – non asbestos-containing fibre cement sheeting.

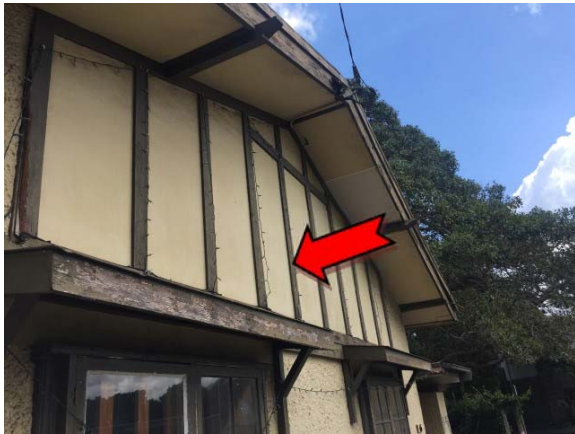
Photo 3. Exterior, east elevation, gable – asbestos-containing fibre cement sheeting.

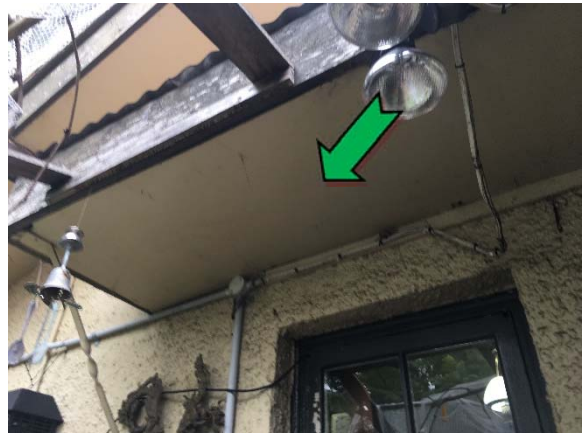
Photo 4. Exterior, rec room, new extension, north, south and west elevation, eaves – non asbestos-containing fibre cement sheeting.

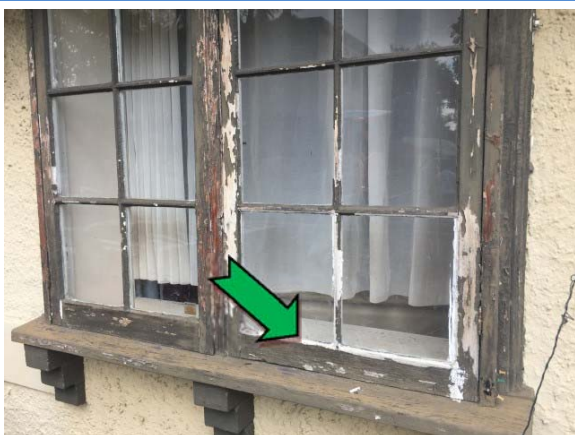
Photo 5. Exterior, throughout, window frames – non asbestos-containing window caulking.

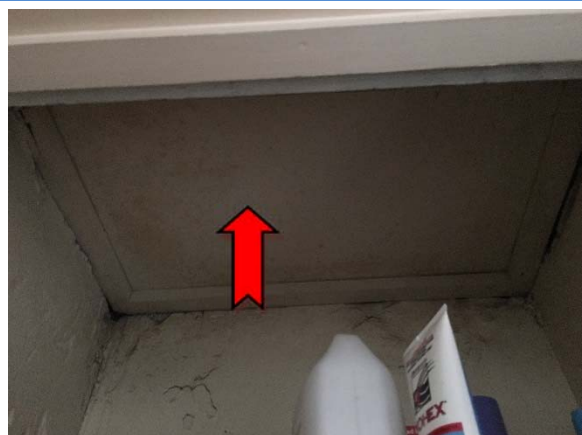
Photo 6. Interior, cupboard, infill panel to form ceiling – suspected asbestos-containing fibre cement sheeting.

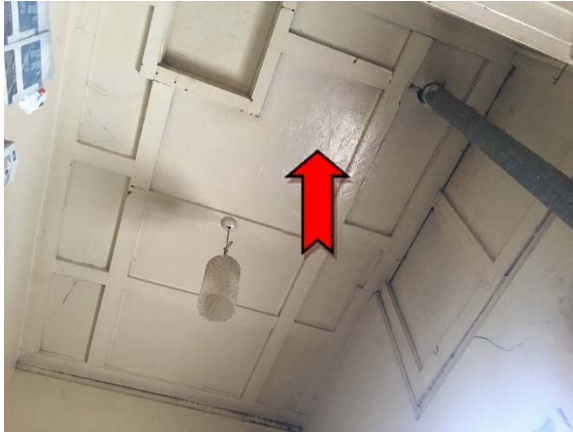
Photo 7. Interior, washroom, ceiling – suspected asbestos-containing fibre cement sheeting.

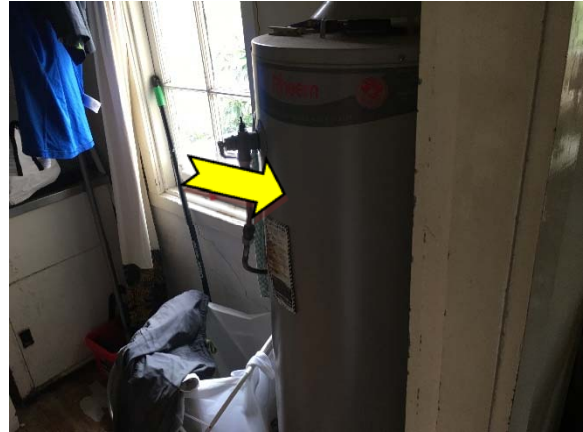
Photo 8. Interior, washroom, hot water heater – suspected SMF internal insulation material.

- SMF materials that are likely to be disturbed during any proposed demolition/refurbishment works should be handled in accordance with the *Code of Practice for the Safe Use of Synthetic Mineral Fibres* [NOHSC:2006(1990)]. If these materials are impacted upon by accident or by pre-planned works, the Inner West Council must be informed via the contact detailed within Section 7: *Accidental Disturbance of Known or Suspected Hazardous Building Materials*. Following disturbance, inspection by a competent person should be undertaken.

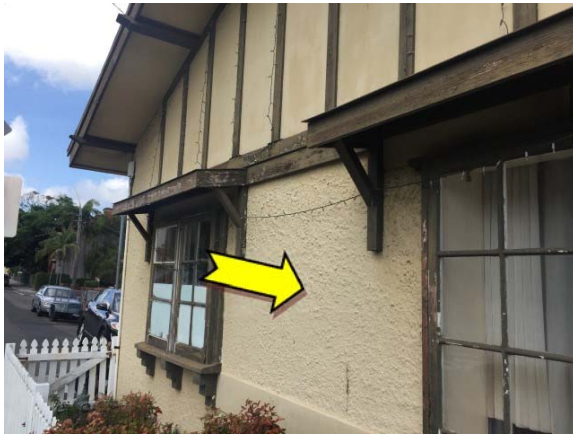
Photo 9. Exterior, throughout, walls – suspected lead-containing cream upper paint systems.

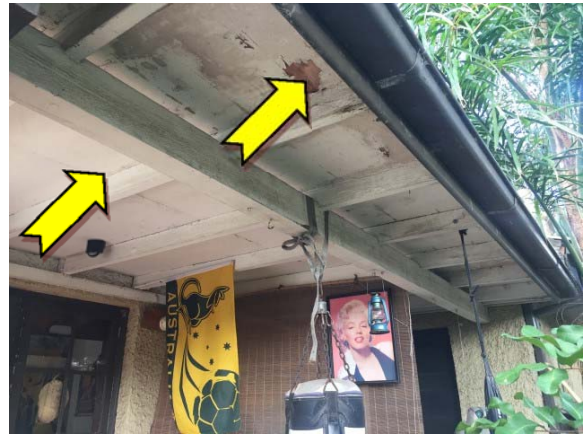
Exterior	North-east elevation	Awning	Pink - lower coloured paint system	Lead Paint - Swab	-	Suspected Positive	-	Low	Fair	Low	15m ²	Confirm status by quantitative test method, remove flaking sections and over paint with a lead-free paint. Remove under controlled conditions in accordance with AS 4361.2:2017 Guide to hazardous paint management prior to renovation or demolition works.	-	-	10
Exterior	Throughout	Skirting board	Brown - upper coloured paint system	Lead Paint - Swab	-	Suspected Positive	-	Low	Fair	Low	40m	Confirm status by quantitative test method, remove flaking sections and over paint with a lead-free paint. Remove under controlled conditions in accordance with AS 4361.2:2017 Guide to hazardous paint management prior to renovation or demolition works.	-	-	-
Exterior	Throughout	Fencing	White - upper coloured paint system	Lead Paint - Swab	-	Suspected Positive	-	Low	Good	Low	50m ²	Confirm status by quantitative test method, maintain in current condition, over paint with a lead-free paint as part of ongoing maintenance. Remove under controlled conditions in accordance with AS 4361.2:2017 Guide to hazardous paint management prior to renovation or demolition works.	-	-	11

Photo 10. Exterior, throughout, north-east awning – suspected lead-containing white upper and pink lower coloured paint systems.

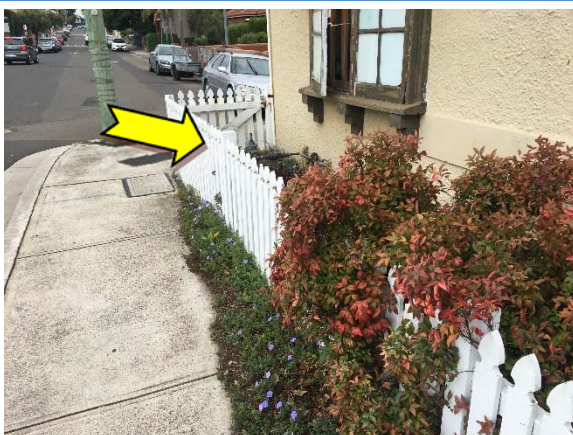
Photo 11. Exterior, throughout, fence – suspected lead-containing white upper paint systems.

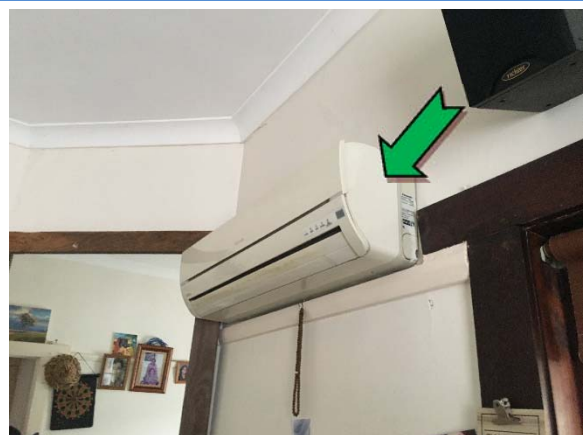
Photo 12. Interior, living room, air conditioning unit – non ODS-containing refrigerant gas.
