Hazardous Building Materials Assessment Leichhardt Oval No.1 Groundsman's Room Mary Street, Lilyfield NSW 2040

Inner West Council
April 2018

Executive Summary

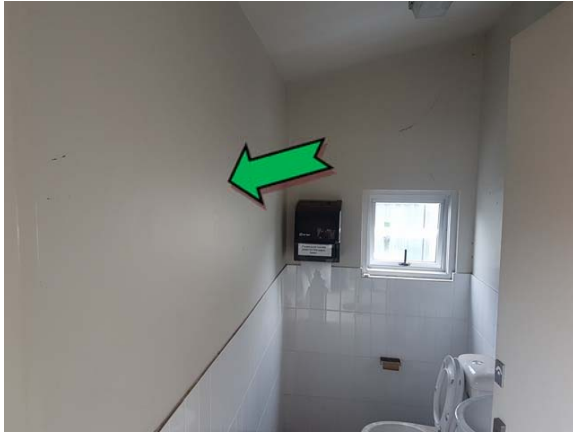
Photo 1. Interior, toilet, throughout, walls – non asbestos-containing fibre cement sheeting.

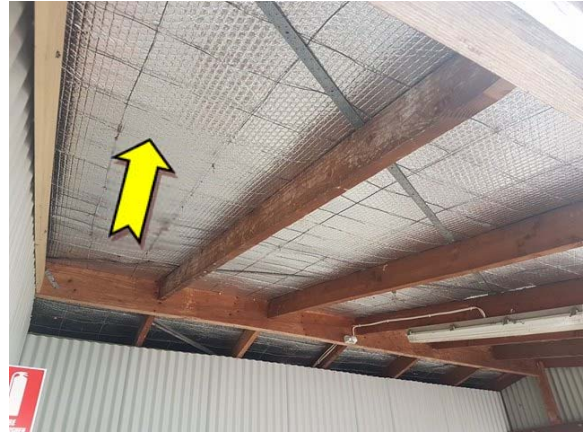
Photo 2. Interior, throughout, underside of roof – suspected SMF sarking insulation material.

- SMF sarking insulation material was suspected to the underside of the roof.

- SMF materials that are likely to be disturbed during any proposed demolition/refurbishment works should be handled in accordance with the *Code of Practice for the Safe Use of Synthetic Mineral Fibres* [NOHSC:2006(1990)]. If these materials are impacted upon by accident or by pre-planned works, the Inner West Council must be informed via the contact detailed within Section 7: *Accidental Disturbance of Known or Suspected Hazardous Building Materials*. Following disturbance, inspection by a competent person should be undertaken.

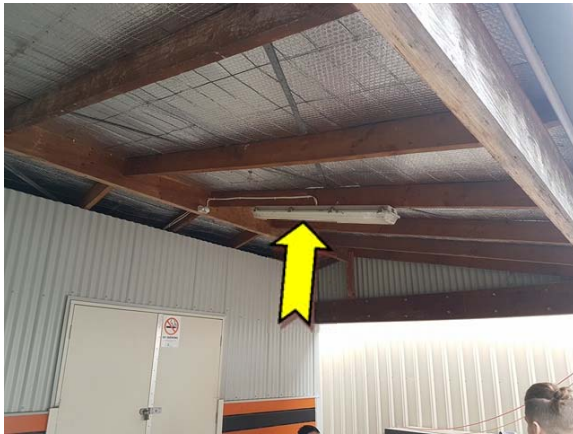
Photo 3. Exterior, throughout, double tubed fluorescent light fitting – suspected PCB-containing capacitors.

- PCBs were suspected within the capacitors of the double tubed fluorescent light fittings located throughout the building.

- Electrical fittings suspected of containing PCB oil capacitors should be treated as containing PCB oils until such time as evidence suggest otherwise e.g. further assessed.
- Electrical fittings that contain or suspected to contain PCB oil-containing capacitors should be removed as hazardous/regulated waste under controlled working conditions prior to the demolition or refurbishment works in accordance with the *Polychlorinated Biphenyls Management Plan, Revised Edition April 2003*.

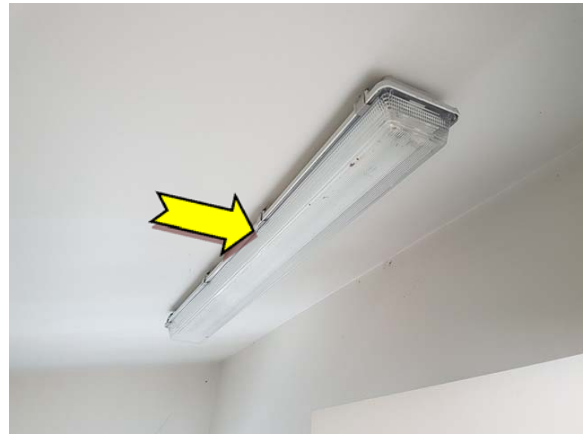
Photo 4. Interior, throughout, double tubed fluorescent light fitting – suspected PCB-containing capacitors.

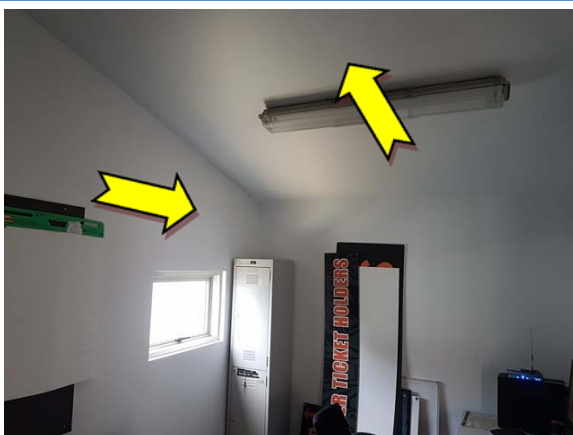
Photo 5. Interior, throughout, walls and ceiling – suspected lead-containing white upper paint systems.

- LCP was suspected in the form of white upper coloured paint systems throughout the interior of the building.

- The safest method of dealing with LCP is to replace or remove the items in their entirety that have LCP on them and replace them with new items that do not contain lead. This allows the items to be disposed of as regular building or demolition unsegregated waste in accordance with the NSW Environment Protection Authority (EPA) *Waste Classification Guidelines 2014 Part 1 – Classifying Waste*. The advantage of this method is the reduction in labour requirements to remove the lead paint and also this reduces the risk to workers from exposure to lead dust or fumes. If the removal of the LCP or coatings is the preferred or required option this may generate significant amounts of potential hazardous waste. This waste must be removed, collected and disposed of by an appropriately licensed contractor under controlled conditions that minimises the release to air, water and soil. Disposal of lead waste must be disposed of as hazardous waste at an approved waste facility.
