Hazardous Building Materials Assessment Leichhardt Oval No. 2 – Toilet Block / Change Room Glover Street, Lilyfield NSW 2040

Inner West Council
April 2018

Executive Summary

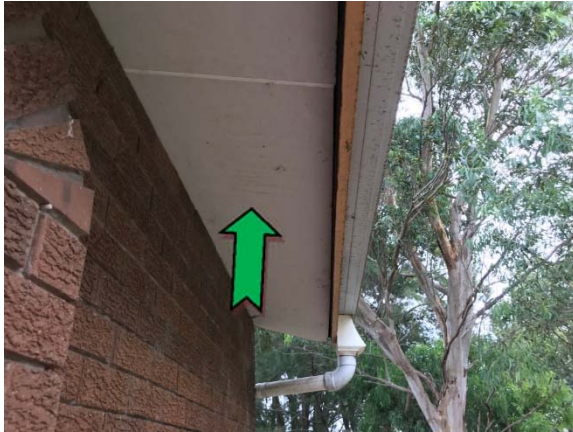
Photo 1. Exterior, west elevation, eaves – non asbestos-containing fibre cement sheeting.

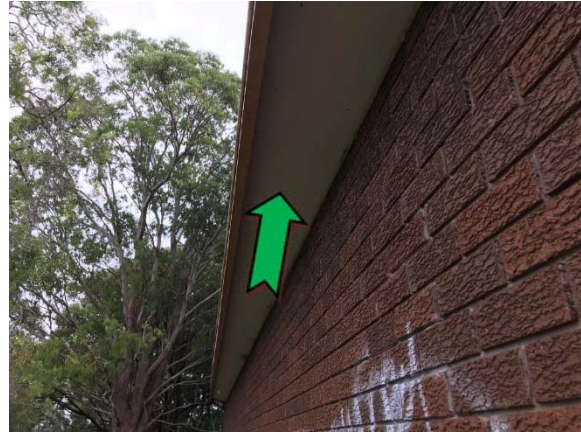
Photo 2. Exterior, east elevation, eaves – assumed non asbestos-containing fibre cement sheeting.

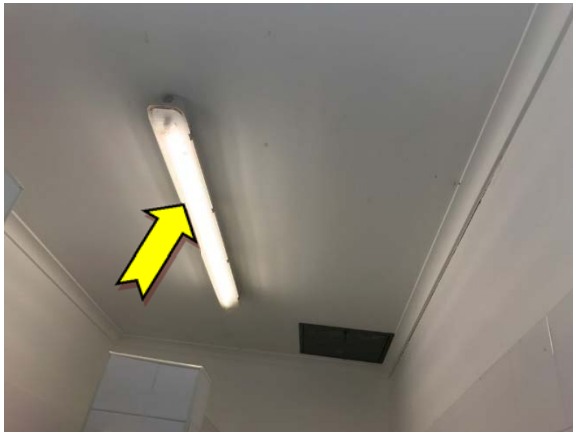
Photo 3. Interior, throughout, single tube fluorescent light fitting – suspected PCB-containing capacitors.

- PCBs were suspected within the capacitors of the single tube fluorescent light fittings located throughout the building during the Assessment.

- Electrical fittings suspected of containing PCB oil capacitors should be treated as containing PCB oils until such time as evidence suggest otherwise e.g. further assessed.
- Electrical fittings that contain or suspected to contain PCB oil-containing capacitors should be removed as hazardous/regulated waste under controlled working conditions prior to the demolition or refurbishment works in accordance with the *Polychlorinated Biphenyls Management Plan, Revised Edition April 2003*.
