# Hazardous Building Materials Assessment Leichhardt Oval No.1 Amenities (Female) Mary Street, Lilyfield NSW 2040

Inner West Council  
April 2018

Prensa Pty Ltd (Prensa) was engaged by Inner West Council (IWC) to conduct a Hazardous Building Materials Assessment (Assessment) of Leichhardt Oval No.1 - Amenities (Female) located at Mary Street, Lilyfield NSW 2040 (the site). Mackenzie Morrison, Andrew Pittaway and Jessica Wood of Prensa conducted the Assessment on 27<sup>th</sup> February 2018 at the request of Rick Jarvis of IWC.

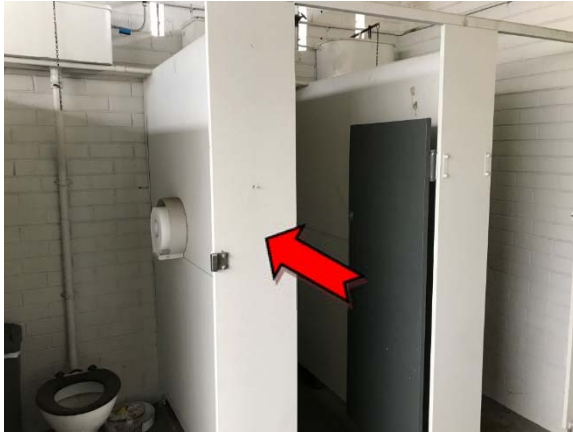
**Photo 1.** Interior, cubicle, front partitions – asbestos-containing compressed cement sheeting.

- Non-friable asbestos was identified in the form of compressed cement sheeting throughout the toilets cubicle front and side partitions.

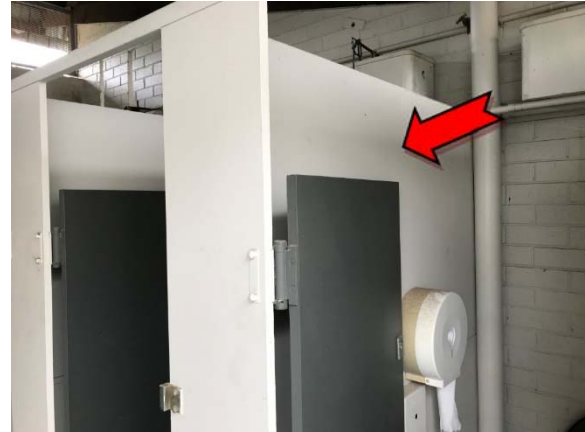
**Photo 2.** Interior, cubicle, side partitions – asbestos-containing compressed cement sheeting.

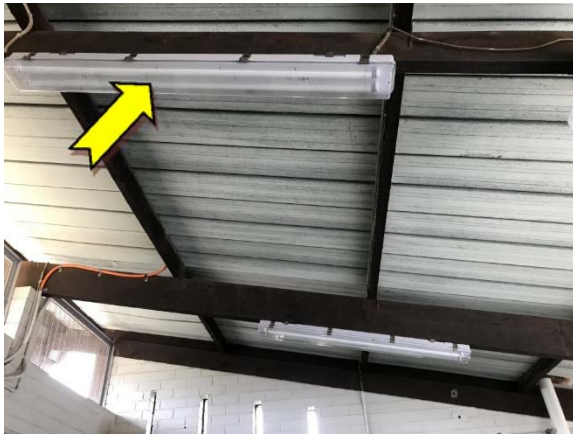
**Photo 3.** Interior, throughout, double tube fluorescent light fitting – suspected PCB-containing capacitors.

- PCBs were suspected within the capacitors of the double tubed fluorescent light fittings located throughout the building.

- Electrical fittings suspected of containing PCB oil capacitors should be treated as containing PCB oils until such time as evidence suggest otherwise e.g. further assessed.
- Electrical fittings that contain or suspected to contain PCB oil-containing capacitors should be removed as hazardous/regulated waste under controlled working conditions prior to the demolition or refurbishment works in accordance with the *Polychlorinated Biphenyls Management Plan, Revised Edition April 2003*.

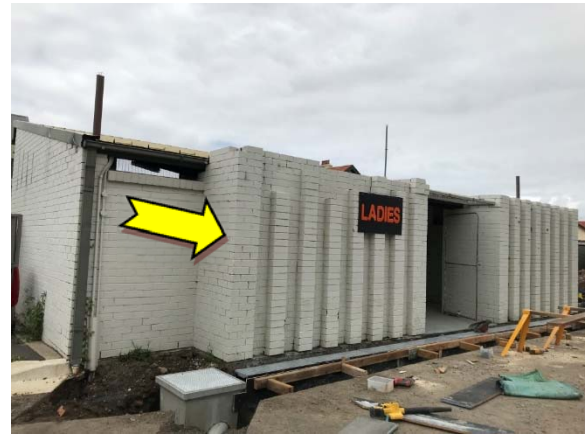
**Photo 4.** Exterior, throughout, walls – suspected lead-containing white upper paint systems.

- LCP was suspected in the form of white and grey upper paint systems throughout the building during the Assessment.

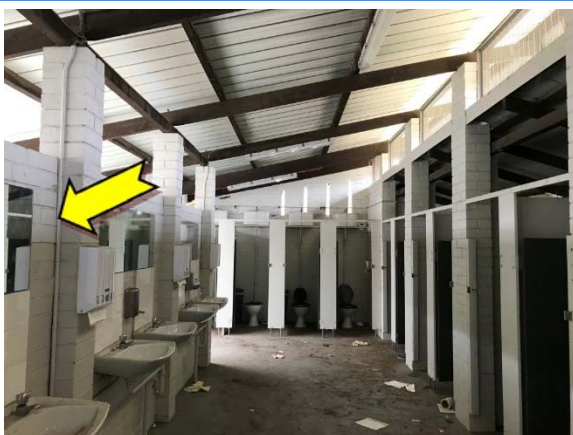
**Photo 5.** Interior, throughout, walls – suspected lead-containing white upper paint systems.

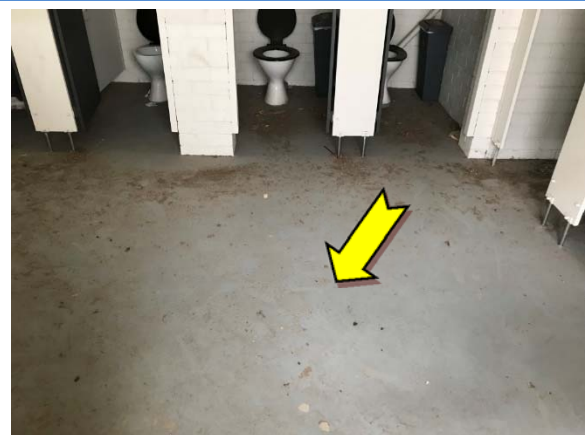
**Photo 6.** Interior, throughout, floors – suspected lead-containing grey upper paint systems.
