Hazardous Building Materials Assessment Leichhardt Oval No. 1 - Grandstand Amenities (west) [Keith Barnes Stand] Mary Street Lilyfield NSW 2040

Inner West Council
April 2018

Job No.: 57722-056

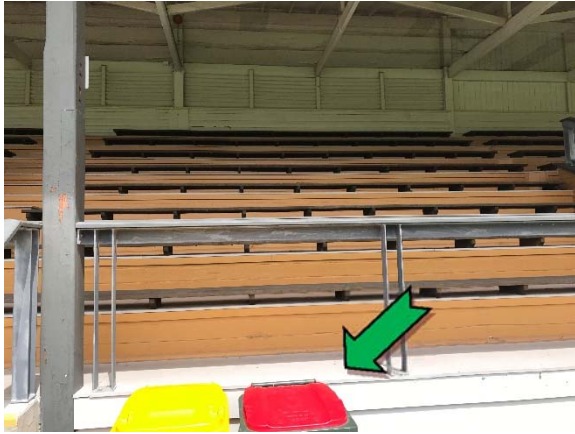
Photo 1. Exterior. Keith Barnes grandstand, floor – non asbestos-containing fibre cement sheeting.

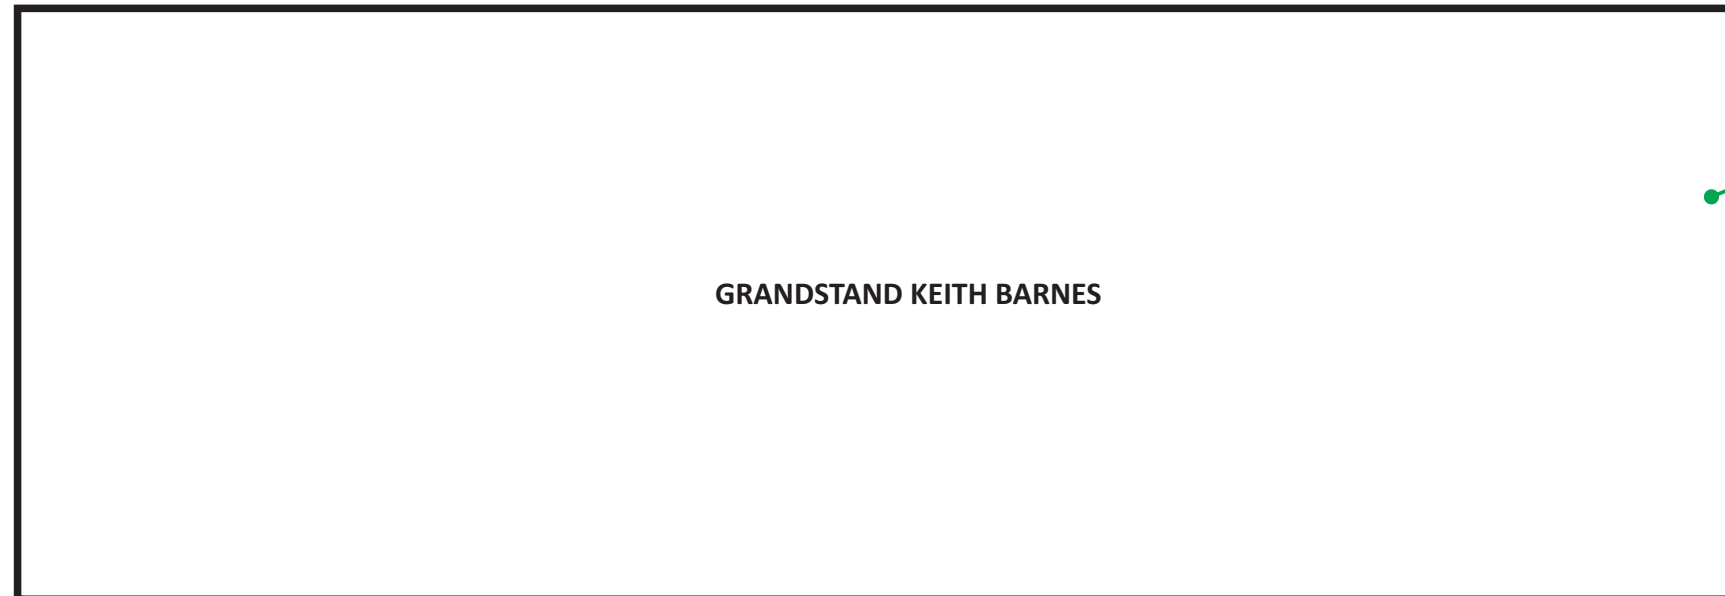
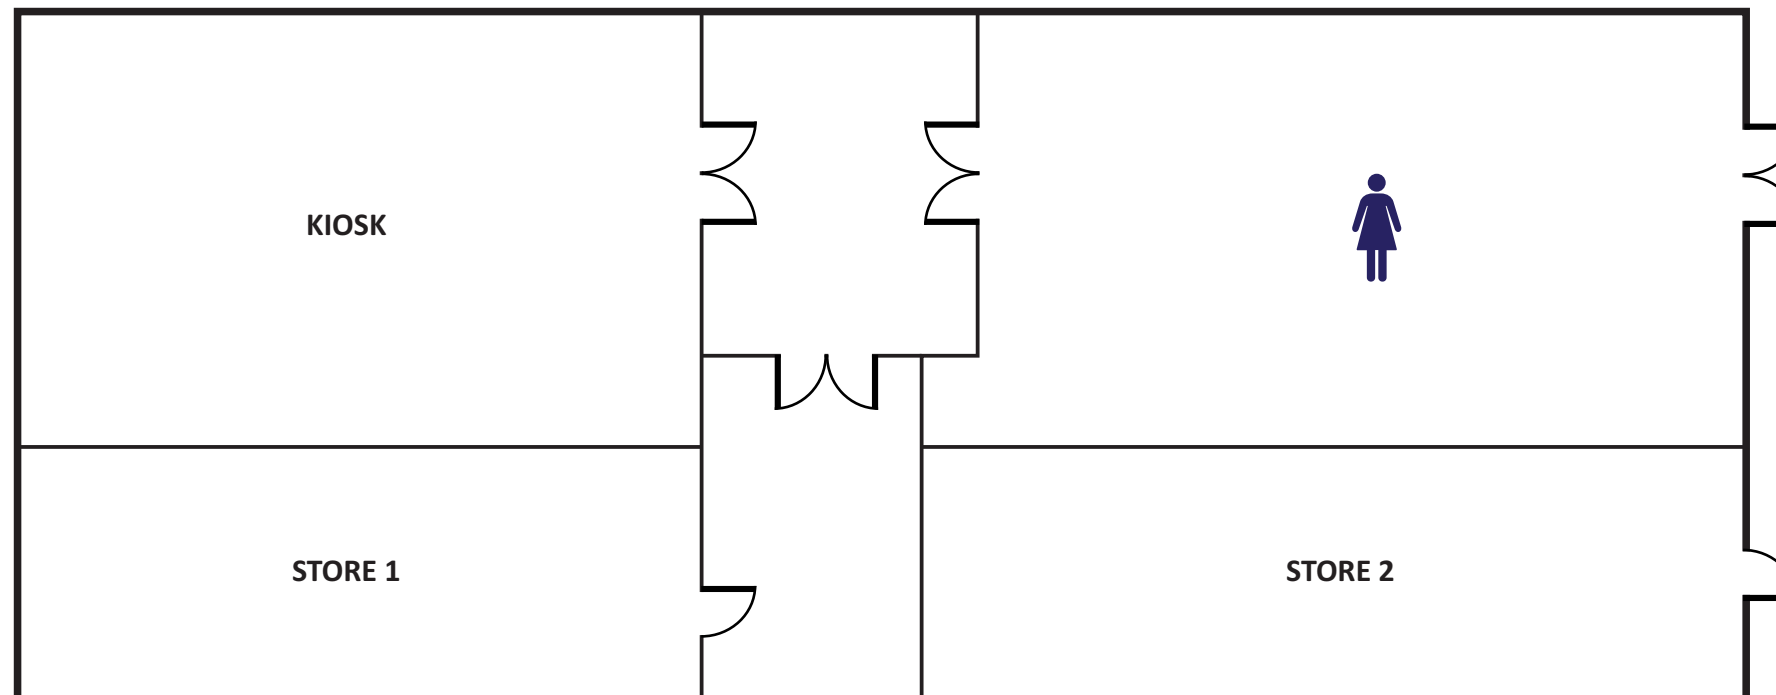
Leichhardt Oval No.1 Grandstand/ Amenities (West) Keith Barnes Stand Lilyfield - Ground Level

Legend: 57722-056-xxx Negative Asbestos Sample
