Hazardous Building Materials Assessment

Leichhardt Oval No.1

Main Grandstand/Clubrooms

Inner West Council
April 2018

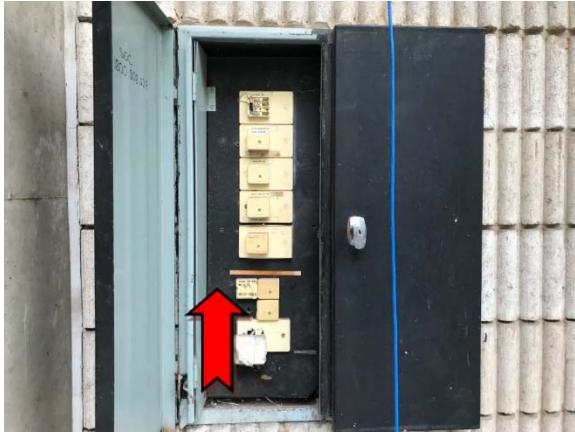
Photo 1. Exterior, west elevation adjacent to main entrance, electrical box – suspected asbestos-containing bituminous backing board.

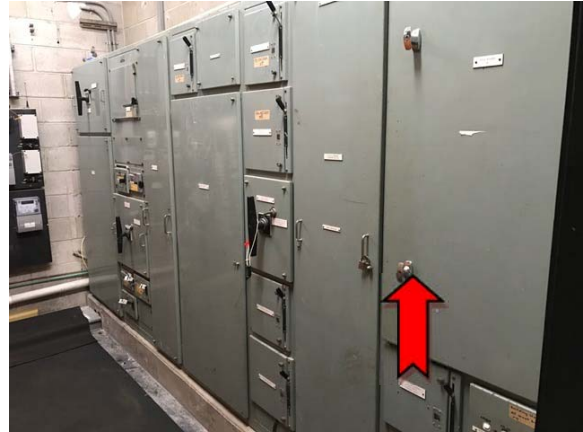
Photo 2. Interior, electrical switch room, electrical backing board – suspected asbestos-containing bituminous backing board.

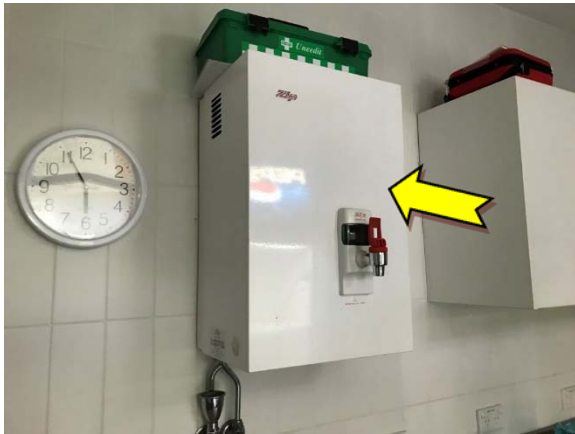
Photo 3. Exterior, west elevation, hot water heater – suspected SMF internal insulation.

- SMF internal insulation was suspected to the hot water heaters to west elevation of building and interior to the back of the bar area.
- SMF was also suspected within air conditioning ductwork running throughout change rooms.

Interior	West elevation	Hot Water Heater	Insulation Material - internal	SMF	-	Suspected Positive	Bonded	Low	Good	Low	6 units	Maintain in current condition if to remain in-situ. Remove under controlled SMF conditions as per the Code of Practice for the Safe Use of Synthetic Mineral Fibres [NOHSC: 2006 (1990)].	-	-	3
Interior	Changerooms, throughout	Air conditioning ductwork	Insulation Material - internal	SMF	-	Suspected Positive	Bonded	Low	Good	Low	5m	Maintain in current condition if to remain in-situ. Remove under controlled SMF conditions as per the Code of Practice for the Safe Use of Synthetic Mineral Fibres [NOHSC: 2006 (1990)].	-	-	-
Interior	Back of bar	Hot Water Heater	Insulation Material - internal	SMF	-	Suspected Positive	Bonded	Low	Good	Low	1 unit	Maintain in current condition if to remain in-situ. Remove under controlled SMF conditions as per the Code of Practice for the Safe Use of Synthetic Mineral Fibres [NOHSC: 2006 (1990)].	-	-	-

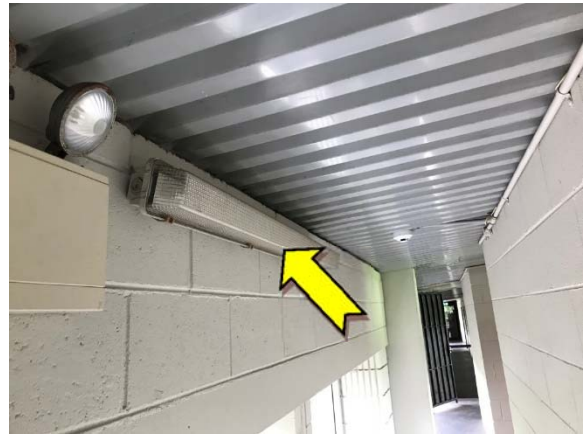
Photo 4. Interior, throughout, fluorescent light fitting - double tube – suspected PCB-containing capacitors.

- Electrical fittings suspected of containing PCB oil capacitors should be treated as containing PCB oils until such time as evidence suggest otherwise e.g. further assessed.
- Electrical fittings that contain or suspected to contain PCB oil-containing capacitors should be removed as hazardous/regulated waste under controlled working conditions prior to the demolition or refurbishment works in accordance with the *Polychlorinated Biphenyls Management Plan, Revised Edition April 2003*.

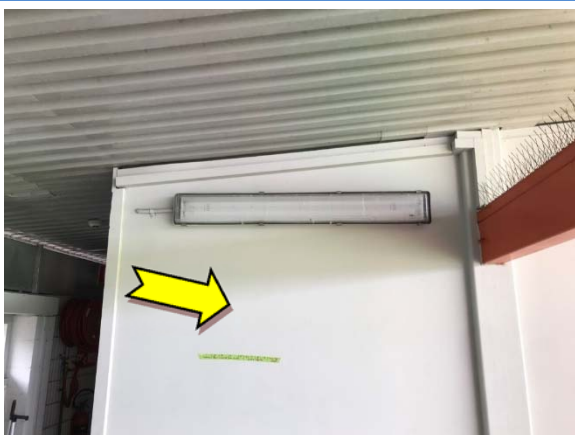
Photo 5. Interior change rooms throughout, walls – suspected lead-containing white upper paint system.

Interior	Changerooms, throughout	Walls	Black - upper coloured paint system	Lead Paint - Swab	-	Suspected Positive	-	Low	Good	Low	400 m ²	Confirm status by quantitative test method, maintain in current condition, over paint with a lead-free paint as part of ongoing maintenance. Remove under controlled conditions in accordance with AS 4361.2:2017 Guide to hazardous paint management prior to renovation or demolition works.	-	-	-
Interior	Throughout	Door frame	Black - upper coloured paint system	Lead Paint - Swab	-	Suspected Positive	-	Low	Good	Low	60 m	Confirm status by quantitative test method, maintain in current condition, over paint with a lead-free paint as part of ongoing maintenance. Remove under controlled conditions in accordance with AS 4361.2:2017 Guide to hazardous paint management prior to renovation or demolition works.	-	-	-
Interior	Throughout	Door	Orange - upper coloured paint system	Lead Paint - Swab	-	Suspected Positive	-	Low	Good	Low	60 m ²	Confirm status by quantitative test method, maintain in current condition, over paint with a lead-free paint as part of ongoing maintenance. Remove under controlled conditions in accordance with AS 4361.2:2017 Guide to hazardous paint management prior to renovation or demolition works.	-	-	-

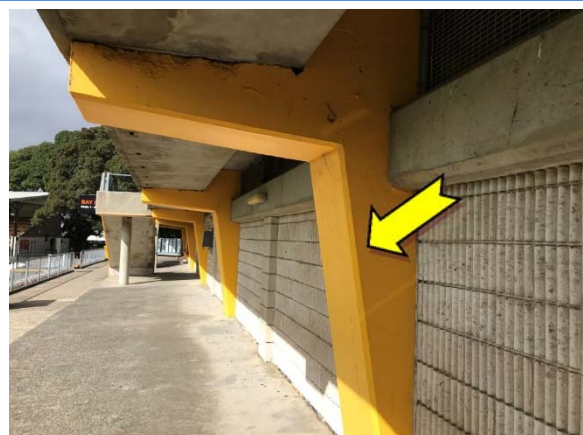
Photo 6. Exterior, throughout, features – suspected lead-containing yellow upper paint system.

Exterior	Throughout	Features	Yellow - upper coloured paint system	Lead Paint - Swab	-	Suspected Positive	-	Low	Good	Low	200 m ²	Confirm status by quantitative test method, maintain in current condition, over paint with a lead-free paint as part of ongoing maintenance. Remove under controlled conditions in accordance with AS 4361.2:2017 Guide to hazardous paint management prior to renovation or demolition works.	-	-	6
Interior, level 1	Throughout	Floor	Yellow - lower coloured paint system	Lead Paint - Swab	-	Suspected Positive	-	Low	Good	Low	60 m ²	Confirm status by quantitative test method, maintain in current condition, over paint with a lead-free paint as part of ongoing maintenance. Remove under controlled conditions in accordance with AS 4361.2:2017 Guide to hazardous paint management prior to renovation or demolition works.	-	-	-
Interior, level 1	Throughout	Floor	Red - lower coloured paint system	Lead Paint - Swab	-	Suspected Positive	-	Low	Good	Low	60 m ²	Confirm status by quantitative test method, maintain in current condition, over paint with a lead-free paint as part of ongoing maintenance. Remove under controlled conditions in accordance with AS 4361.2:2017 Guide to hazardous paint management prior to renovation or demolition works.	-	-	-

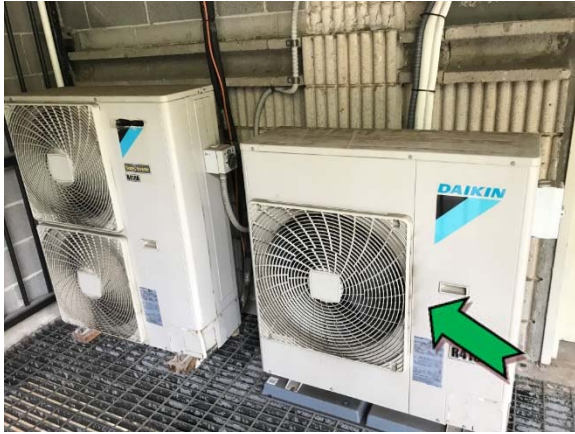
Photo 7. Exterior, west elevation central staircase, air conditioning unit – suspected negative ODS.

- No ODS-containing air conditioning units were identified or suspected during the Assessment.
