Hazardous Building Materials Assessment Leichhardt Oval No.1 Pump Room (East) Mary Street Lilyfield NSW 2040

Inner West Council
April 2018

Job No.: 57722-058

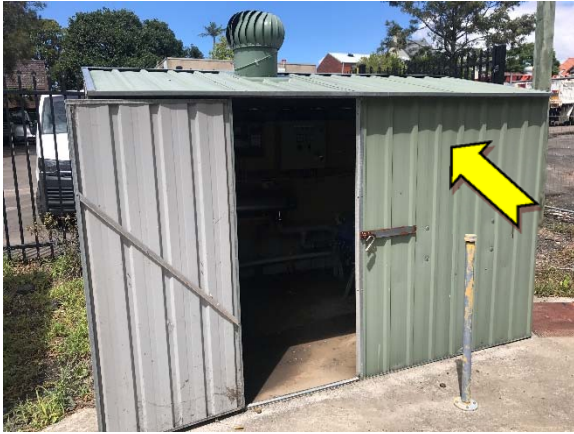
Area / Level	Room & Location	Feature	Item Description	Hazard Type	Sample No.	Sample Status	Friability	Disturb. Potential	Condition	Risk Status	Approx. Quantity	Recommendations & Comments	Control Priority	Reinspect Date	Photo No.
Throughout	-	-	-	Asbestos	-	-	-	-	-	-	-	No suspect asbestos material identified at the time of the assessment.	-	-	-
Throughout	-	-	-	SMF	-	-	-	-	-	-	-	No suspect SMF material identified at the time of the assessment.	-	-	-
Throughout	-	-	-	PCBs	-	-	-	-	-	-	-	No suspect PCB-containing capacitors identified at the time of the assessment.	-	-	-
Exterior	Pump room	Walls and roof	Green (dark) - upper coloured paint system	Lead Paint - Swab	-	Suspected Positive	-	Low	Good	Low	20 m ²	Confirm status by quantitative test method, maintain in current condition, over paint with a lead-free paint as part of ongoing maintenance. Remove under controlled conditions in accordance with AS 4361.2:2017 Guide to hazardous paint management prior to renovation or demolition works.	-	-	1

Photo Exterior, throughout, walls and ceiling -
1. suspected lead-containing green upper paint system.

- LCP was suspected to green upper coloured paint systems to exterior walls and ceiling throughout.

- The *LeadCheck* paint swab method can detect lead in paint at concentrations of 0.5% and above, and may indicate lead in some paint films as low as 0.2%. As paint with a lead content greater than 0.1% by dry weight is now considered to be lead-containing, Prensa recommends confirming status of suspected LCP identified during the Assessment by quantitative test method.

- The safest method of dealing with LCP is to replace or remove the items in their entirety that have LCP on them and replace them with new items that do not contain lead. This allows the items to be disposed of as regular building or demolition unsegregated waste in accordance with the NSW Environment Protection Authority (EPA) *Waste Classification Guidelines 2014 Part 1 – Classifying Waste*. The advantage of this method is the reduction in labour requirements to remove the lead paint and also this reduces the risk to workers from exposure to lead dust or fumes. If the removal of the LCP or coatings is the preferred or required option this may generate significant amounts of potential hazardous waste. This waste must be removed, collected and disposed of by an appropriately licensed contractor under controlled conditions that minimises the release to air, water and soil. Disposal of lead waste must be disposed of as hazardous waste at an approved waste facility.

- Advise all relevant site personnel and site contractors of the results of the LCP and the safe work procedures required and/or work practices to be avoided in the areas of confirmed LCP.

- Any remediation works that may generate dust or fumes (i.e. sanding, burning) must be performed under controlled conditions by a suitably resourced and experienced hazardous material/waste abatement contractor (e.g. a Class A licensed asbestos removal contractor).
