Hazardous Building Materials Assessment Leichhardt Oval No.1 – Pump Room (South) Mary Street, Lilyfield NSW 2040

Inner West Council
April 2018

Job No.: 57722-154

Count ID: CID: 214

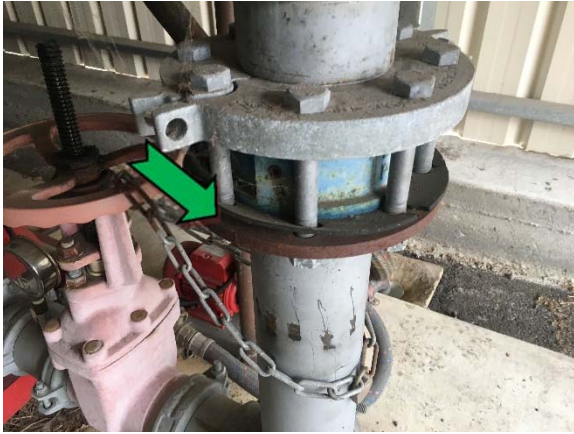
Photo 1. Interior, fire suppression pump system, gasket – non asbestos-containing gasket material.
