Hazardous Building Materials Assessment Leichhardt Oval No.1 - Scoreboard & Kiosk Mary Street Lilyfield NSW 2040

Inner West Council
April 2018

Job No.: 57722-055

Count ID: CID: 216

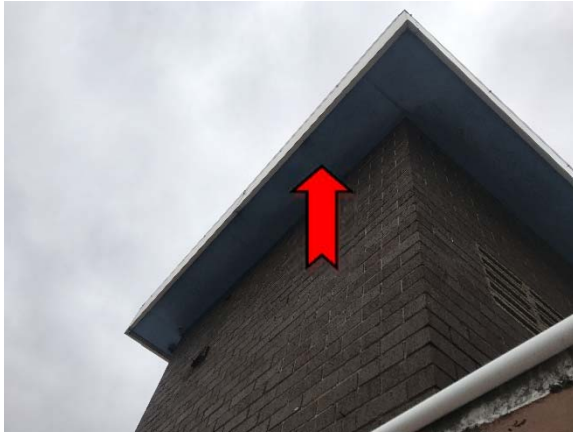
Photo 1. Exterior, throughout, eaves – suspected asbestos-containing fibre cement sheeting.

- Non-friable asbestos was suspected in the form of fibre cement sheeting eaves throughout the exterior of the building.

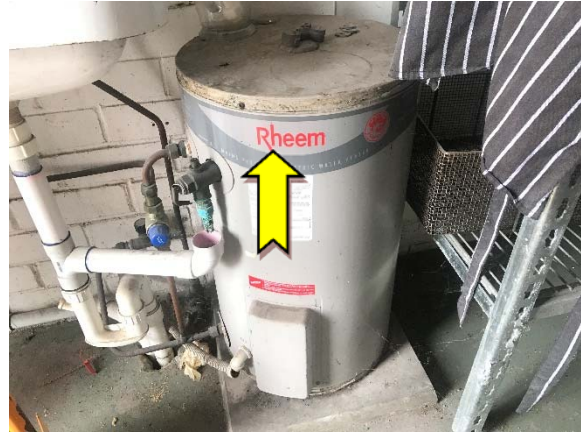
Photo 2. Interior, ground level, canteen, hot water heater – suspected SMF internal insulation.

- Suspected SMF internal insulation was located within hot water heater located in the canteen and in the form of sarking insulation to the first floor.

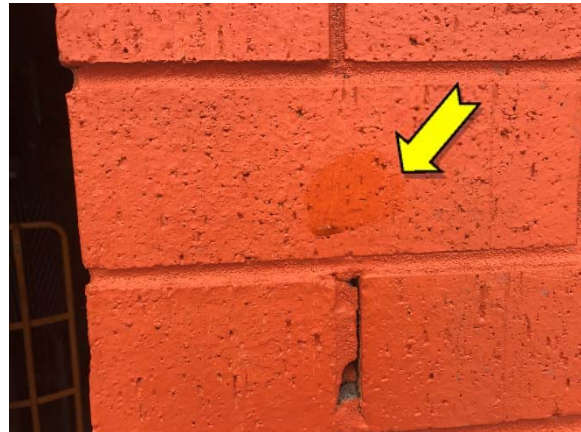
Photo 4. Exterior, throughout, walls – suspected lead-containing orange upper paint system.

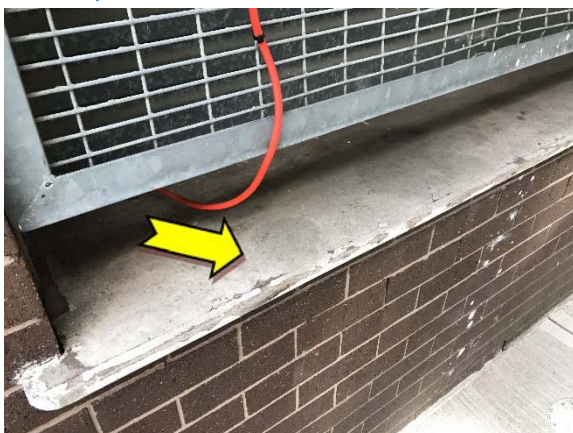
Photo 5. Exterior, throughout, window frames – suspected lead-containing white upper paint system.

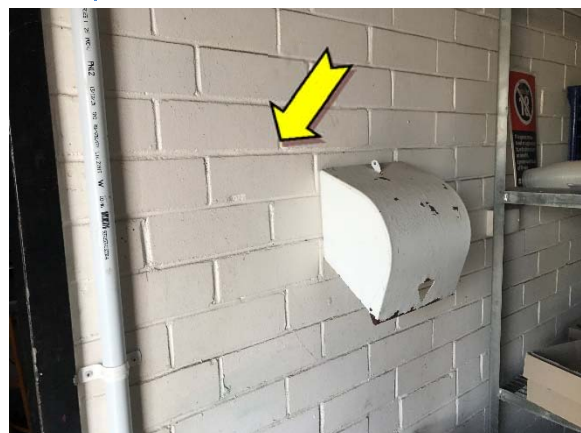
Photo 6. Interior, throughout, walls – suspected lead-containing white upper paint system.
