Hazardous Building Materials Assessment Leichhardt Oval No. 1 – Turnstiles (Glover St) Glover Street, Lilyfield NSW 2040

Inner West Council
April 2018

Job No.: 57722-155

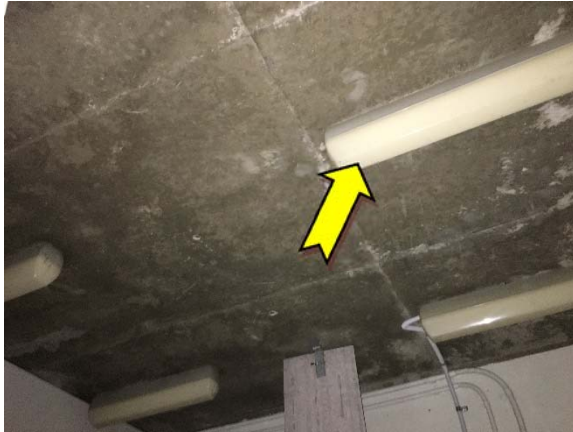
Photo 1. Interior, cashier area, ceiling – suspected PCB-containing capacitors.

- PCBs were suspected within the capacitors of the single tubed fluorescent light fittings located in the cashier area and back of house area.

- Electrical fittings suspected of containing PCB oil capacitors should be treated as containing PCB oils until such time as evidence suggest otherwise e.g. further assessed.
- Electrical fittings that contain or suspected to contain PCB oil-containing capacitors should be removed as hazardous/regulated waste under controlled working conditions prior to the demolition or refurbishment works in accordance with the *Polychlorinated Biphenyls Management Plan, Revised Edition April 2003*.

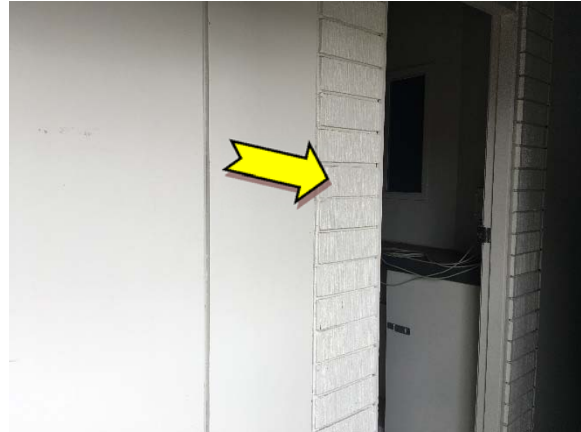
Interior	Throughout	Walls	White - upper coloured paint system	Lead paint - Swab	-	Suspected Positive	-	Low	Good	Low	60m ²	Confirm status by quantitative test method, maintain in current condition, over paint with a lead-free paint as part of ongoing maintenance. Remove under controlled conditions in accordance with AS 4361.2:2017 Guide to hazardous paint management prior to renovation or demolition works.	-	-	2
Throughout	-	-	-	Ozone Depleting Substances	-	-	-	-	-	-	-	No suspect ODS's identified at the time of the assessment.	-	-	-

Photo 2. Interior, throughout, walls – suspected lead-containing white upper paint systems.

- LCP was suspected in the form of white upper paint systems throughout the walls in the building.

- The *LeadCheck* paint swab method can detect lead in paint at concentrations of 0.5% and above, and may indicate lead in some paint films as low as 0.2%. As paint with a lead content greater than 0.1% by dry weight is now considered to be lead-containing, Prensa recommends confirming status of suspected LCP identified during the Assessment by quantitative test method.

- The safest method of dealing with LCP is to replace or remove the items in their entirety that have LCP on them and replace them with new items that do not contain lead. This allows the items to be disposed of as regular building or demolition unsegregated waste in accordance with the NSW Environment Protection Authority (EPA) *Waste Classification Guidelines 2014 Part 1 – Classifying Waste*. The advantage of this method is the reduction in labour requirements to remove the lead paint and also this reduces the risk to workers from exposure to lead dust or fumes. If the removal of the LCP or coatings is the preferred or required option this may generate significant amounts of potential hazardous waste. This waste must be removed, collected and disposed of by an appropriately licensed contractor under controlled conditions that minimises the release to air, water and soil. Disposal of lead waste must be disposed of as hazardous waste at an approved waste facility.
