Hazardous Building Materials Assessment Leichhardt Oval No.1 - Turnstiles (Mary St) Mary Street, Lilyfield NSW 2040

Inner West Council
April 2018

Job No.: 57722-146

Executive Summary

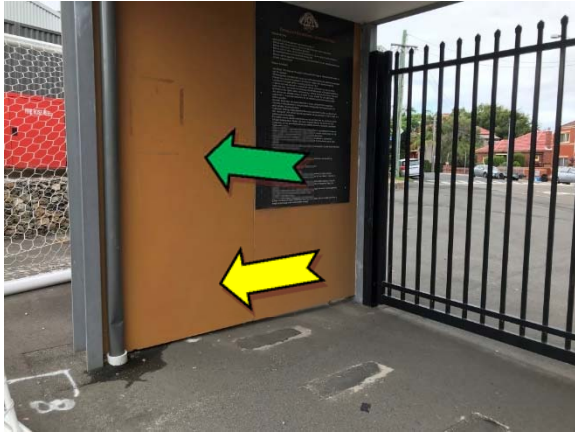
Photo 1. Exterior, throughout, walls – non asbestos-containing fibre cement sheeting and suspected lead-containing orange upper paint systems.

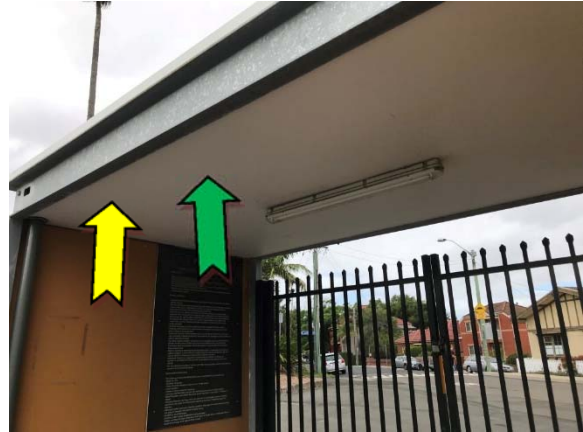
Photo 2. Exterior, throughout, ceiling – non asbestos-containing fibre cement sheeting and suspected lead-containing white upper paint system.

Exterior	Throughout	Ceiling	White - upper coloured paint system	Lead Paint - Swab	-	Suspected Positive	-	Low	Good	Low	20m ²	Confirm status by quantitative test method, maintain in current condition, over paint with a lead-free paint as part of ongoing maintenance. Remove under controlled conditions in accordance with AS 4361.2:2017 Guide to hazardous paint management prior to renovation or demolition works.	-	-	2
Throughout	-	-	-	Ozone Depleting Substances	-	-	-	-	-	-	-	No suspect ODS's identified at the time of the assessment.	-	-	-
