Hazardous Building Materials Assessment Leichhardt Oval No.1 – Underground Toilets Mary Street, Lilyfield NSW 2040

Inner West Council
April 2018

Prensa Pty Ltd (Prensa) was engaged by Inner West Council (IWC) to conduct a Hazardous Building Materials Assessment (Assessment) of Leichhardt Oval No.1 – Underground Toilets located at Mary Street, Lilyfield NSW 2040 (the site). Mackenzie Morrison, Charly Golding and Jessica Wood of Prensa conducted the Assessment on 27th February 2018 at the request of Rick Jarvis of IWC.

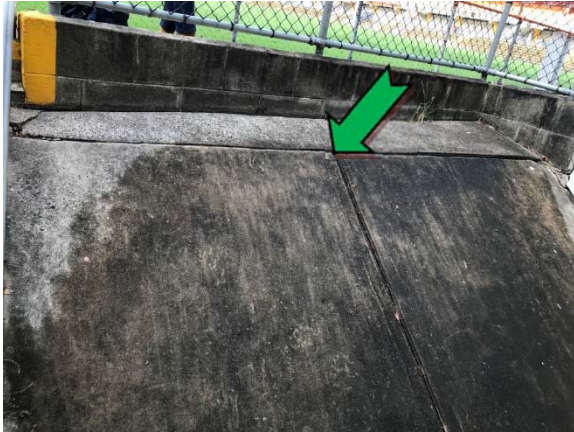
Photo 1. Exterior, floor, expansion joint – non asbestos-containing construction joint mastic.

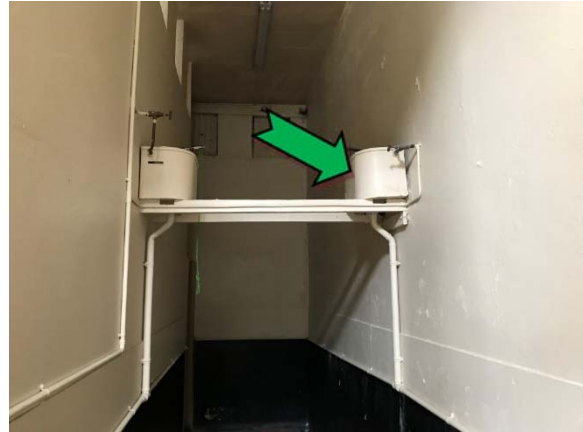
Photo 2. Interior, men's toilet, cistern – non asbestos-containing moulded fibre cement.

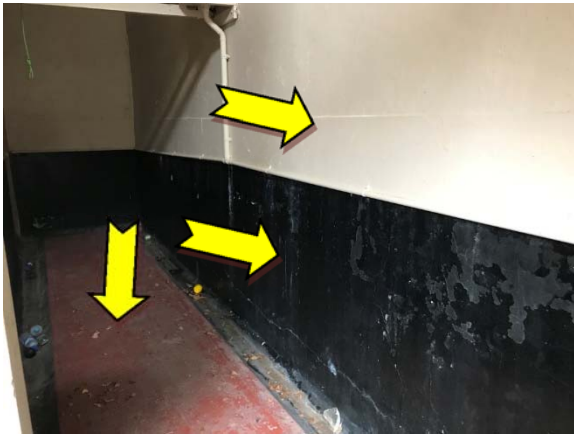
Interior	Mens toilet, low level	Walls	Black - upper coloured paint system	Lead Paint - Swab	-	Suspected Positive	-	Low	Good	Low	20 m ²	Confirm status by quantitative test method, maintain in current condition, over paint with a lead-free paint as part of ongoing maintenance. Remove under controlled conditions in accordance with AS 4361.2:2017 Guide to hazardous paint management prior to renovation or demolition works.	-	-	3
Interior	Mens toilet, throughout	Floor	Red - upper coloured paint system	Lead Paint - Swab	-	Suspected Positive	-	Low	Good	Low	20 m ²	Confirm status by quantitative test method, maintain in current condition, over paint with a lead-free paint as part of ongoing maintenance. Remove under controlled conditions in accordance with AS 4361.2:2017 Guide to hazardous paint management prior to renovation or demolition works.	-	-	3
Interior	Mens toilet, throughout	Ceiling	Cream - upper coloured paint system	Lead Paint - Swab	-	Suspected Positive	-	Low	Good	Low	20 m ²	Confirm status by quantitative test method, maintain in current condition, over paint with a lead-free paint as part of ongoing maintenance. Remove under controlled conditions in accordance with AS 4361.2:2017 Guide to hazardous paint management prior to renovation or demolition works.	-	-	-

Photo 3. Interior, throughout, walls and floor – suspected lead-containing cream, black and red upper coloured paint systems.

- LCP was suspected in cream, black and red upper coloured paint systems throughout the interior of the building.

- The *LeadCheck* paint swab method can detect lead in paint at concentrations of 0.5% and above, and may indicate lead in some paint films as low as 0.2%. As paint with a lead content greater than 0.1% by dry weight is now considered to be lead-containing, Prensa recommends confirming status of suspected LCP identified during the Assessment by quantitative test method.

- The safest method of dealing with LCP is to replace or remove the items in their entirety that have LCP on them and replace them with new items that do not contain lead. This allows the items to be disposed of as regular building or demolition unsegregated waste in accordance with the NSW Environment Protection Authority (EPA) *Waste Classification Guidelines 2014 Part 1 – Classifying Waste*. The advantage of this method is the reduction in labour requirements to remove the lead paint and also this reduces the risk to workers from exposure to lead dust or fumes. If the removal of the LCP or coatings is the preferred or required option this may generate significant amounts of potential hazardous waste. This waste must be removed, collected and disposed of by an appropriately licensed contractor under controlled conditions that minimises the release to air, water and soil. Disposal of lead waste must be disposed of as hazardous waste at an approved waste facility.

- Advise all relevant site personnel and site contractors of the results of the LCP and the safe work procedures required and/or work practices to be avoided in the areas of confirmed LCP.

- Any remediation works that may generate dust or fumes (i.e. sanding, burning) must be performed under controlled conditions by a suitably resourced and experienced hazardous material/waste abatement contractor (e.g. a Class A licensed asbestos removal contractor).
