# Hazardous Building Materials Assessment

## Whites Creek Cottage

31-39 White Street,  
Lilyfield NSW 2040

Inner West Council  
April 2018

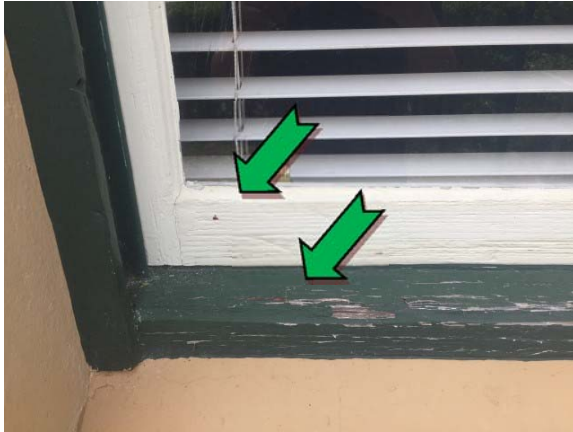
**Photo 1.** Exterior, western elevation, window frames – non asbestos-containing window caulking and lead-containing green and white upper coloured paint systems.

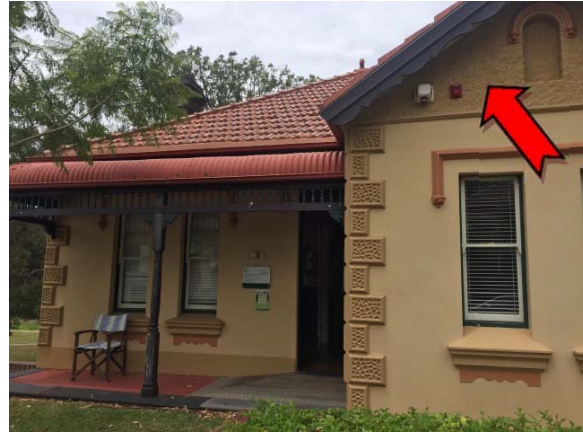
**Photo 2.** Exterior, western elevation, at height, walls – suspected asbestos-containing textured coatings.

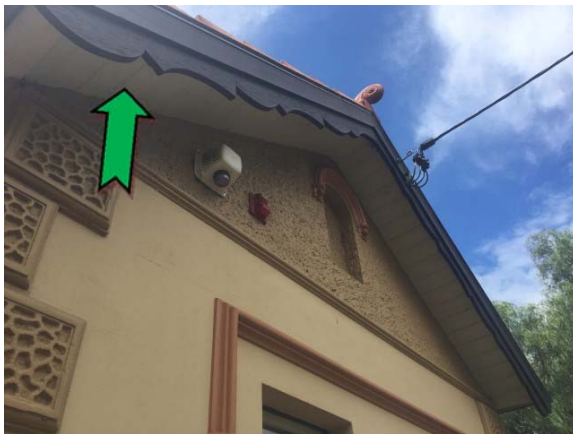
**Photo 3.** Exterior, throughout, eaves – suspected non asbestos-containing material.

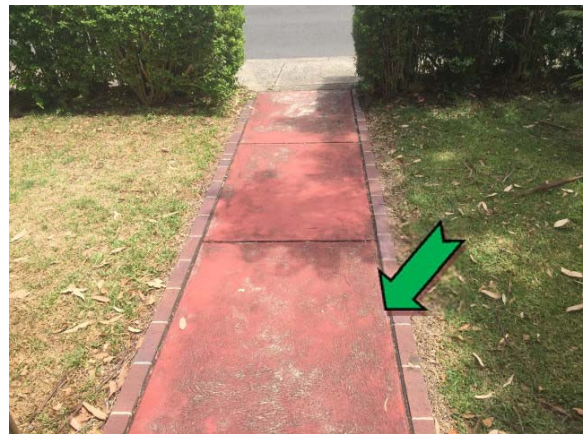
**Photo 4.** Exterior, west elevation, foot path – non asbestos-containing bituminous material.

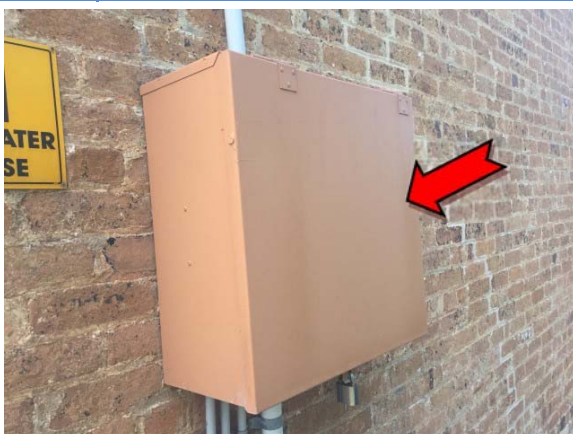
**Photo 5.** Exterior, south-west elevation, electrical backing board – suspected bituminous backing board.

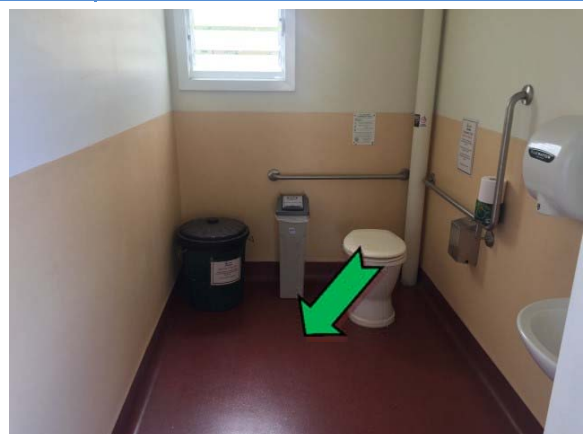
**Photo 6.** Interior, eastern elevation, disabled toilet, red floor coverings – suspected non-asbestos containing sheet vinyl.

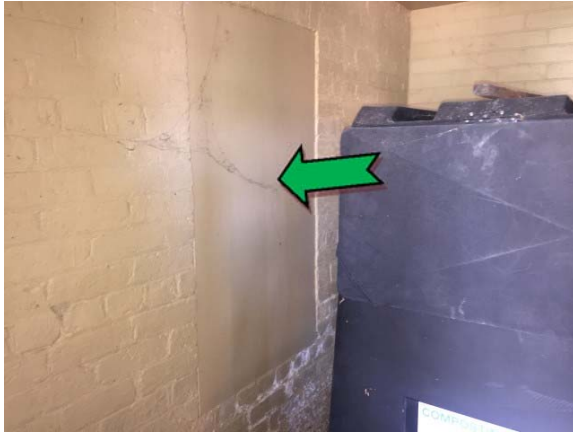
**Photo 7.** Interior, lower ground, toilet, tank room, western wall – non asbestos-containing fibre cement sheeting.

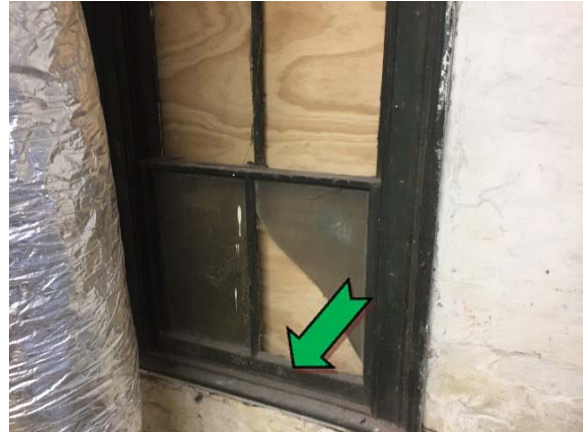
**Photo 8.** Interior, lower ground, storage room 1, eastern wall, window frames – non asbestos-containing window caulking.

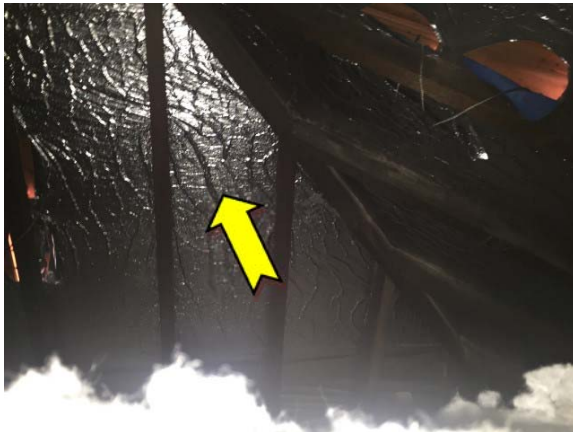
**Photo 9.** Interior, ground level, throughout, ceiling space – suspected SMF sarking insulation .

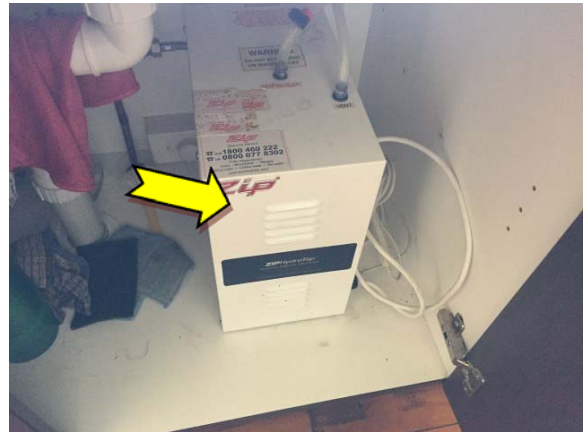
**Photo 10.** Interior, ground level, kitchen, hot water heater – suspected SMF internal insulation material.

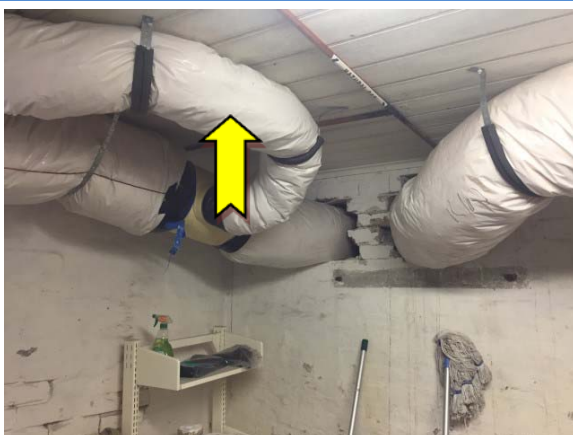
**Photo 11.** Interior, lower ground, storage room 1, flexible ductwork – suspected SMF internal insulation material.

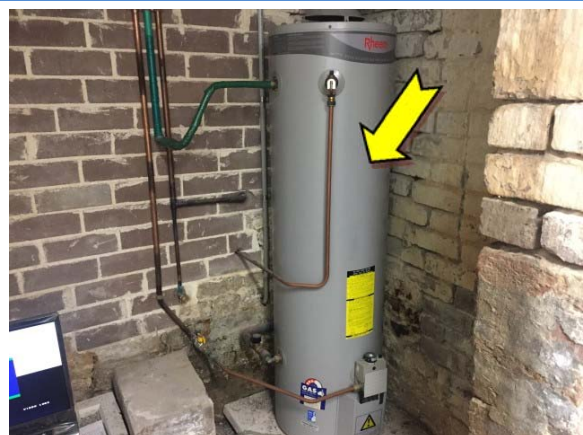
**Photo 12.** Interior, lower ground, storage room 2, hot water heater – suspected SMF internal insulation material.

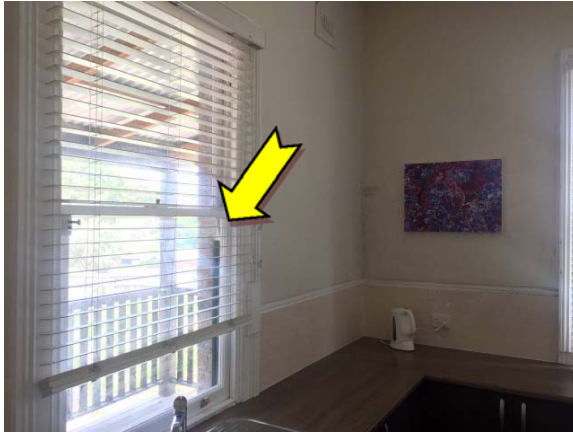
**Photo 13.** Interior, throughout, window frames – lead-containing white upper paint systems.

- Remove flaking lead containing paint to window surrounds throughout the property in accordance with AS4361.2-2017 Guide to Hazardous Paint Management and relevant legislation.

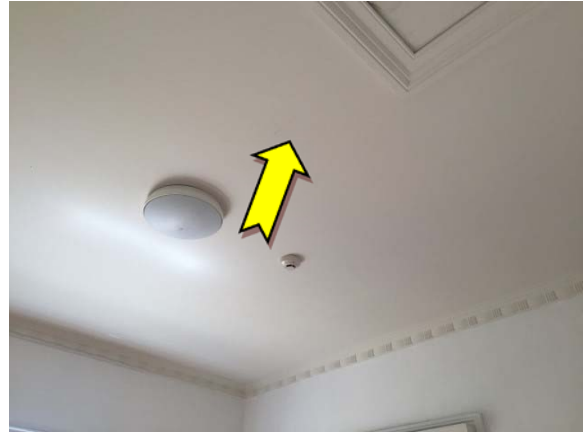
**Photo 14.** Interior, throughout, ceiling – suspected lead-containing white upper paint systems.

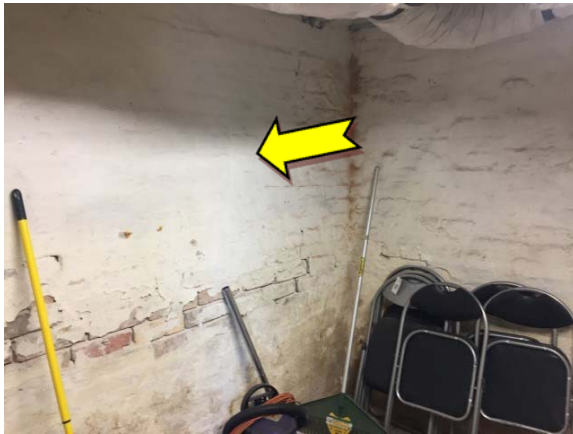
**Photo 15.** Interior, lower ground, walls – suspected lead-containing white upper paint systems.
